BRIDGE NO. 1
STRUCTURE 002-0005
FOR INFORMATION ONLY

BRIDGE REPAIRS
OLD CAIRO BRIDGE OVER MISSISSIPPI RIVER
FAS RTE. 944 (US 60 & 62)
SEC. (138D-BR)I-5
ALEXANDER COUNTY
SN 002-0005

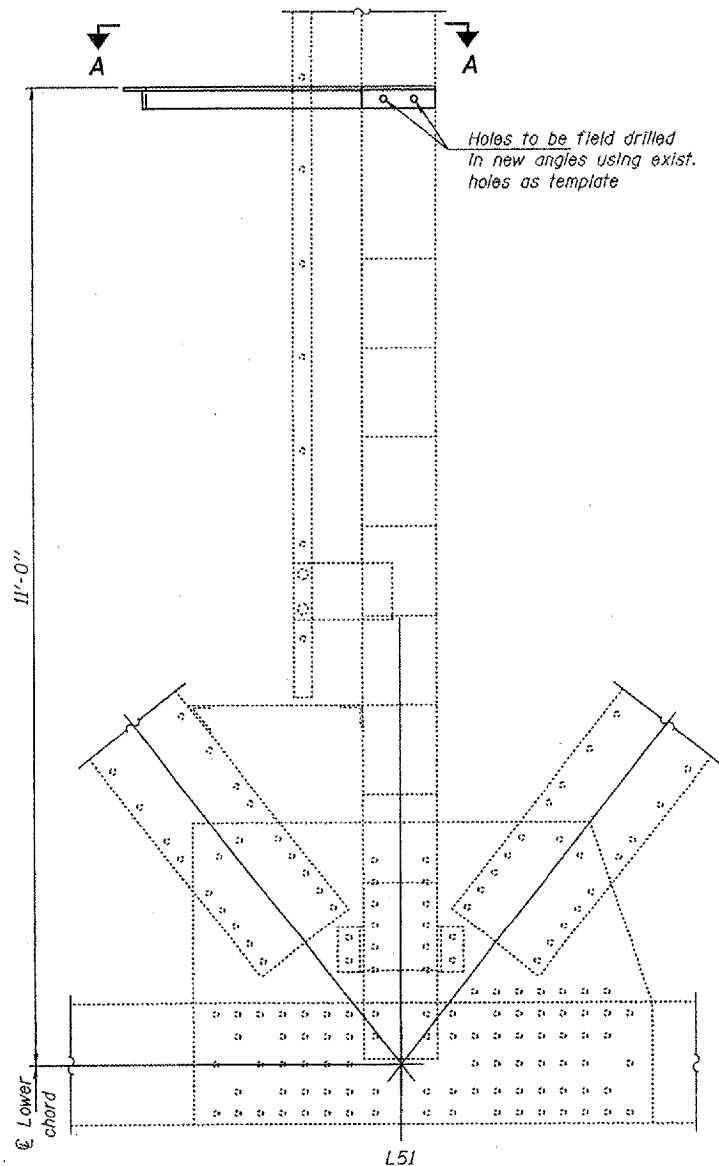
REPAIR 10
SAFETY LOOP ANGLE REPAIR
Typ. each truss

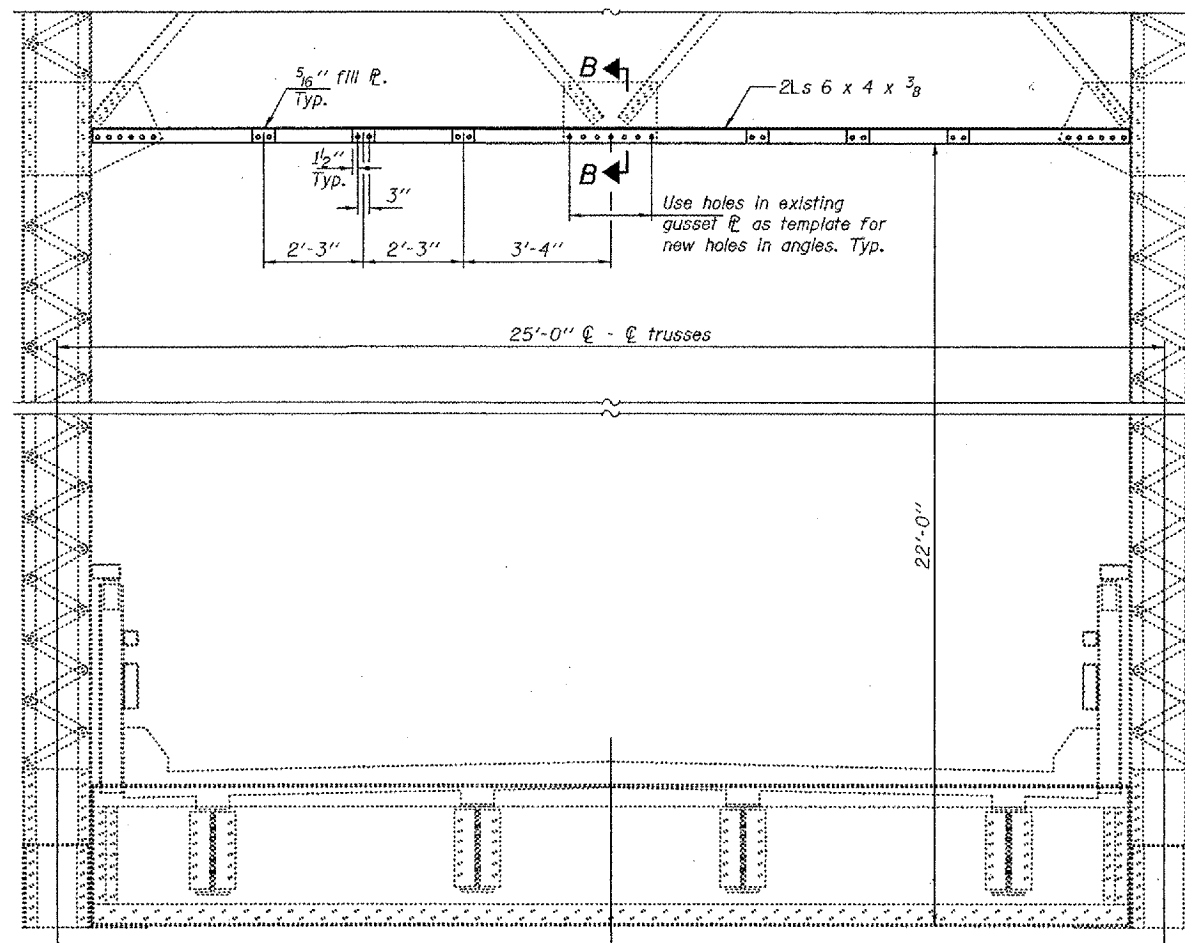
REPAIR 11
CROSS SECTION
STRUT REPAIR AT PANEL POINT 66
