ILLINOIS
CONTRACT NO. 66365
Sheet 14 of 18

Rehabilitation Project

PIER 2 REPAIR DETAILS
U.S. RTE. 45/52 OVER
SOUTH BRANCH ROCK CREEK
F.A.P. RTE. 330 - SECTION 16BR
KANKAKEE COUNTY
STA. 356+17.50 - STR. NO. 046-0047

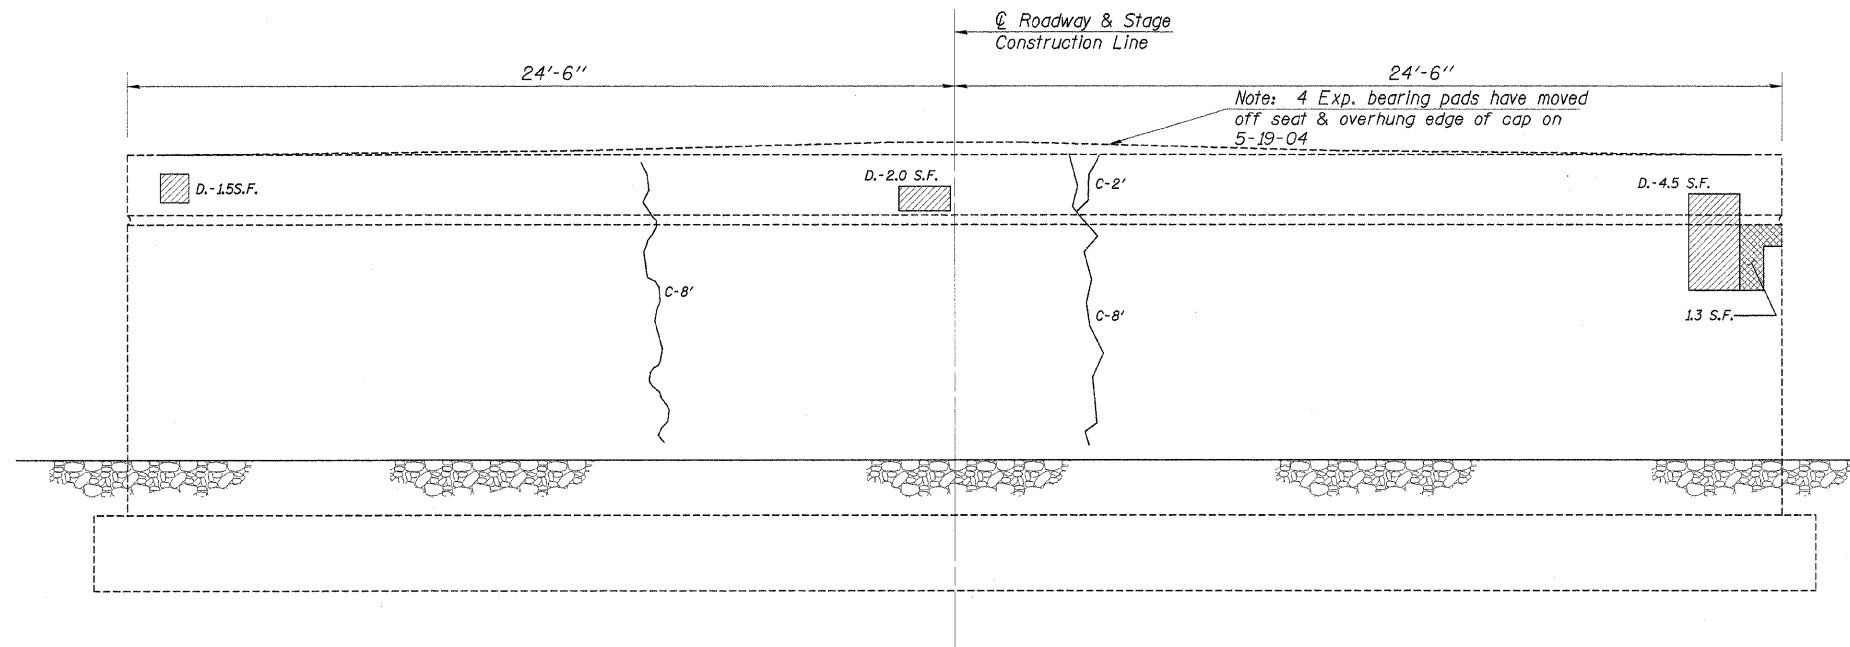
SOUTH ELEVATION - PIER 2

NOTE: PIER 2 CRACK REPAIR LENGTHS AND F.C.R. AREAS ARE ESTIMATED FROM 5-19-04 SURVEY WORK. ACTUAL LOCATIONS AND QUANTITIES OF REPAIRS SHALL BE SHOWN BY THE ENGINEER ON AS-BUILT PLANS FOR THIS SECTION.
