STATE OF ILLINOIS
 DEPARTMENT OF TRANSPORTATION

BEAM STRAIGHTENING DETAILS
 SN 016-2068

SHEET NO. 2 OF 7 SHEETS

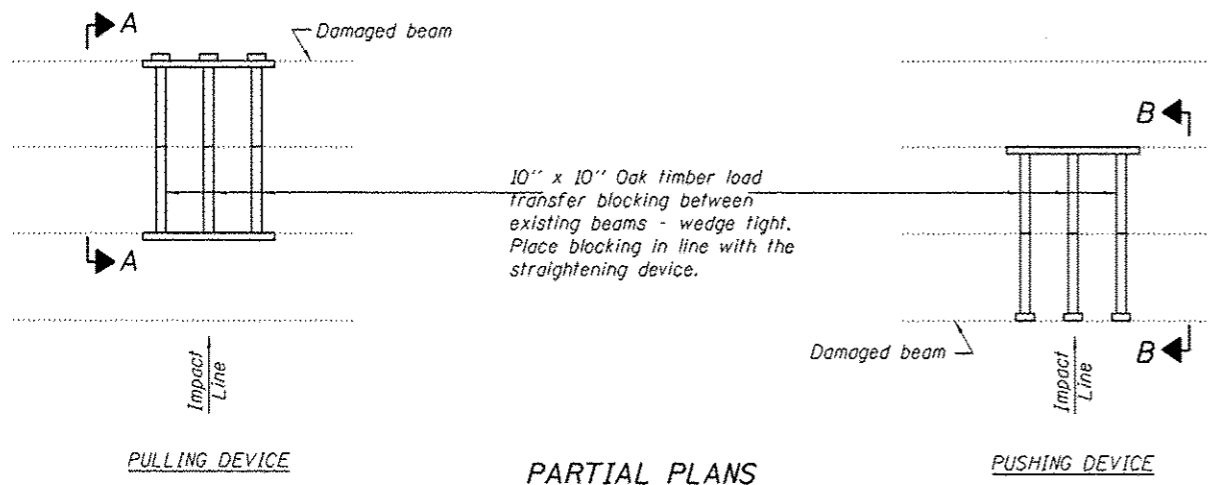
EXISTING DEFORMATION TO BE STRAIGHTENED
 (Looking West)
 (Approximate max. deflections)
 Deflected length of beam to be straightened is approximately 4'.

PARTIAL PLANS
SUGGESTED BEAM STRAIGHTENING METHODS
 Straightening force shall be maintained on all load transfer blocking during beam straightening.
