**STATE OF ILLINOIS
 DEPARTMENT OF TRANSPORTATION**

**REPAIRS TO - PIER NUMBER 20 - COLUMNS
 STRUCTURE NO. 060-0255**

SHEET NO. 44 OF 48 SHEETS

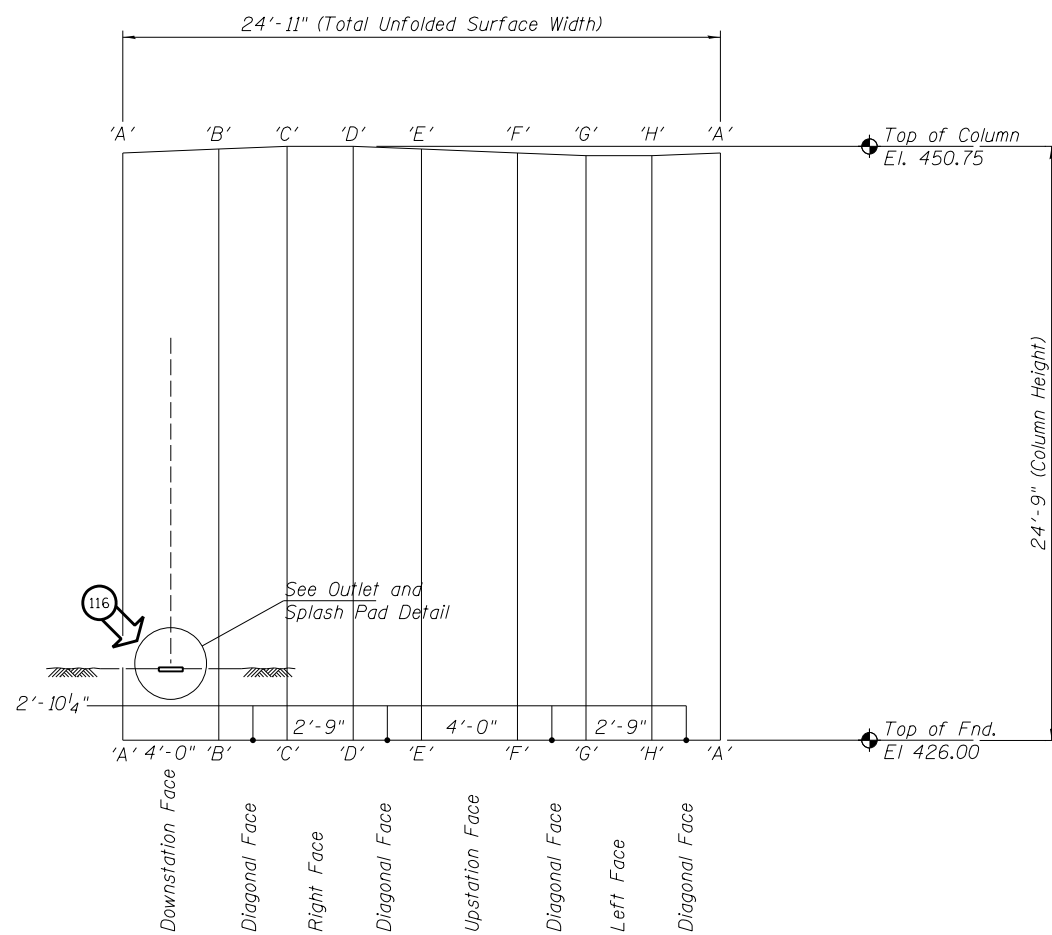
PIER NO. 20 - ELEVATION - LEFT COLUMN
 Column Surface Shown Unfolded

I.D.	Description	Pay Item	Units	Quantity
116	Erosion Under Drain Outlet	Slope Wall 6 Inch	SQ. YD.	1.78
117	Gaffiti on Concrete	Graffiti Removal	SQ. YD.	19.37
-	-	-	-	-
-	-	-	-	-
-	-	-	-	-
-	-	-	-	-
