SN 099-0008

I-55 (South Bound) over Des Plaines River Smith Bridge

2021 Bridge Inspection Report

Bridge Inspection By: The Illinois Department of Transportation

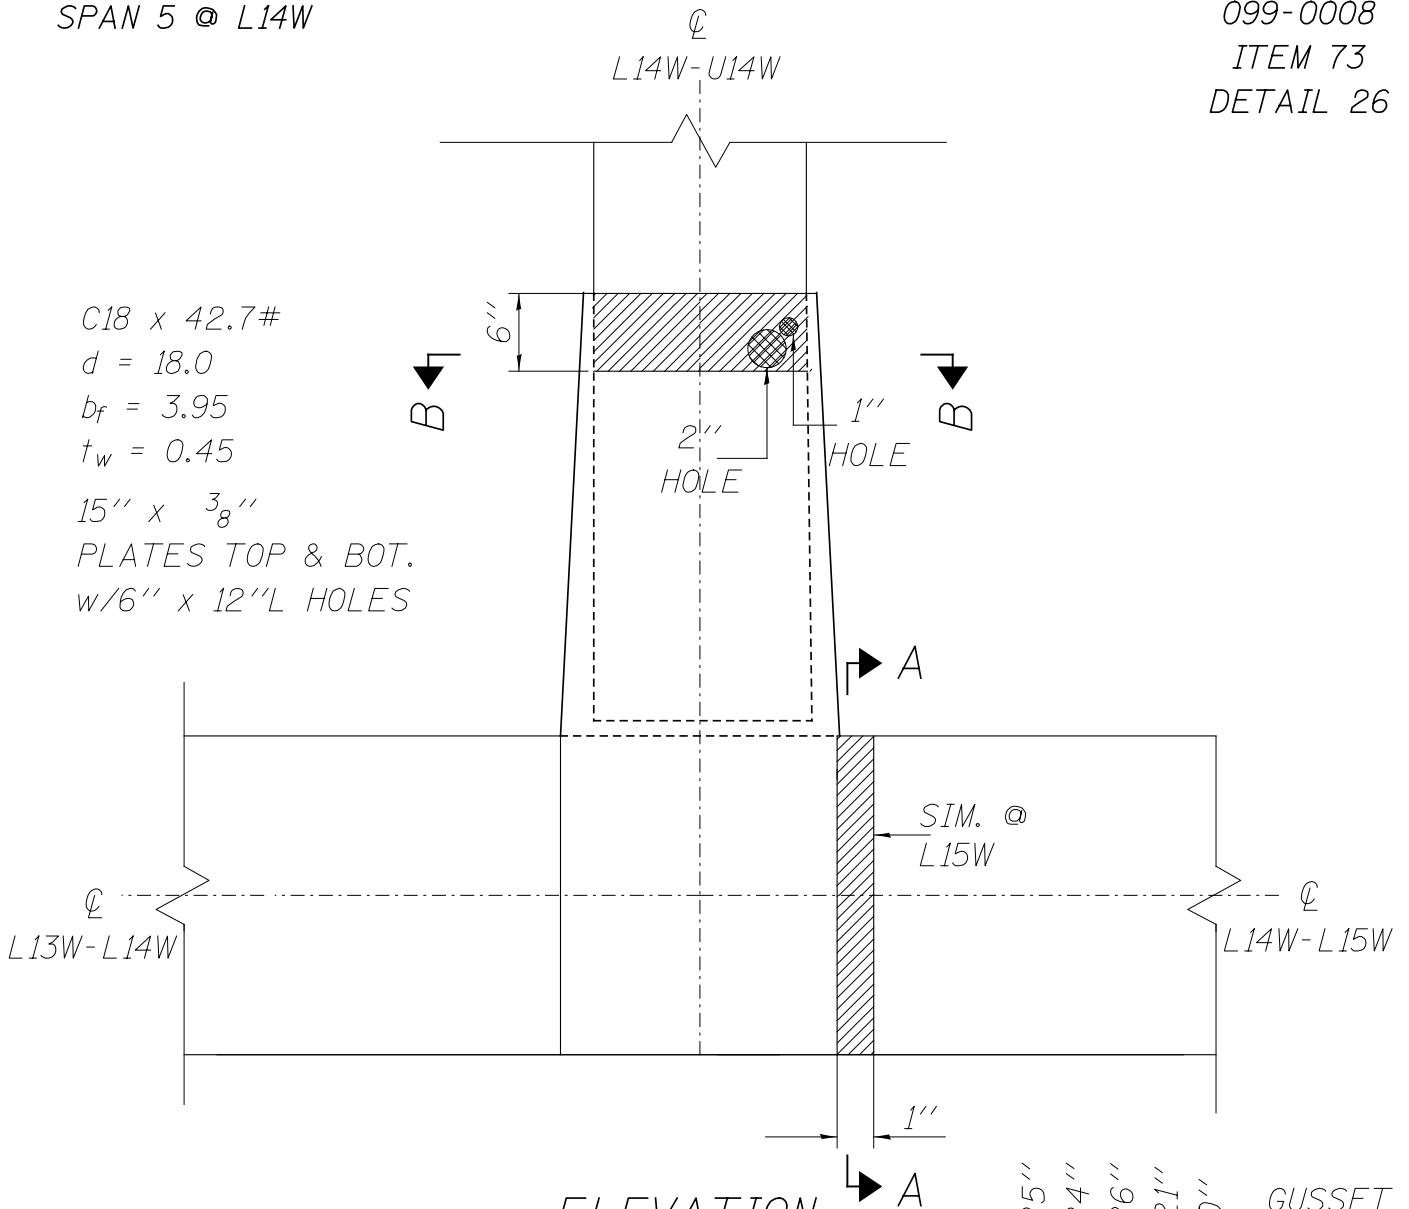
099-0008
ITEM 73
DETAIL 26

Item #	Span(s)	Member(s)	Location(s)	Photo(s)	Deficiency(ies)	Corrective Action	Year	Load Cap. Re-Eval.
68	5	Stringer 5	at Floorbeam 13, Panel 13	84 LW	0% SL, 1" X 3"L Hole top of Web, 1" Hole above repair angle	N/A	2005	
69	5	Lateral Brace	mid Floorbeam14 to L13E & mid Floorbeam14 to L13W at mid Floorbeam14	85 LN	12% SL, 8 – 13/16" Misdrilled Holes in Lateral Brace at connection Plate (2 in section)	N/A	2015	
70	5	Stringer 3	Panel 14, full length	86 LNW	9% SL BottomFlange 3% SL Web (See Detail 24)	N/A 9% SL, IRF=1.64	2011/ 2013	
71	5	Stringer 1	at Floorbeam 14 , Panel 14	87 LS	12 % SL Web (See Detail 25)	N/A No Live Load 2013	2011/ 2013	
72	5	L13E-L14E	at L14E	88 LSW	9% SL, (See Detail 45)	N/A 7% SL, IRF=4.56	2009	
73	5	L14W-U14W	at L14W, I.South Channel	89 LE	9% SL (See Detail 26)	N/A 9% SL, IRF=1.59	2011/ 2013	
74	5	L14W-L15W	at L14W & L15W	90 LE	10% SL (See Detail 26)	N/A 10 % SL, IRF=4.56	2011/ 2013

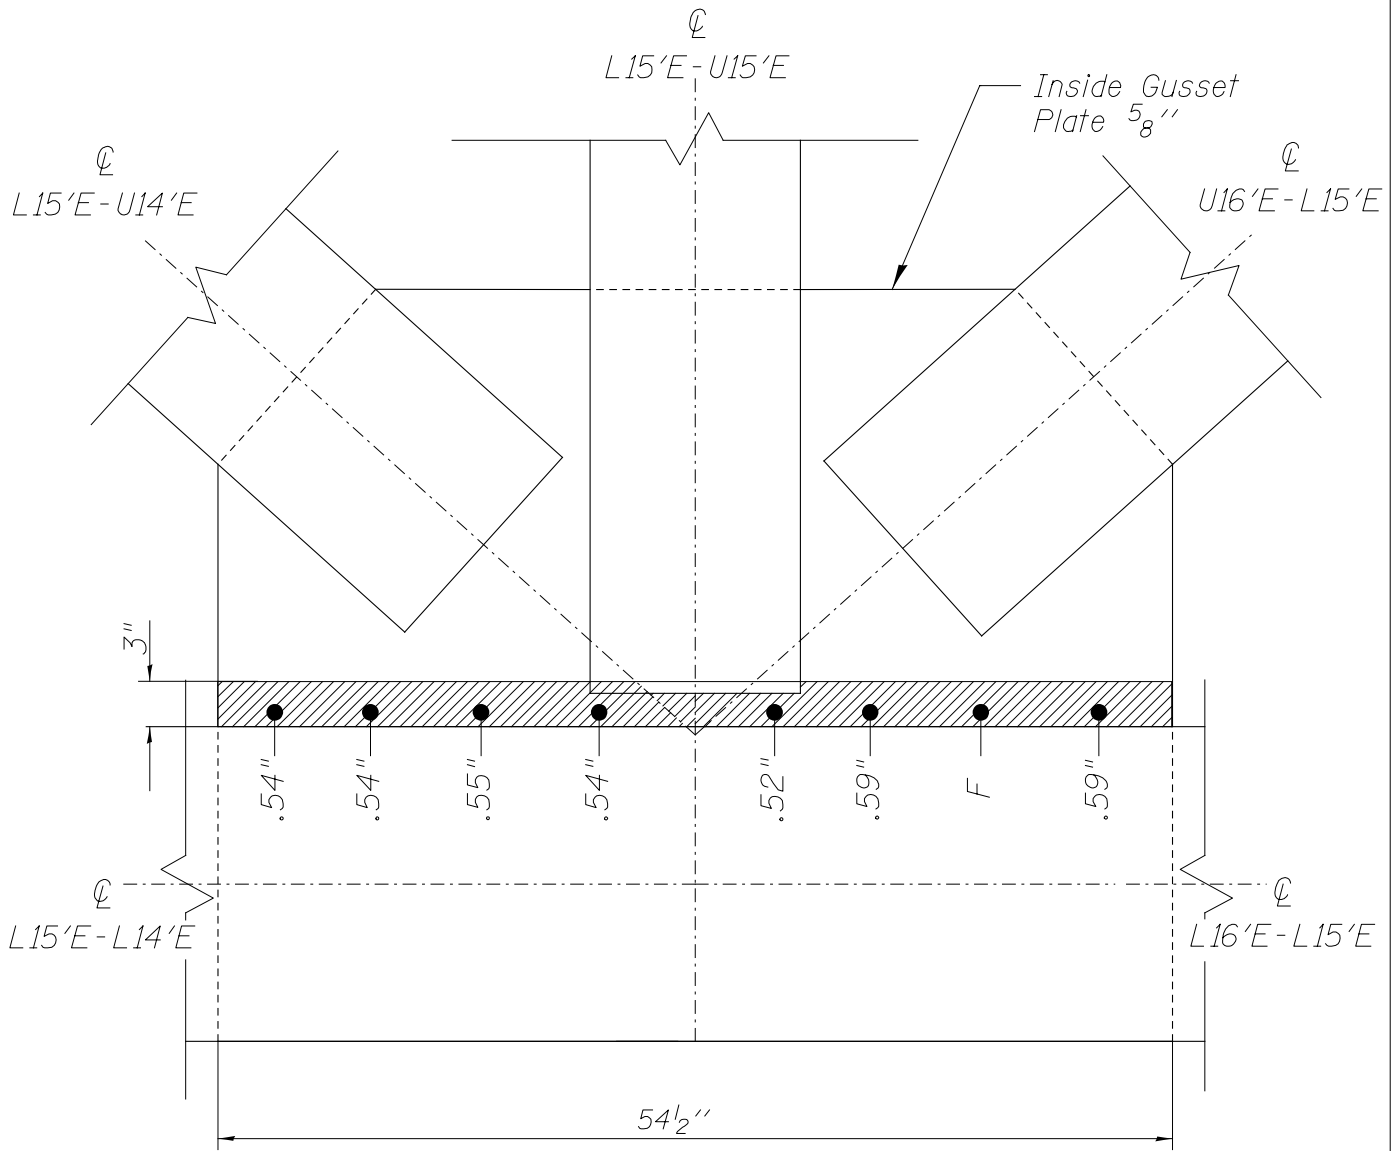
099-0008
ITEM 92
DETAIL 35

87	5	Gusset Plate	L16'E (outside)	105 LW	16" X 1/2" offset due to Pack Rust	N/A	2009	
88	5	L16'E-L15'E	at L16'E	106 LW	4% SL (See Detail 32)	N/A 4% SL, IRF=2.83	2011/ 2013	
89	5	U16'E-U16'W	at U16'E	107 LS	2- 1/4" Deep cuts into side Bottom Flange	N/A	2011	
143	5	L16'E-L15'E	2' from L15'E	108 LS	0% SL, 1" Holes in Top & bottom Plate (between access holes)	N/A	2017	
144	5	L16'E-L15'W	Last 4' from L15'W	109 LW	30% SL in angles, 2" Hole, 15% SL in bottom connection Plate, 1" Hole	N/A	2017	
90	5	Gusset Plate	L15'W (outside)	110 LN	9% SL, (See Detail 33)	N/A	2009	
91	5	Gusset Plate	L15'W (inside)	111 LN	10% SL, (See Detail 34)	N/A	2009	
92	5	Gusset Plate	L15'E (inside)	112 LE	10% SL, (See Detail 35)	N/A	2009

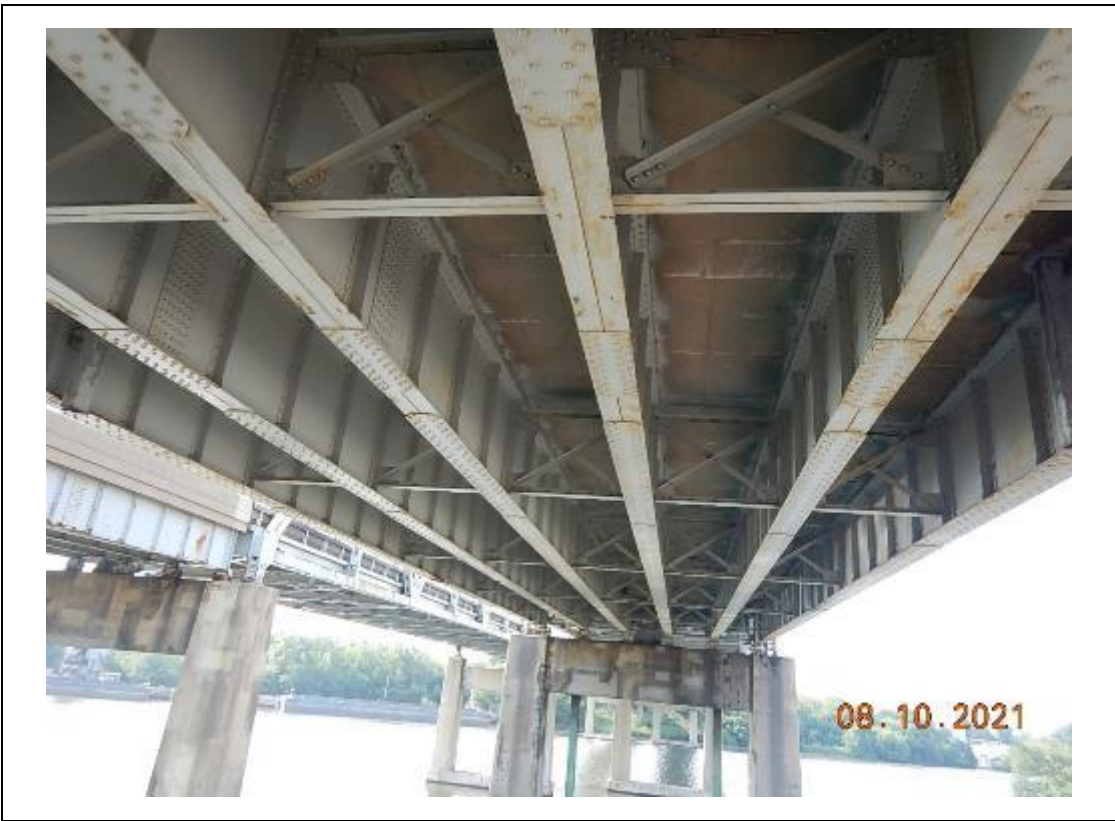
PHOTO 1

Span 3 looking South

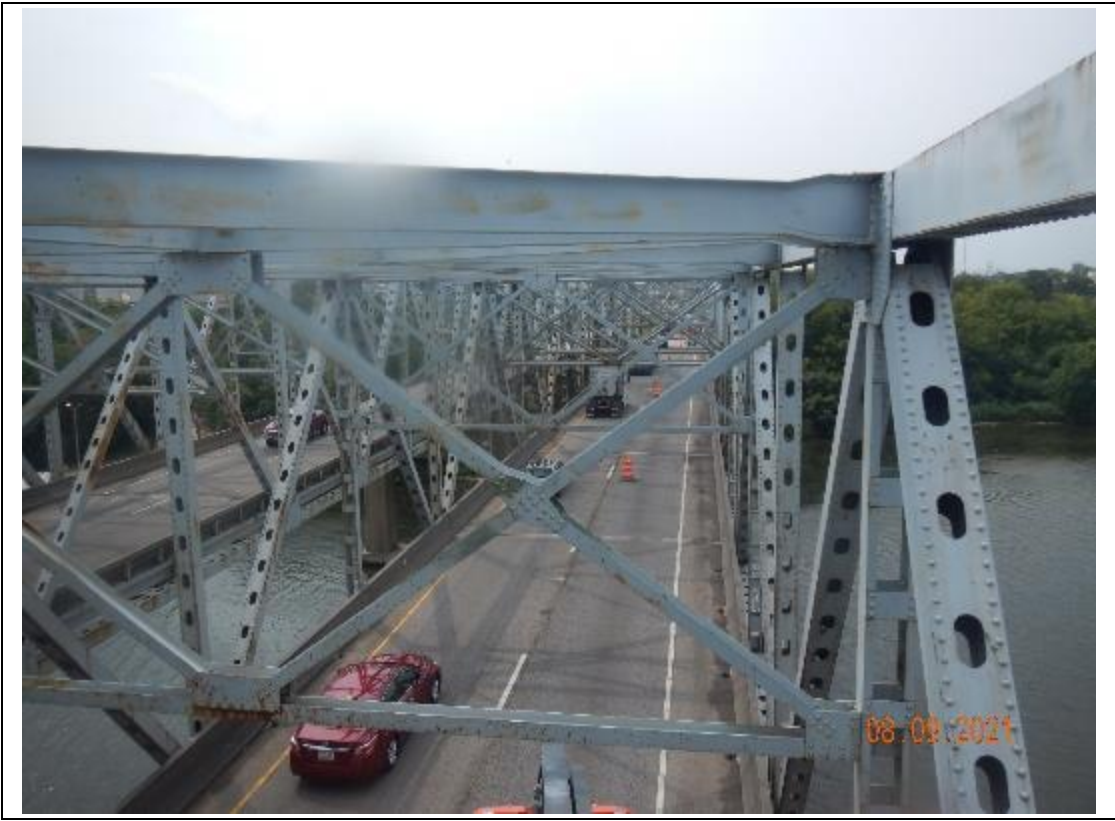
PHOTO 2

Span 5 looking South

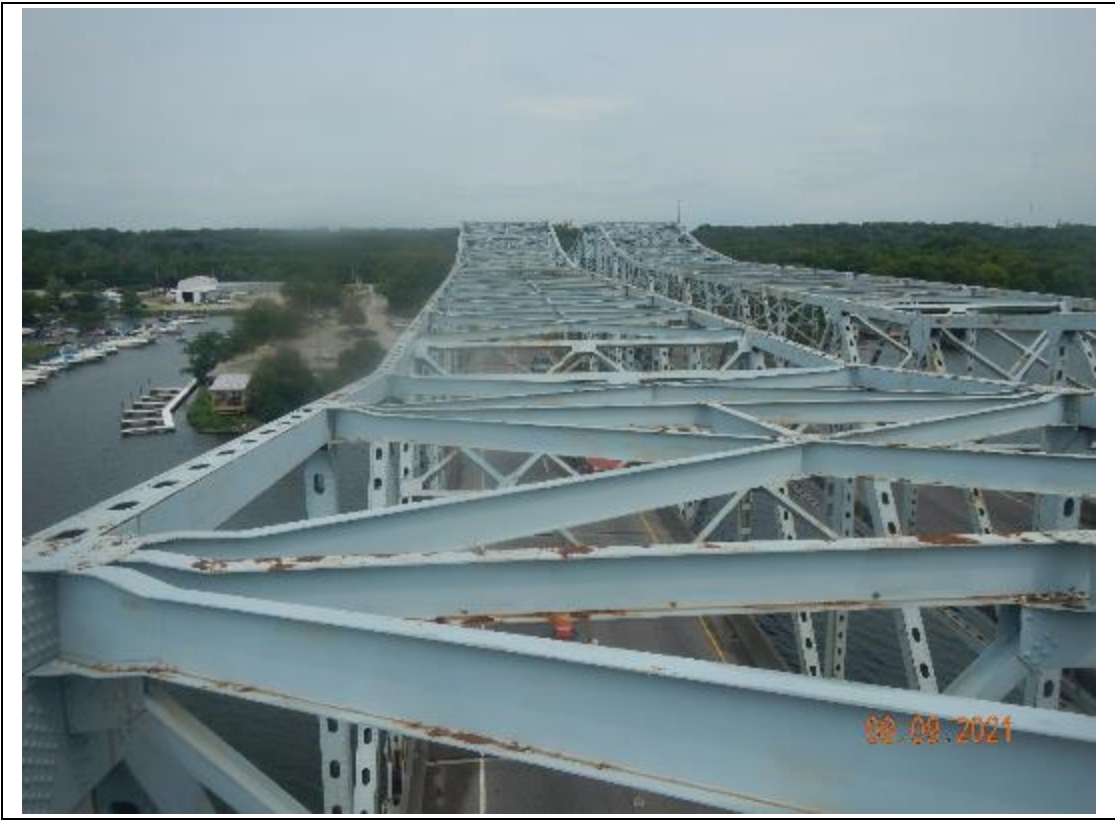
PHOTO 4

Span 6 looking North

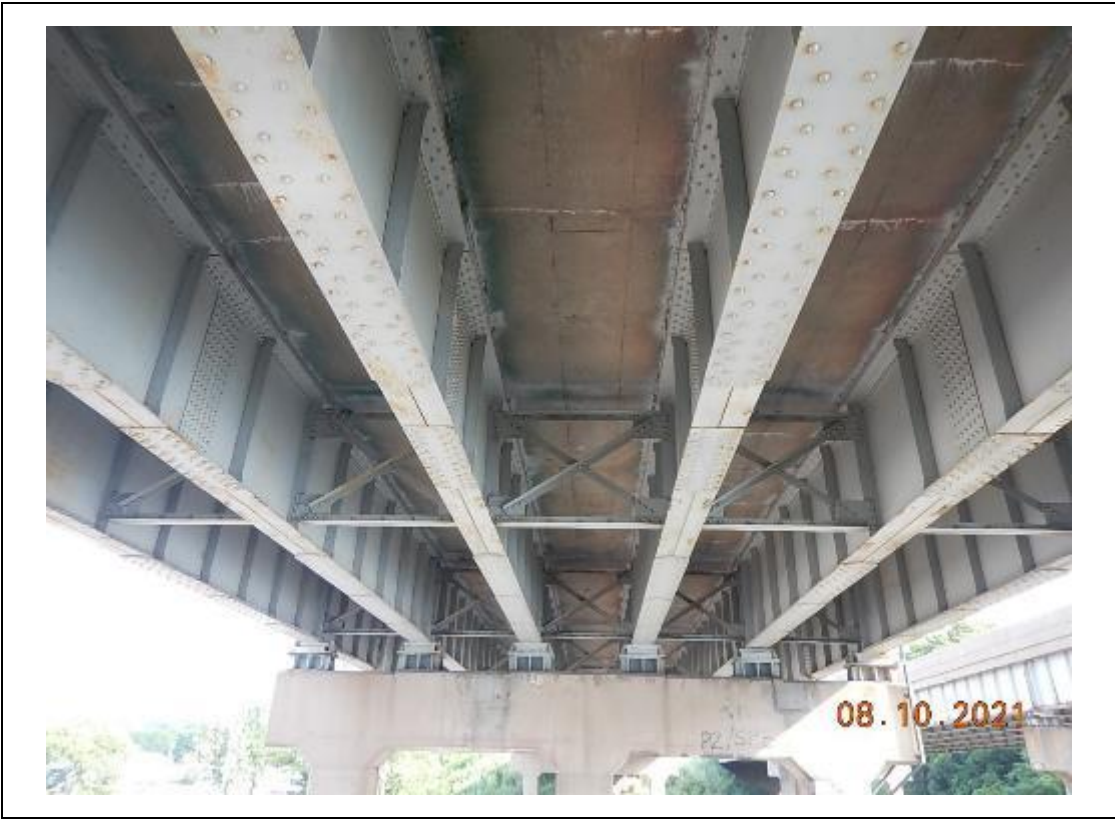
PHOTO 5 Span 3 looking North

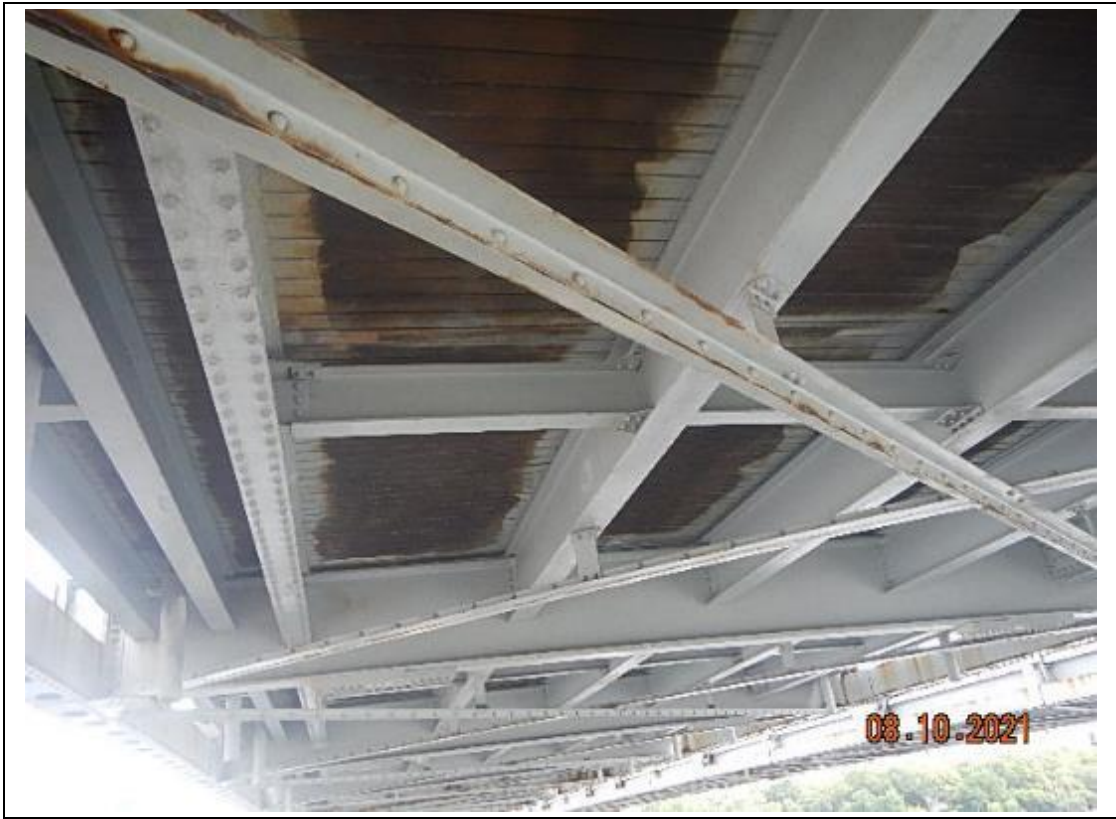
PHOTO 7

Span 5 looking North

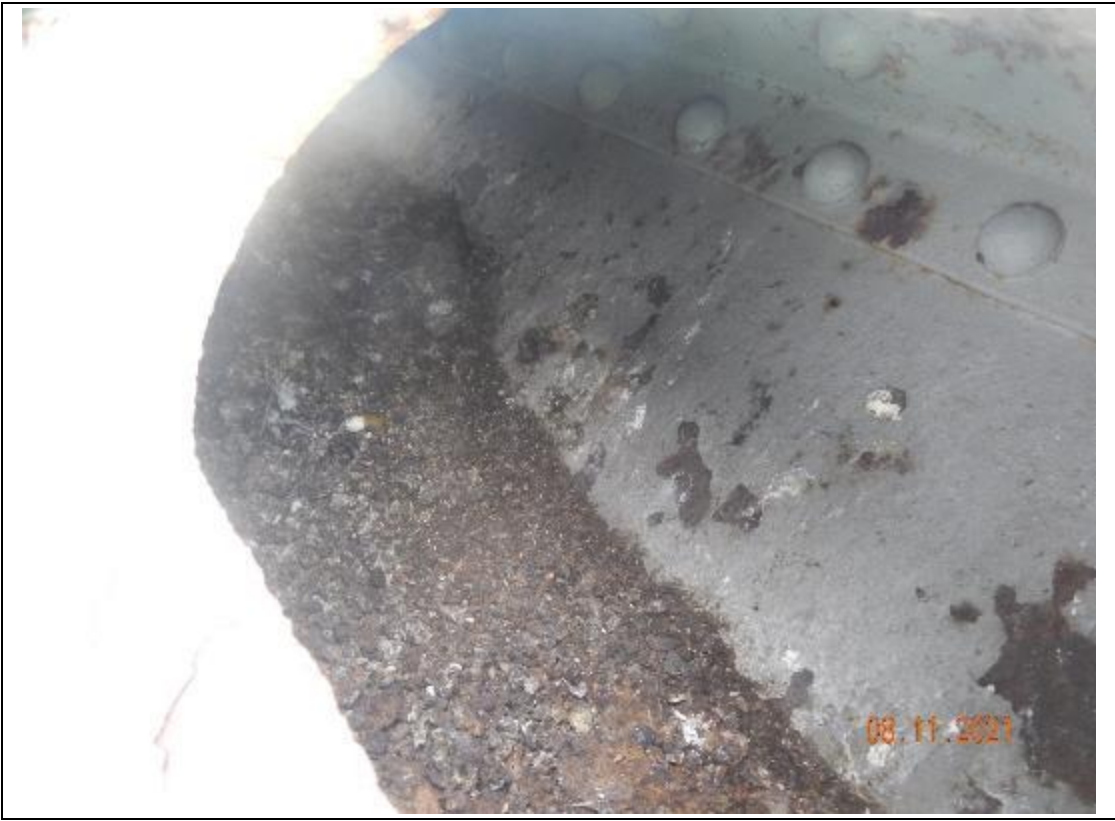
PHOTO 14 Span 6 looking Southeast
