STATE OF ILLINOIS
DEPARTMENT OF TRANSPORTATION

SLOPEWALL REPAIRS
EASTBOUND FAI-80 OVER RAILROADGARDNER STREET
STRUCTURE NO. 099-0060

SHEET NO. S-7 OF 15 SHEETS

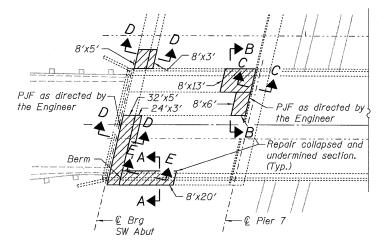
Repair collapsed and undermined section

Slopewall Remove and Replace
