STATE OF ILLINOIS  
DEPARTMENT OF TRANSPORTATION

**SUPERSTRUCTURE REPAIRS I**  
S.N. 016-0540

SHEET NO. S-7 S-27 SHEETS	F.A.U. RTE. 2697	SECTION 142 B-1-I	COUNTY COOK	TOTAL SHEETS 48	SHEET NO. 21
	CONTRACT NO. 60D89				
FED. ROAD DIST. NO.		ILLINOIS	FED. AID PROJECT

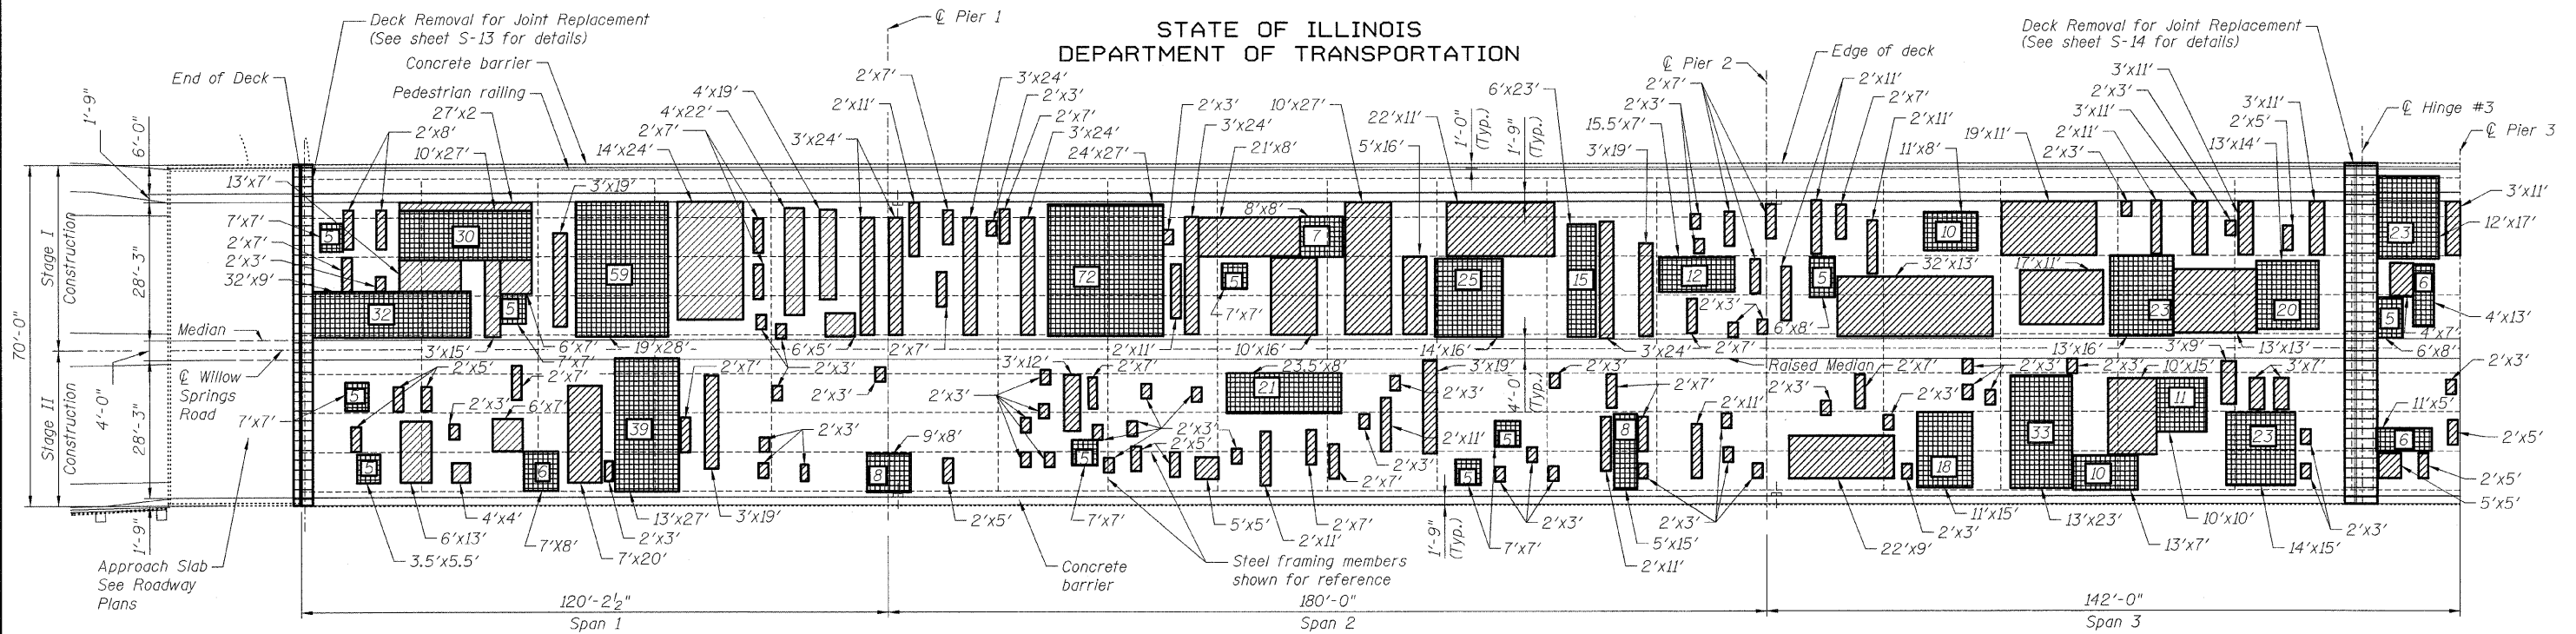
DECK PLAN

Deck Slab Repair (Partial Depth)  
Estimated Quantity 1,131 Sq. Yd.  
**FOR INFORMATION ONLY**

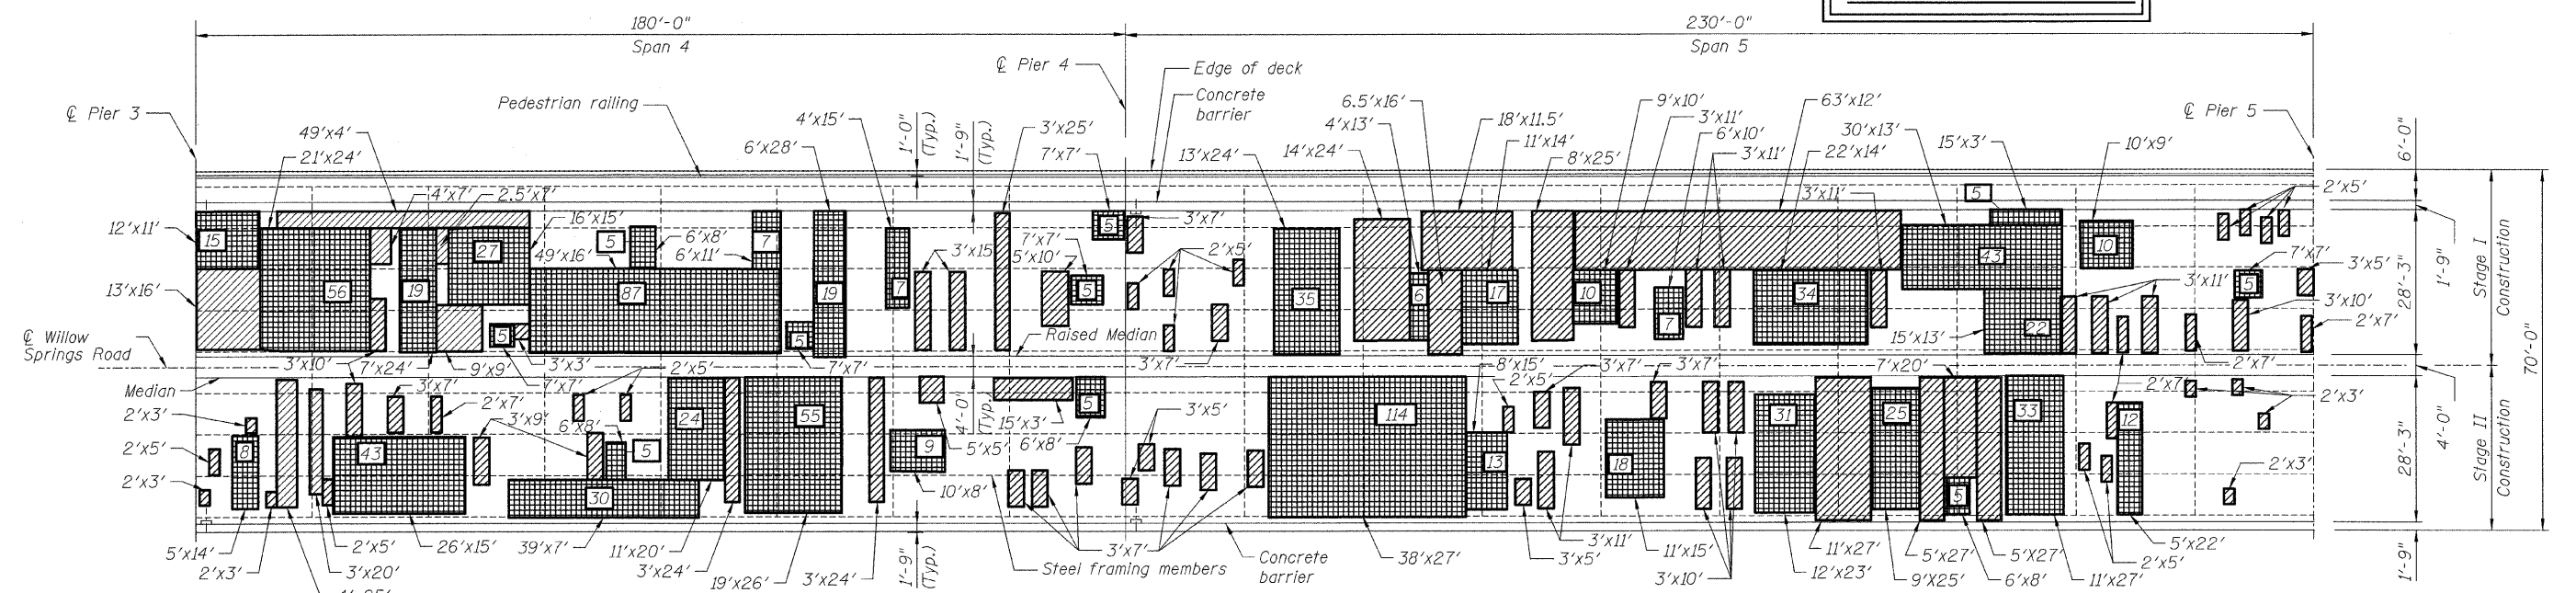
DECK PLAN

**LAST DELAMINATION SURVEY:**  
November 27, 2007  
(Typical for all superstructure repairs)
