STATE OF ILLINOIS
DEPARTMENT OF TRANSPORTATION

Contract Number: 68B57 ++(102-HB-2)1-2

BEAM STRAIGHTENING DETAILS
F.A. RT. 317
TAZEWELL COUNTY
SN 090-0069

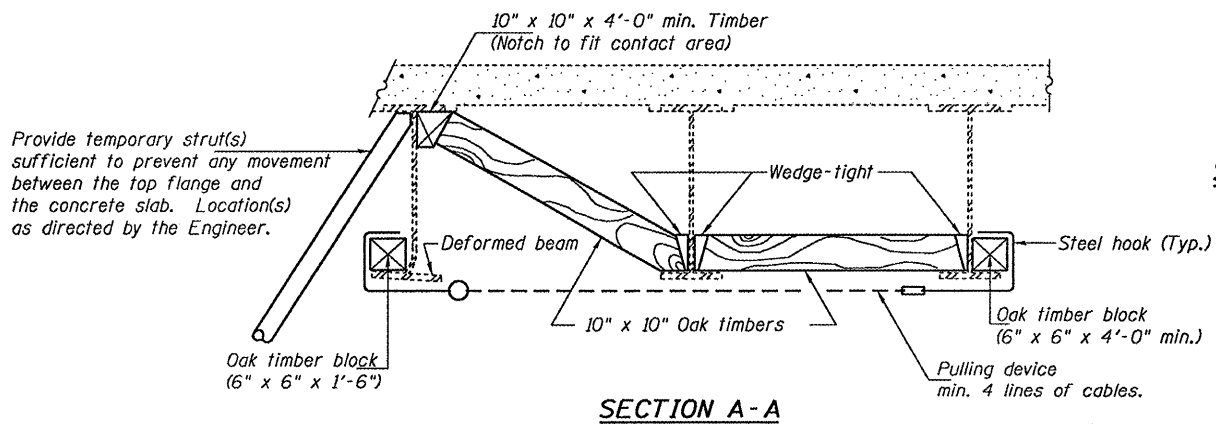
SECTION A-A

EXISTING DEFORMATION TO BE STRAIGHTENED

(Looking East)
(Approximate max. deflections)
Deflected length of beam to be straightened is approximately ±10'-0".
