ABBOTT ST. CONNECTOR  
MATCH LINE STA. 31+00  
SHEET NO. 85

CONDITION OF EXISTING COMBINED SEWERS

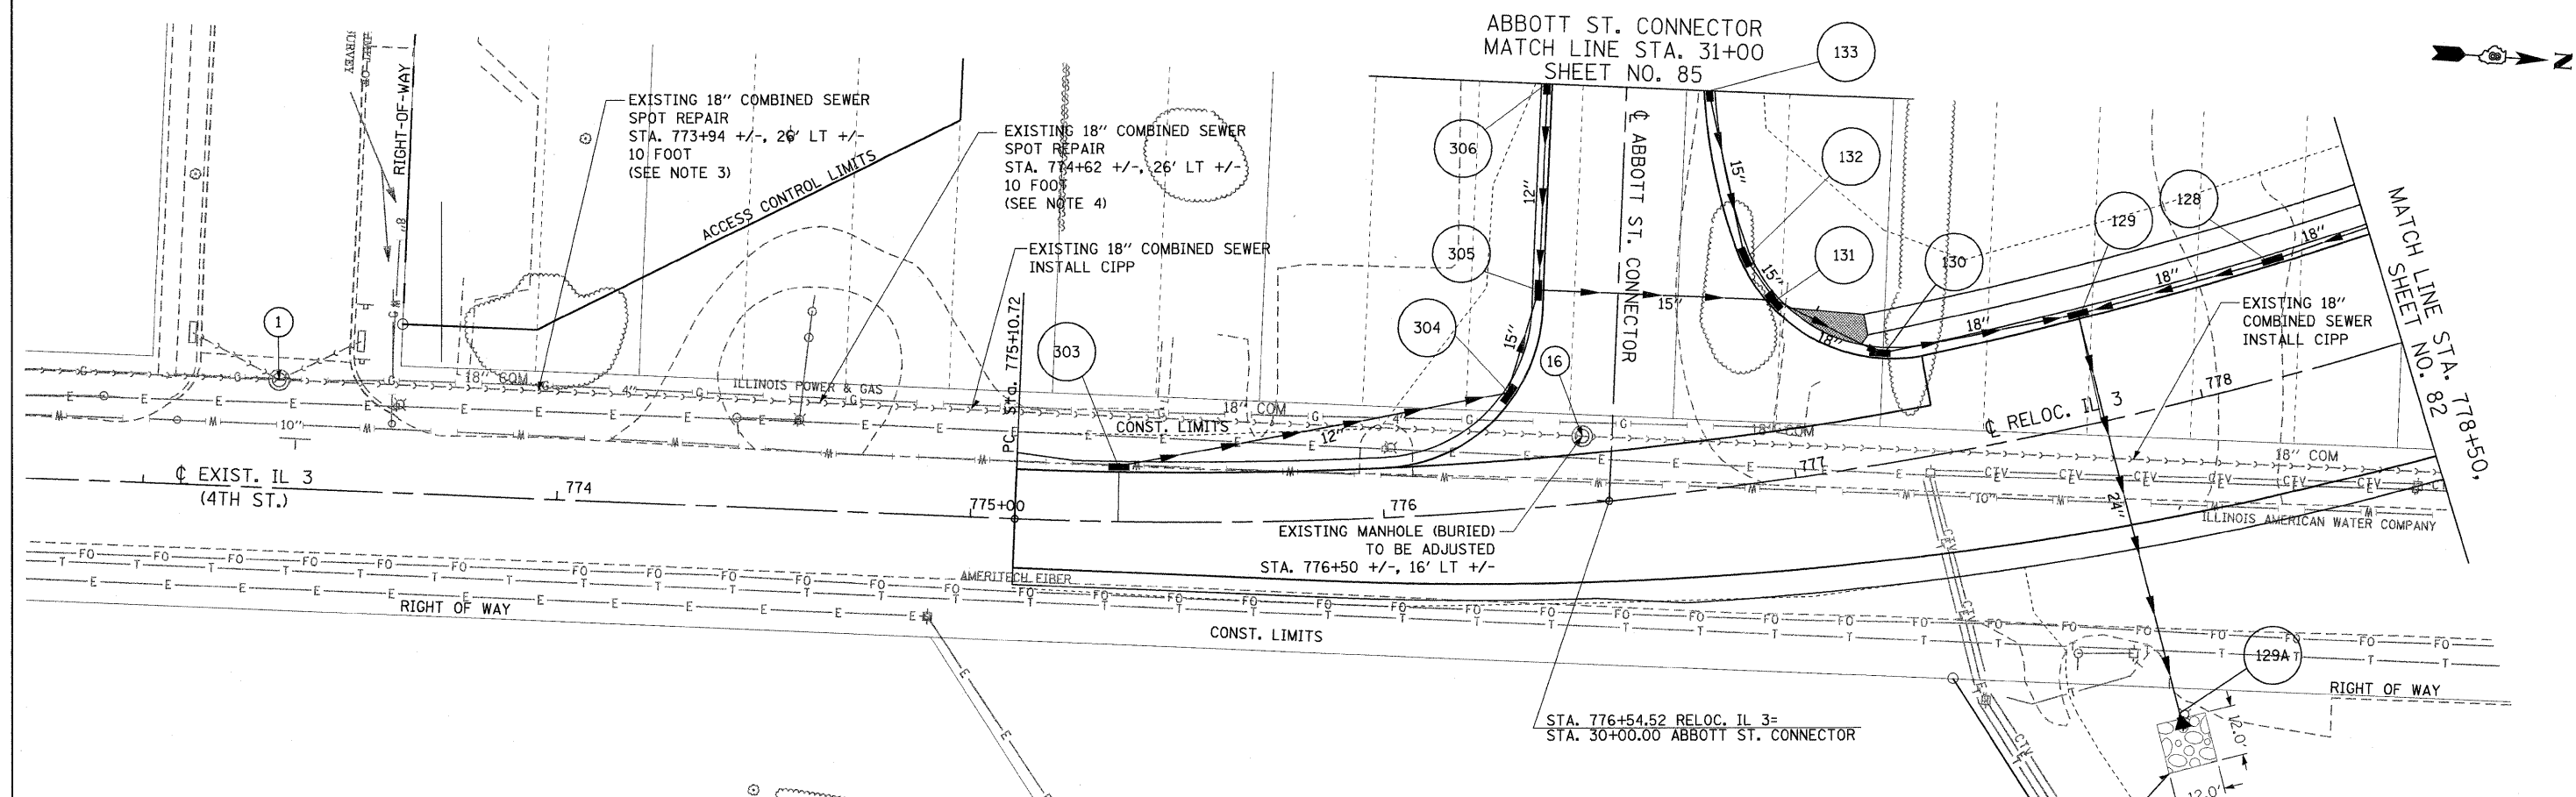
Structure	CCTV Section #	CCTV Date	Condition
1 16	5a	12/21/2007	Fair - poor. Large hole at 61' and 129' from #1 Joints are separated slightly.
2 (403) 3	8	12/26/2007	Poor - top of pipe missing at 68'; heavy roots/debris at 92'; water level at 45% most of inspection. Distances from #3.
4 (HMD-6) 2 (403)	6	12/26/2007	Fair - heavy debris/sand throughout entire reach
6 (2ND-1) HMD-7	11	1/3/2008	Fair-poor - 40' to 90' apparently some type of liner possibly NSCL; minor to moderate longitudinal cracking at 90' to 116'. SC at 121' has moderate roots. The TV operator could not televise after 300' due to debris. Distances from #6.
7 6 (2ND-1)	1	12/14/2007	Fair. Moderate broken pipe at 88' and slight to moderate circumferential crack at 81' with light roots and moderate offset joints in a couple locations. Distances from #7.
3RD-4 6 (2ND-1)	4	12/18/2007	Fair-poor. Heavy debris/sludge most of the reach; moderate/severe offset joint at 375' from #8. A new structure (3RD-4) will be added at approximately 48' from #8 toward #6. The pipe from #8 to 3RD-4 will be grouted (Abandoned).

10 4 (HMD-6)	13	1/11/2008	Fair - poor. Moderate to heavy debris/roots throughout reach. Joints are slightly to moderate separated throughout.
11 14 (600A)	9a	1/3/2008	Fair - poor. Light to moderate roots and minor longitudinal crack first 60'. Square pipe at 168' from #11 to MH #14 (at 177'). Distances from #11.
15 6 (2ND-1)	10b	1/3/2008	Good. VSB (Vitrified Segmental Block) was used for first 30'. Missing block at 20'. Turns into VCP at 30'. Minor longitudinal crack at 115' to 120'. Distances from #15
16 2 (403)	5b	1/4/2008	Fair. Joints are separated slightly.

- NOTES:
1. THE REPLACEMENT OF EXISTING SEWERS REQUIRES AN OPEN TRENCH MEETING THE LATEST O.S.H.A. STANDARDS.
  2. SEE STORM SEWER, DRAINAGE STRUCTURE, AND COMBINED SEWER REHABILITATION SCHEDULES FOR ADDITIONAL DETAILS.
  3. SEWER SPOT REPAIR 1- AT 61 FEET FROM #1
  4. SEWER SPOT REPAIR 2- AT 129 FEET FROM #1
