**FATIGUE RETROFIT DETAILS**  
STATE OF ILLINOIS  
DEPARTMENT OF TRANSPORTATION  
REHABILITATION AND RETROFIT REPAIRS  
FAI ROUTE 70  
POPLAR STREET BRIDGE APPROACHES  
ST. CLAIR COUNTY  
STRUCTURE NO. 082-0141 (ROADWAY A)  
SCALE: N.T.S.  
DATE: 02/01/2007

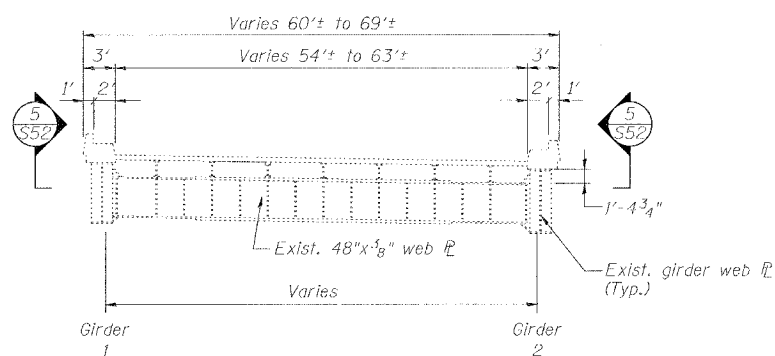
**4**  
LONG SPAN FLOOR BEAMS (> 50')  
S52

Note B: Two repair locations shown

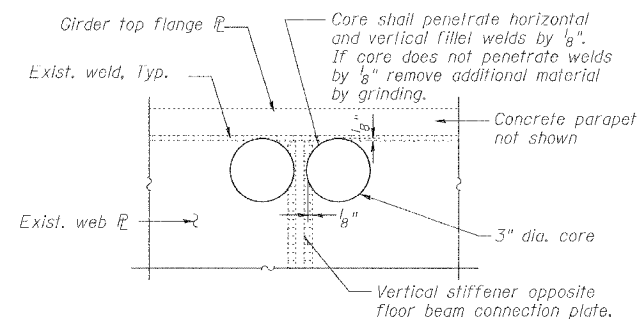
**6**  
LONG SPAN FLOOR BEAM RETROFIT  
S52

Note C: One repair location shown

Procedure Detail 6/S52:

1. Inspect using magnetic particle (MT) methods. Notify Engineer if a crack is detected (Cost included with long span floor beam retrofit).
2. Remove parapet concrete, as required, for equipment access.
3. Core 3" diameter holes through web plate adjacent to the top flange as positioned in Detail 6/S52. Core holes shall penetrate the horizontal and vertical fillet welds approximately 1/8". If core does not penetrate weld by 1/8", remove additional material by grinding. Remove all burrs from cored or ground surface. Surface shall have a roughness average (Ra) of 500 or less.
4. Obtain approval of Engineer.
5. Clean and paint steel surfaces adjacent to the repair in accordance with the Special Provisions.
