# Asbestos Abatement Survey

**Work Order No.: 46**

**Route: US 40, IL 33 (FAP 95)**

**303 E. Fayette Avenue**

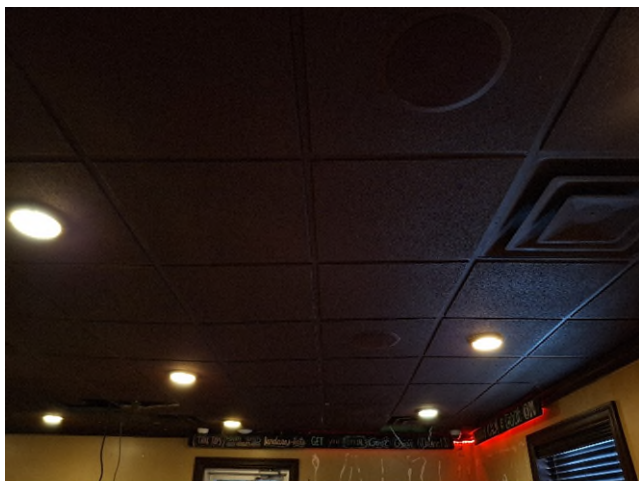
| HA No. | Material Description | Material Location | Sample Number | Condition | Friability | Asbestos Content | Estimated Quantity | Unit | Notes |
|---|---|---|---|---|---|---|---|---|---|
| 1 | Black 16" x 16" Ceiling Tile | Dining Area 1, Dining Area 2, Hallway 1, Hallway 2, Bar | 1A, 1B, 1C | Good | Friable | NAD | 1,700 | SF | |

**HA-1: Black 16" x 16" Ceiling Tile**

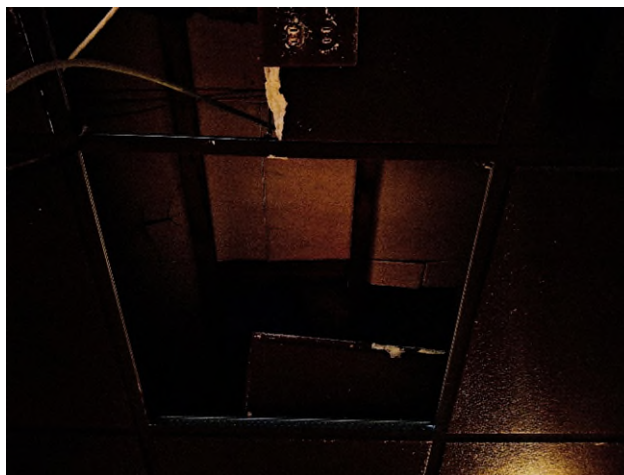
| HA No. | Material Description | Material Location | Sample Number | Condition | Friability | Asbestos Content | Estimated Quantity | Unit | Notes |
|---|---|---|---|---|---|---|---|---|---|
| 2 | White 12" x 12" Ceiling Tile above HA-1 | Dining Area 1, Dining Area 2, Bar | 2A, 2B, 2C | Good | Friable | NAD | 800 | SF | |

**HA-2: White 12" x 12" Ceiling Tile above HA-1**

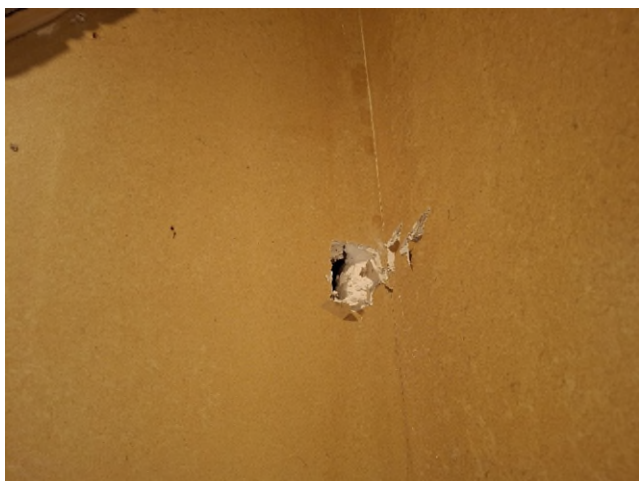
| HA No. | Material Description | Material Location | Sample Number | Condition | Friability | Asbestos Content | Estimated Quantity | Unit | Notes |
|---|---|---|---|---|---|---|---|---|---|
| 3 | White Gypsum Board | 1st Floor Walls | 3A, 3B, 3C | Good | Non-Friable | NAD | 7,000 | SF | |
| 4 | White Joint Compound associated with HA-3 | 1st Floor Walls | 4A, 4B, 4C | Good | Friable | NAD | 7,000 | SF | |
| 5 | Beige Drywall Tape associated with HA-3 | 1st Floor Walls | 5A, 5B, 5C | Good | Non-Friable | NAD | 7,000 | SF | |

**HA-3: White Gypsum Board**

**HA-4: White Joint Compound associated with HA-3**

**HA-5: Beige Drywall Tape associated with HA-3**

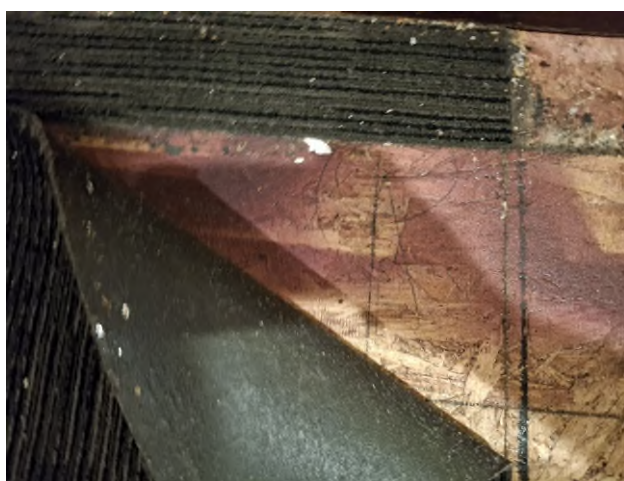
| HA No. | Material Description | Material Location | Sample Number | Condition | Friability | Asbestos Content | Estimated Quantity | Unit | Notes |
|---|---|---|---|---|---|---|---|---|---|
| 6 | Clear Carpet Glue | Dining Area 2, Party Room | 6A, 6B, 6C | Good | Non-Friable | NAD | 646 | SF | |

**HA-6: Clear Carpet Glue**

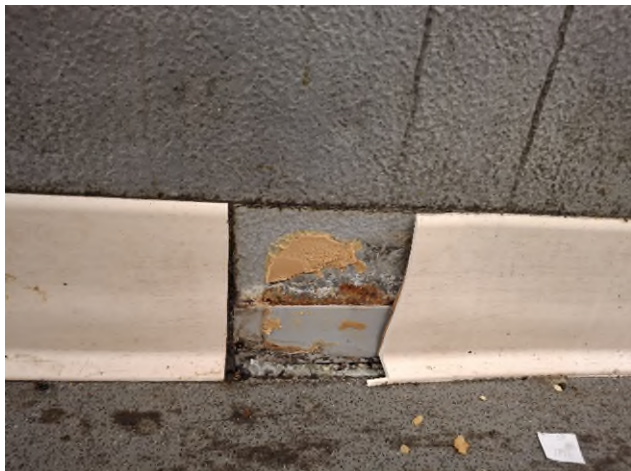
| HA No. | Material Description | Material Location | Sample Number | Condition | Friability | Asbestos Content | Estimated Quantity | Unit | Notes |
|---|---|---|---|---|---|---|---|---|---|
| 7 | White Cove Base | Kitchen, Janitor Room, Food Prep Area, Hallway 3, Refrigerator Room 2, Refrigerator Room 3 | 7A, 7B, 7C | Good | Non-Friable | NAD | 350 | LF | |
| 8 | Gold Mastic associated with HA-7 | Kitchen, Janitor Room, Food Prep Area, Hallway 3, Refrigerator Room 2, Refrigerator Room 3 | 8A, 8B, 8C | Good | Non-Friable | NAD | 350 | LF | |

**HA-7: White Cove Base**  
**HA-8: Gold Mastic associated with HA-7**

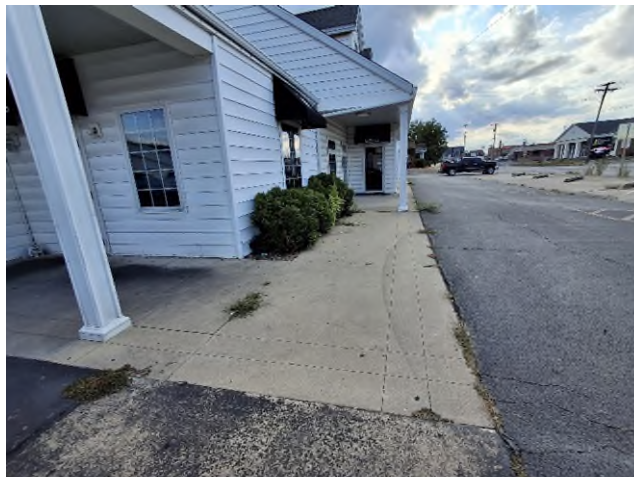
| HA No. | Material Description | Material Location | Sample Number | Condition | Friability | Asbestos Content | Estimated Quantity | Unit | Notes |
|---|---|---|---|---|---|---|---|---|---|
| 9 | Gray Concrete Foundation | Basement, Sidewalk | 9A, 9B, 9C | Good | Non-Friable | NAD | 2,950 | SF | |

**HA-9: Gray Concrete Foundation**

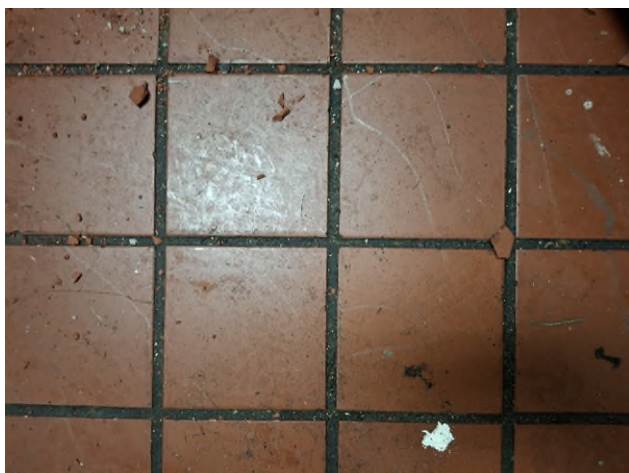
| HA No. | Material Description | Material Location | Sample Number | Condition | Friability | Asbestos Content | Estimated Quantity | Unit | Notes |
|---|---|---|---|---|---|---|---|---|---|
| 10 | Red 4" x 4" Ceramic Floor Tile | Foyer, Kitchen, Food Prep Area | 10A, 10B, 10C | Good | Non-Friable | NAD | 420 | SF | |
| 11 | Black Grout associated with HA-10 | Foyer, Kitchen, Food Prep Area | 11A, 11B, 11C | Good | Non-Friable | NAD | 420 | SF | |

**HA-10: Red 4" x 4" Ceramic Floor Tile**  
**HA-11: Black Grout associated with HA-10**

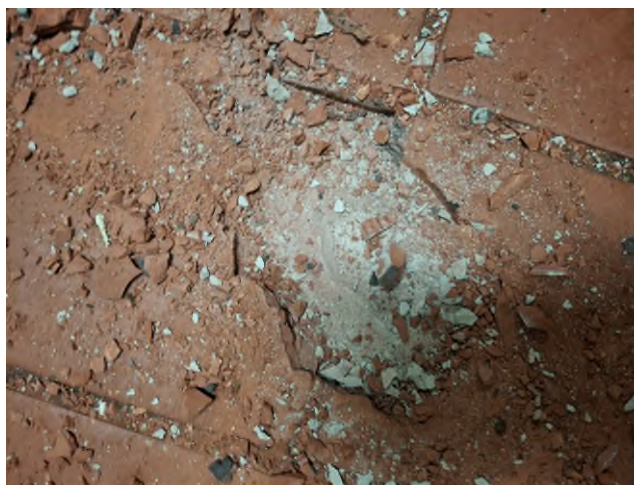
| HA No. | Material Description | Material Location | Sample Number | Condition | Friability | Asbestos Content | Estimated Quantity | Unit | Notes |
|---|---|---|---|---|---|---|---|---|---|
| 12 | Gray Adhesive associated with HA-10 | Foyer, Kitchen, Food Prep Area | 12A, 12B, 12C | Good | Non-Friable | NAD | 420 | SF | |

**HA-12: Gray Adhesive associated with HA-10**

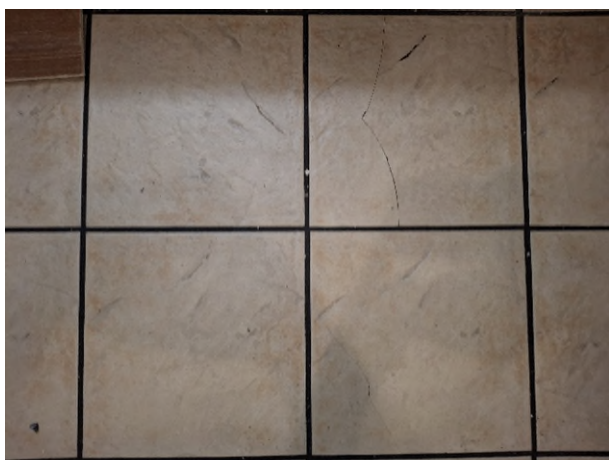
| HA No. | Material Description | Material Location | Sample Number | Condition | Friability | Asbestos Content | Estimated Quantity | Unit | Notes |
|---|---|---|---|---|---|---|---|---|---|
| 13 | Beige 12" x 12" Ceramic Floor Tile | Men's Restroom, Women's Restroom | 13A, 13B, 13C | Good | Non-Friable | NAD | 200 | SF | |
| 14 | Black Grout associated with HA-13 | Men's Restroom, Women's Restroom | 14A, 14B, 14C | Good | Non-Friable | NAD | 200 | SF | |

**HA-13: Beige 12" x 12" Ceramic Floor Tile**  
**HA-14: Black Grout associated with HA-13**

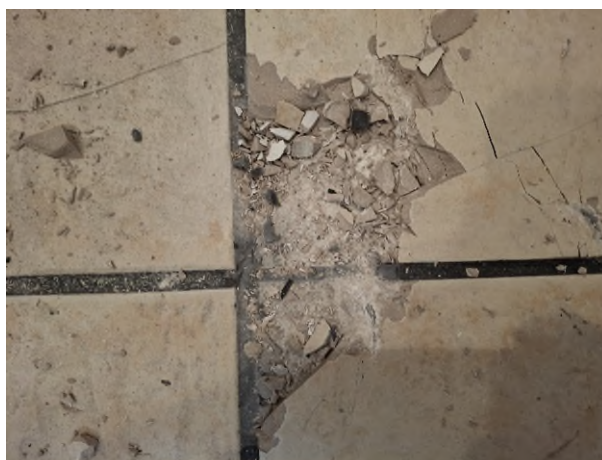
| HA No. | Material Description | Material Location | Sample Number | Condition | Friability | Asbestos Content | Estimated Quantity | Unit | Notes |
|---|---|---|---|---|---|---|---|---|---|
| 15 | Gray Adhesive associated with HA-13 | Men's Restroom, Women's Restroom | 15A, 15B, 15C | Good | Non-Friable | NAD | 200 | SF | |

**HA-15: Gray Adhesive associated with HA-13**

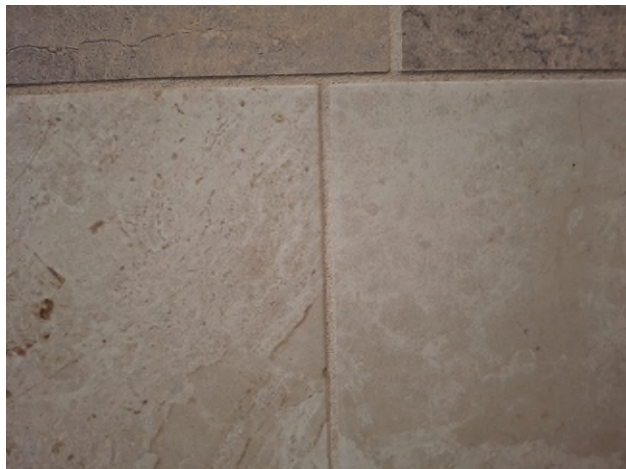
| HA No. | Material Description | Material Location | Sample Number | Condition | Friability | Asbestos Content | Estimated Quantity | Unit | Notes |
|---|---|---|---|---|---|---|---|---|---|
| 16 | Gray 12" x 12" Ceramic Wall Tile | Men's Restroom, Women's Restroom | 16A, 16B, 16C | Good | Non-Friable | NAD | 590 | SF | |
| 17 | Beige Grout associated with HA-16 | Men's Restroom, Women's Restroom | 17A, 17B, 17C | Good | Non-Friable | NAD | 590 | SF | |

**HA-16: Gray 12" x 12" Ceramic Wall Tile**  
**HA-17: Beige Grout associated with HA-16**

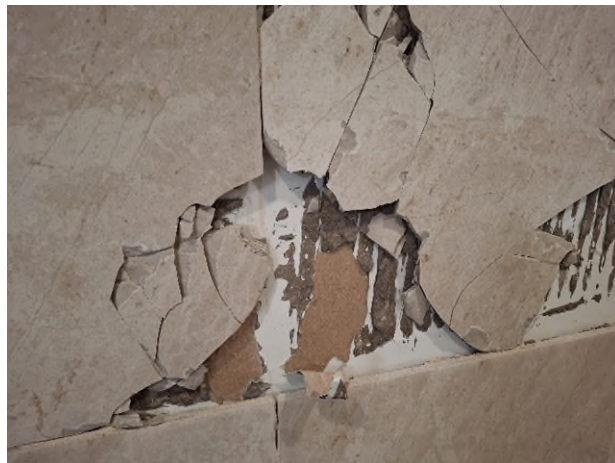
| HA No. | Material Description | Material Location | Sample Number | Condition | Friability | Asbestos Content | Estimated Quantity | Unit | Notes |
|---|---|---|---|---|---|---|---|---|---|
| 18 | Gray Adhesive associated with HA-16 | Men's Restroom, Women's Restroom | 18A, 18B, 18C | Good | Non-Friable | NAD | 590 | SF | |

**HA-18: Gray Adhesive associated with HA-16**

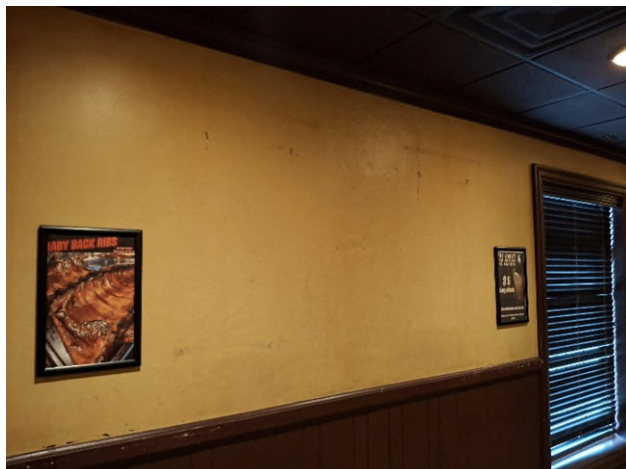
| HA No. | Material Description | Material Location | Sample Number | Condition | Friability | Asbestos Content | Estimated Quantity | Unit | Notes |
|---|---|---|---|---|---|---|---|---|---|
| 19 | Yellow Wallpaper | Dining Area 1, Dining Area 2, Hallway 1, Hallway 2, Bar | 19A, 19B, 19C | Good | Non-Friable | NAD | 1,400 | SF | |

**HA-19: Yellow Wallpaper**

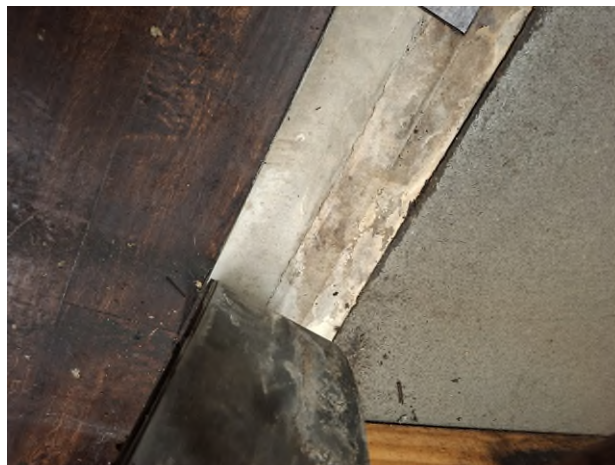
| HA No. | Material Description | Material Location | Sample Number | Condition | Friability | Asbestos Content | Estimated Quantity | Unit | Notes |
|---|---|---|---|---|---|---|---|---|---|
| 20 | Brown Vinyl Flooring | Office | 20A, 20B, 20C | Good | Non-Friable | NAD | 135 | SF | |
| 21 | Beige Mastic associated with HA-20 | Office | 21A, 21B, 21C | Good | Non-Friable | NAD | 135 | SF | |

**HA-20: Brown Vinyl Flooring**  
**HA-21: Beige Mastic associated with HA-20**

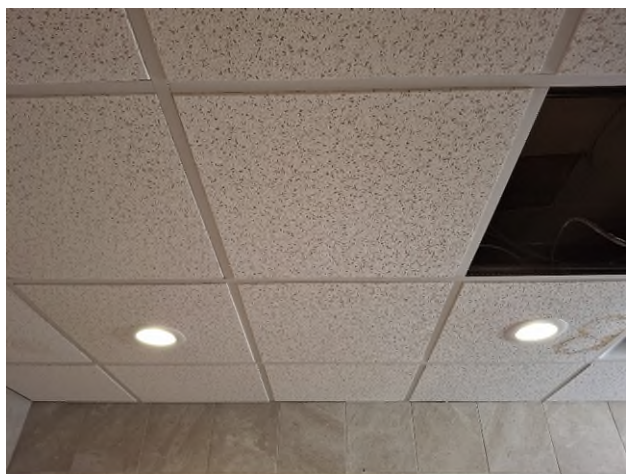
| HA No. | Material Description | Material Location | Sample Number | Condition | Friability | Asbestos Content | Estimated Quantity | Unit | Notes |
|---|---|---|---|---|---|---|---|---|---|
| 22 | White 16" x 16" Ceiling Tiles | Men's Restroom, Women's Restroom | 22A, 22B, 22C | Good | Friable | NAD | 180 | SF | |

**HA-22: White 16" x 16" Ceiling Tiles**

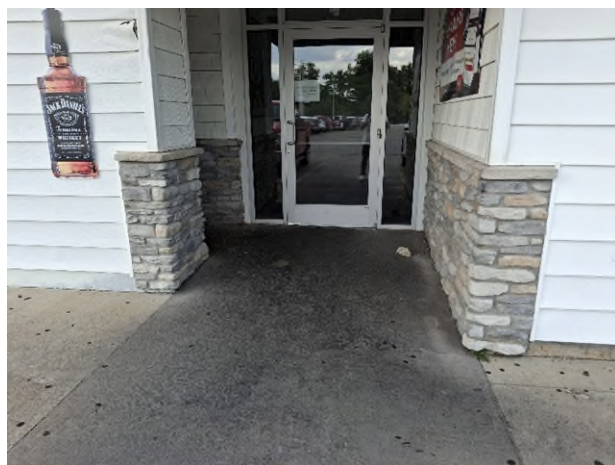
| HA No. | Material Description | Material Location | Sample Number | Condition | Friability | Asbestos Content | Estimated Quantity | Unit | Notes |
|---|---|---|---|---|---|---|---|---|---|
| 23 | Dark Gray Stone | Vestibule 1, Vestibule 2 | 23A, 23B, 23C | Good | Non-Friable | NAD | 162 | SF | |

**HA-23: Dark Gray Stone**

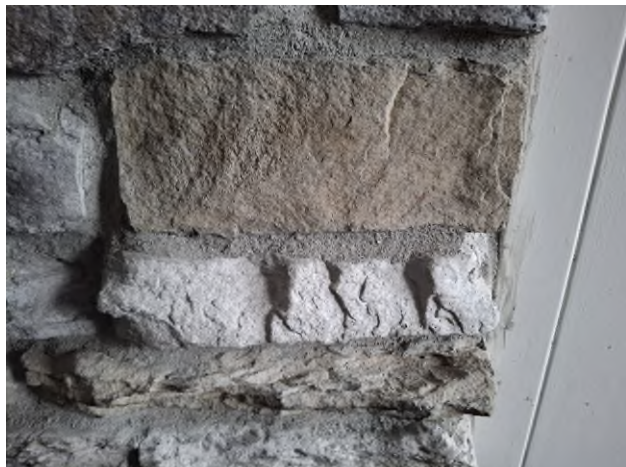
| HA No. | Material Description | Material Location | Sample Number | Condition | Friability | Asbestos Content | Estimated Quantity | Unit | Notes |
|---|---|---|---|---|---|---|---|---|---|
| 24 | Gray Mortar associated with HA-23 | Vestibule 1, Vestibule 2 | 24A, 24B, 24C, | Good | Non-Friable | NAD | 162 | SF | |

**HA-24: Gray Mortar associated with HA-23**

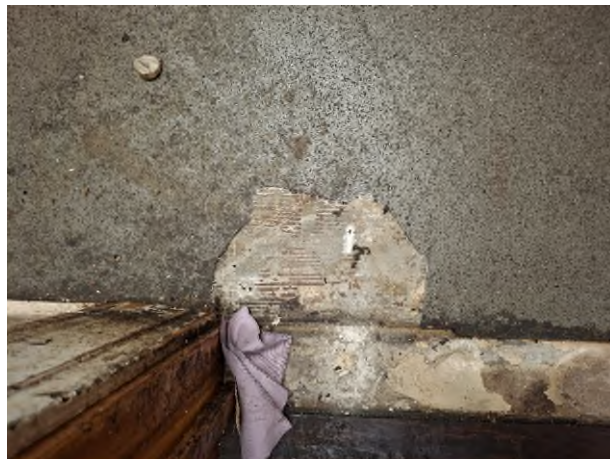
| HA No. | Material Description | Material Location | Sample Number | Condition | Friability | Asbestos Content | Estimated Quantity | Unit | Notes |
|---|---|---|---|---|---|---|---|---|---|
| 25 | Gray Sheet Flooring | Janitor Room, Dish Wash Area, Food Preparation, Hallway 3 | 25A, 25B, 25C | Good | Non-Friable | NAD | 925 | SF | HA-10 is under HA-25 in the food preparation area |

**HA-25: Gray Sheet Flooring**

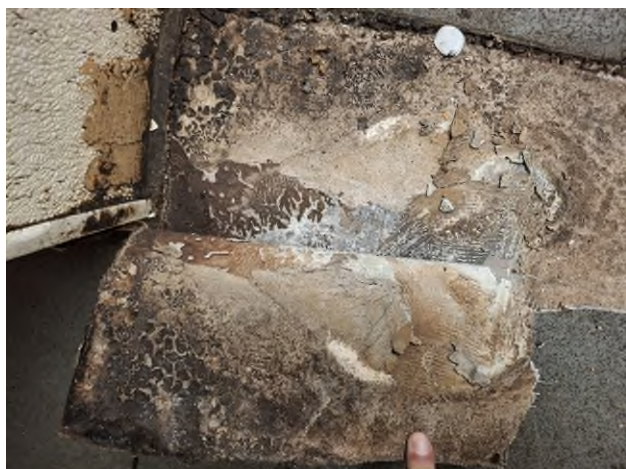
| HA No. | Material Description | Material Location | Sample Number | Condition | Friability | Asbestos Content | Estimated Quantity | Unit | Notes |
|---|---|---|---|---|---|---|---|---|---|
| 26 | Beige Mastic associated with HA-25 | Janitor Room, Dish Wash Area, Food Preparation, Hallway 3 | 26A, 26B, 26C | Good | Non-Friable | NAD | 925 | SF | |

**HA-26: Beige Mastic associated with HA-25**

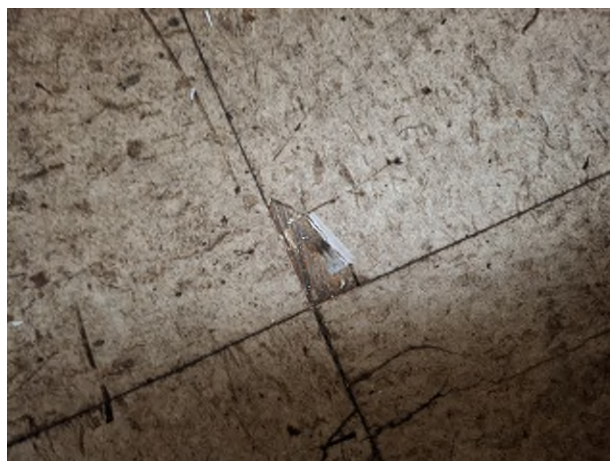
| HA No. | Material Description | Material Location | Sample Number | Condition | Friability | Asbestos Content | Estimated Quantity | Unit | Notes |
|---|---|---|---|---|---|---|---|---|---|
| 27 | Beige 12" x 12" Floor Tile | Storage 1 | 27A, 27B, 27C | Good | Non-Friable | NAD | 102 | SF | |
| 28 | Gold Mastic associated with HA-27 | Storage 1 | 28A, 28B, 28C | Good | Non-Friable | NAD | 102 | SF | |

**HA-27: Beige 12" x 12" Floor Tile**  
**HA-28: Gold Mastic associated with HA-27**

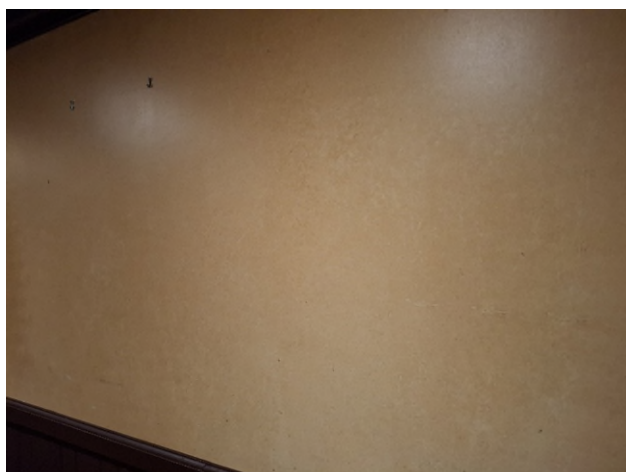
| HA No. | Material Description | Material Location | Sample Number | Condition | Friability | Asbestos Content | Estimated Quantity | Unit | Notes |
|---|---|---|---|---|---|---|---|---|---|
| 29 | Beige Wallpaper | Party Room | 29A, 29B, 29C | Good | Non-Friable | NAD | 115 | SF | |

**HA-29: Beige Wallpaper**

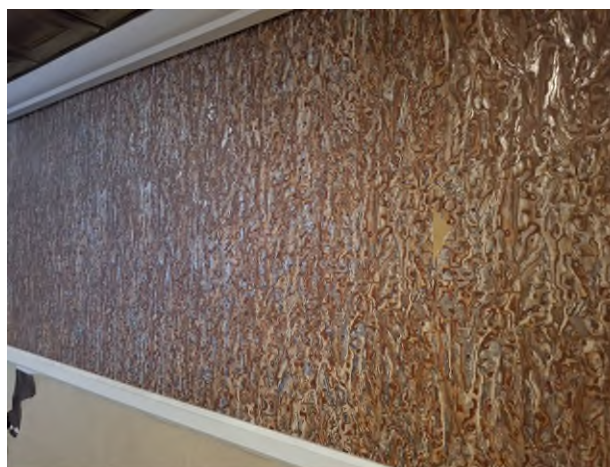
| HA No. | Material Description | Material Location | Sample Number | Condition | Friability | Asbestos Content | Estimated Quantity | Unit | Notes |
|---|---|---|---|---|---|---|---|---|---|
| 30 | Multi-colored Wallpaper | Party Room | 30A, 30B, 30C | Good | Non-Friable | NAD | 165 | SF | |

**HA-30: Multi-colored Wallpaper**

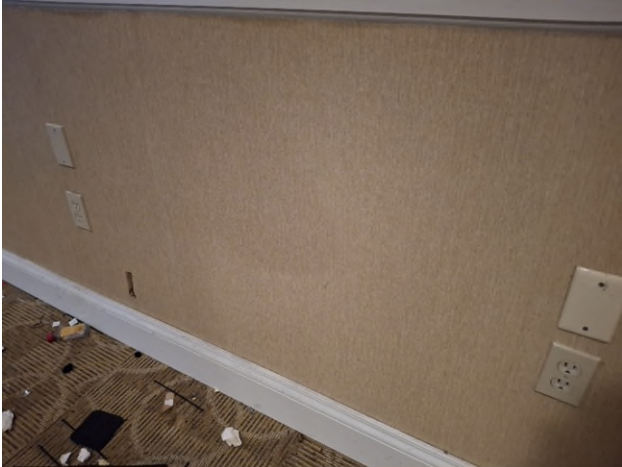
| HA No. | Material Description | Material Location | Sample Number | Condition | Friability | Asbestos Content | Estimated Quantity | Unit | Notes |
|---|---|---|---|---|---|---|---|---|---|
| 31 | Gold Wallpaper (speckled) | Party Room | 31A, 31B, 31C | Good | Non-Friable | NAD | 165 | SF | |

**HA-31: Gold Wallpaper**

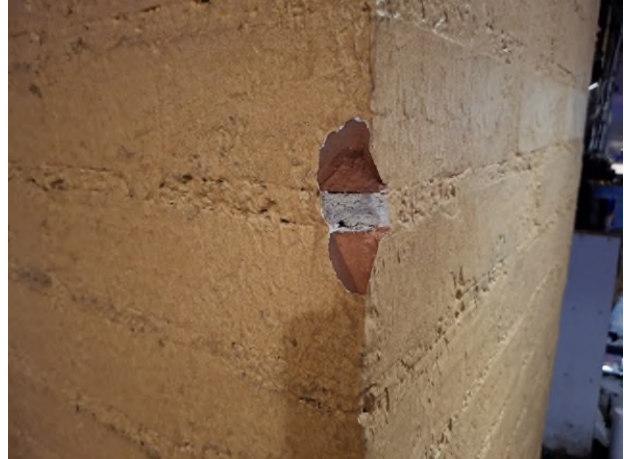
| HA No. | Material Description | Material Location | Sample Number | Condition | Friability | Asbestos Content | Estimated Quantity | Unit | Notes |
|---|---|---|---|---|---|---|---|---|---|
| 32 | Red Brick of Flue | Bar, Basement | 32A, 32B, 32C | Good | Non-Friable | NAD | 240 | SF | |
| 33 | Gray Mortar associated with HA-32 | Bar, Basement | 33A, 33B, 33C | Good | Non-Friable | NAD | 240 | SF | |

**HA-32: Red Brick of Flue**  
**HA-33: Gray Mortar associated with HA-32**

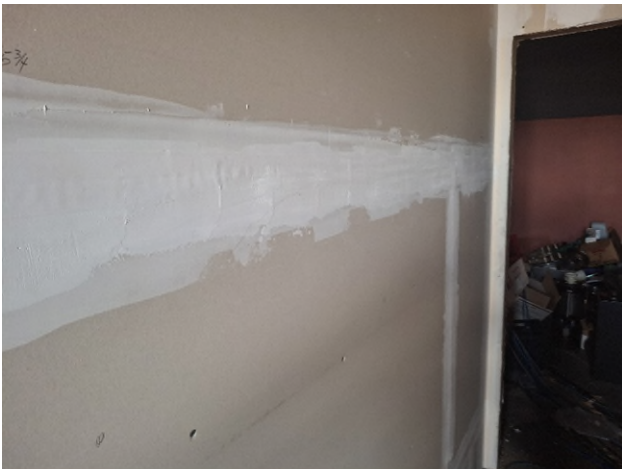
| HA No. | Material Description | Material Location | Sample Number | Condition | Friability | Asbestos Content | Estimated Quantity | Unit | Notes |
|---|---|---|---|---|---|---|---|---|---|
| 34 | White Gypsum Board | HVAC Room, Storage 3, 2nd Floor Bathroom, Shower Room | 34A, 34B, 34C | Good | Non-Friable | NAD | 920 | SF | |

**HA-34: White Gypsum Board**

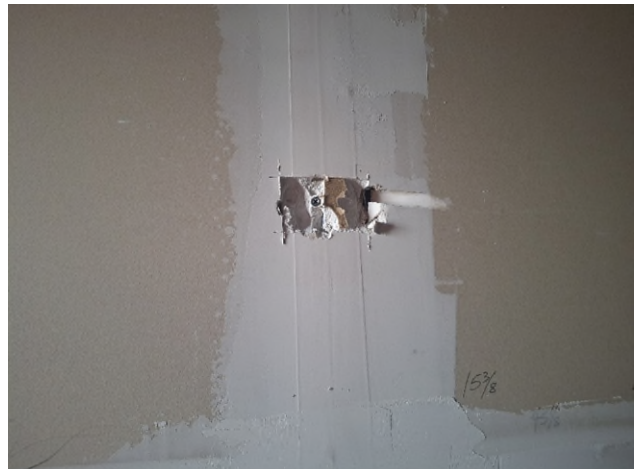
| HA No. | Material Description | Material Location | Sample Number | Condition | Friability | Asbestos Content | Estimated Quantity | Unit | Notes |
|---|---|---|---|---|---|---|---|---|---|
| 35 | White Joint Compound associated with HA-34 | HVAC Room, Storage 3, 2nd Floor Bathroom, Shower Room | 35A, 35B, 35C | Good | Friable | NAD | 920 | SF | |
| 36 | Beige Drywall Tape associated with HA-34 | HVAC Room, Storage 3, Bathroom, Shower Room | 36A, 36B, 36C | Good | Non-Friable | NAD | 920 | SF | |

**HA-35: White Joint Compound associated with HA-34**  
**HA-36: Beige Drywall Tape associated with HA-34**

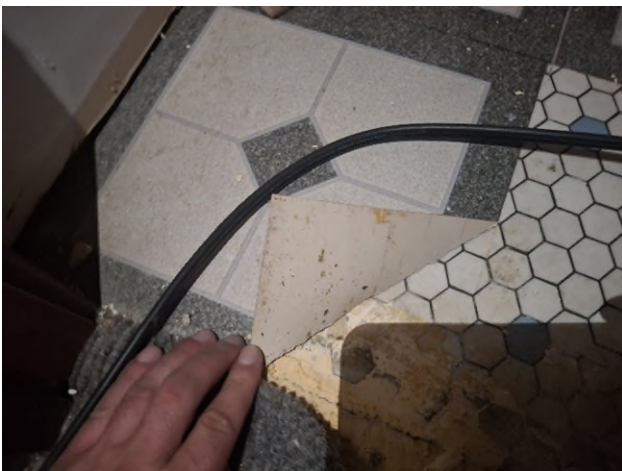
**HA-37: Gray and Beige Linoleum Flooring**  
**HA-38: Clear Mastic associated with HA-37**  
**HA-39: White 1" Hexagonal Stone Tile**

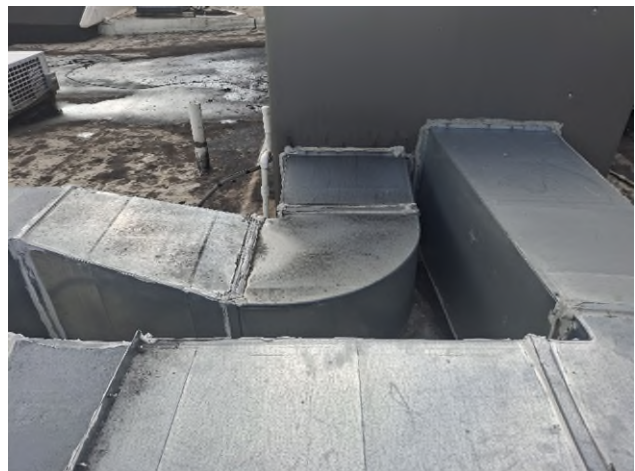
**HA-40: White Duct Sealant**

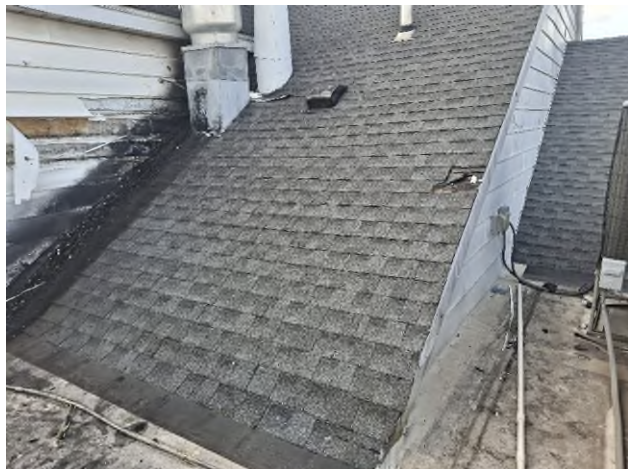
**HA-41: Black Asphalt Shingles**

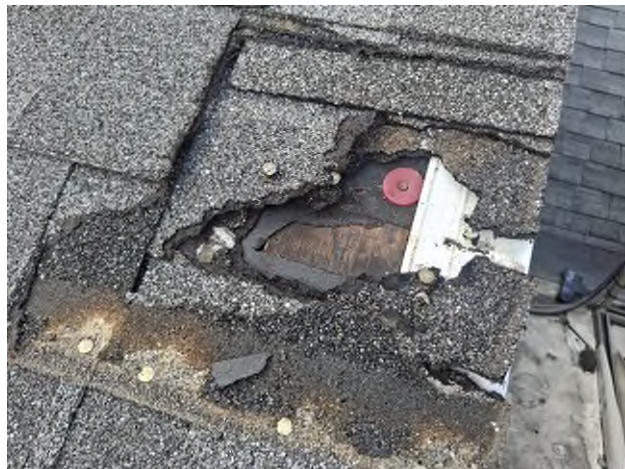
**HA-42: Black Tar Paper associated with HA-41**

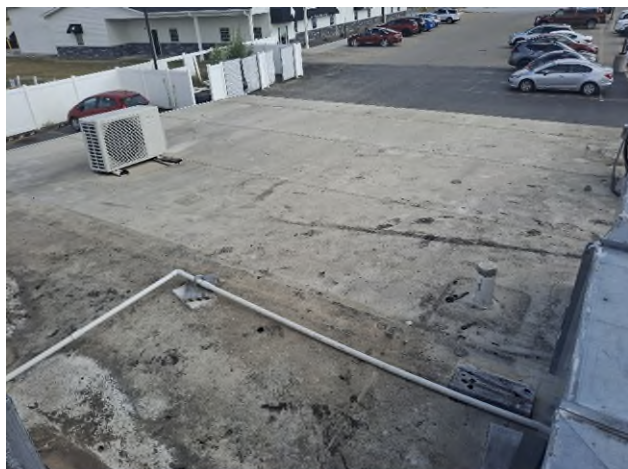
**HA-43: White Roof Membrane**

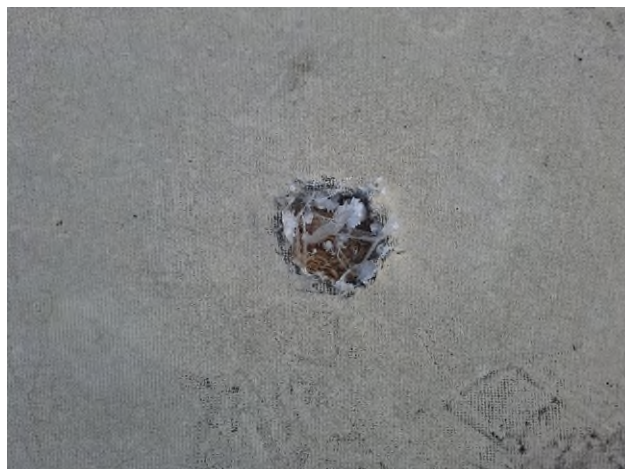
**HA-44: White Foam Layer under HA-43**  
**HA-45: Yellow Foam Layer under HA-43 and HA-44**

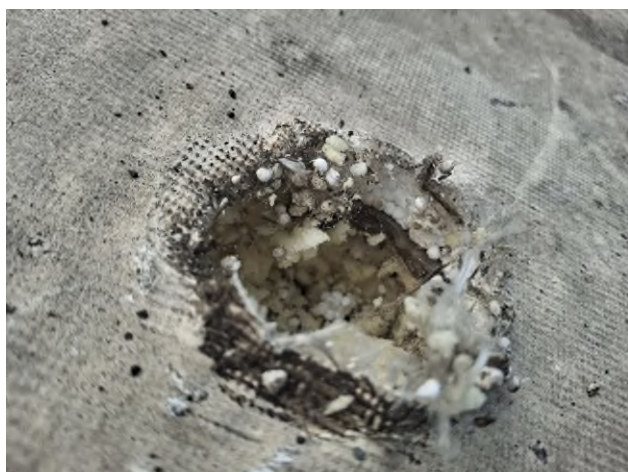
**HA-46: Gray Paper under HA-43, HA-44 and HA-45**

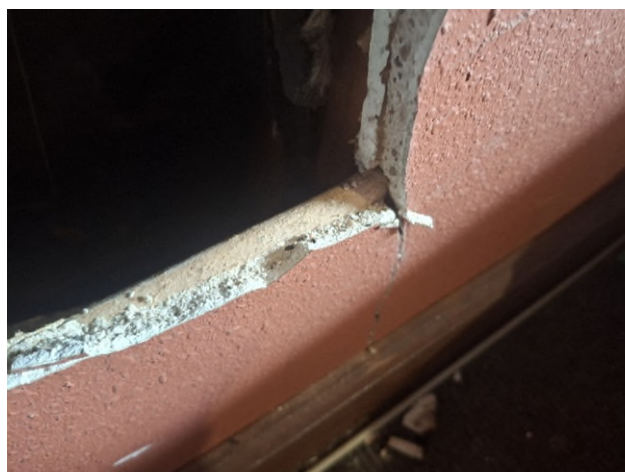
**HA-47: White Plaster Skimcoat**  
**HA-48: Gray Plaster Basecoat**
