# Asbestos Abatement Survey

**Job Order No.: R-97-004-20**

**109 E. Fayette Avenue (East Building)**

**Effingham, Effingham County, IL 62401**

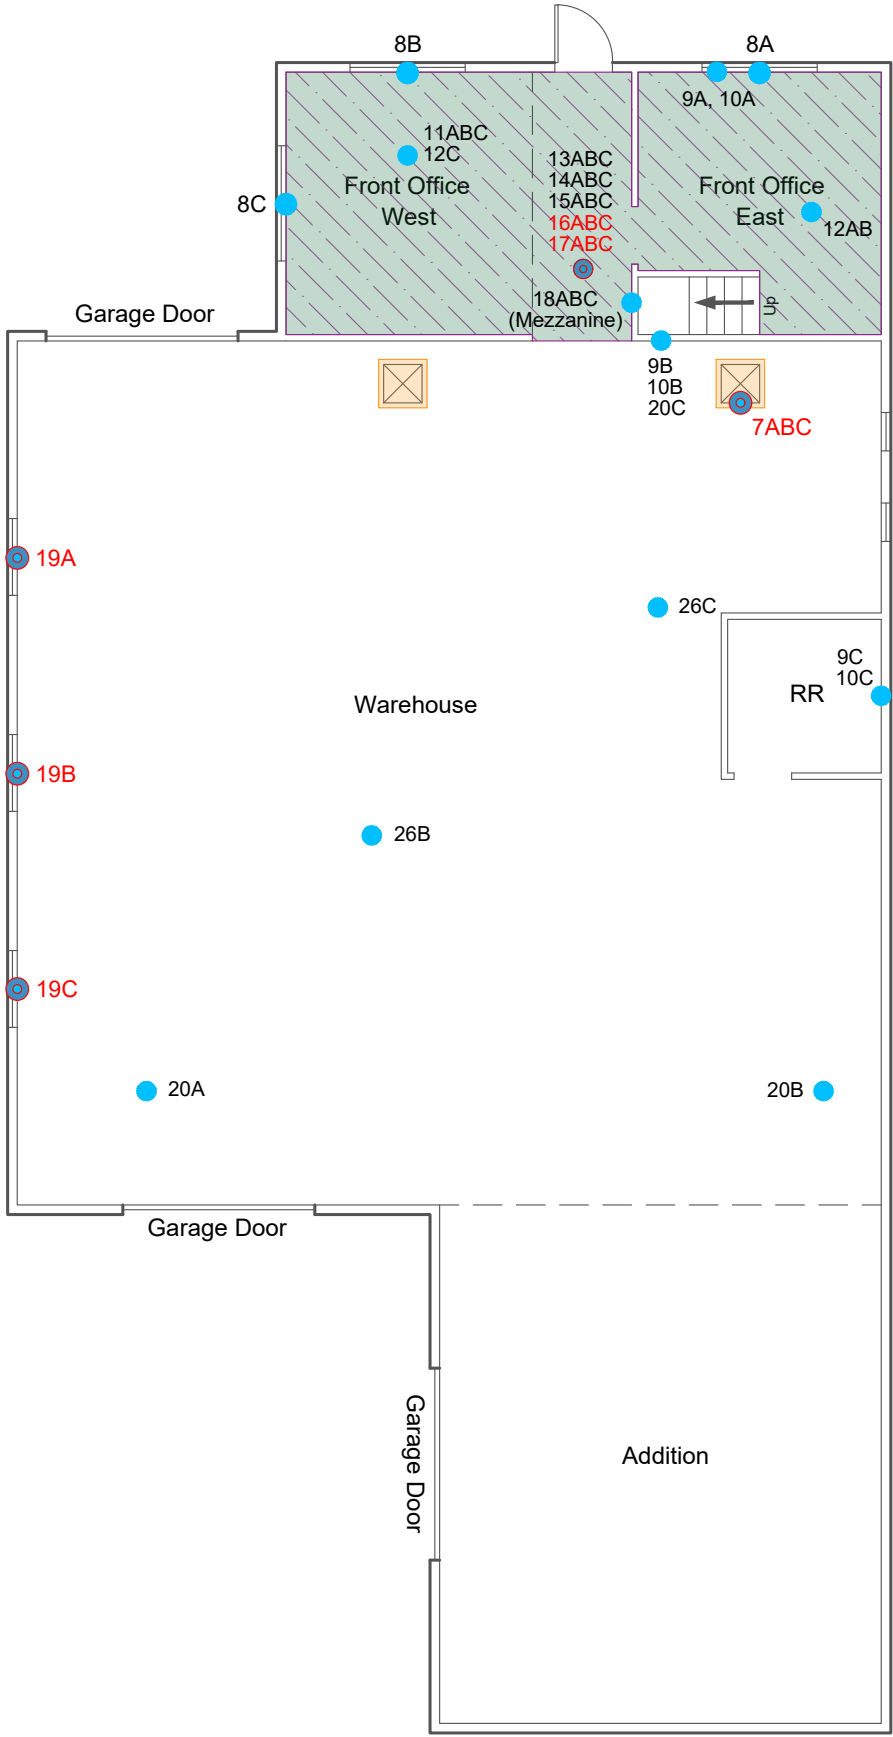
**ASBESTOS CONTAINING  
MATERIAL LOCATIONS -  
First Floor**

- LEGEND**
- ASBESTOS SAMPLE
  - POSITIVE SAMPLE
  - HA-19ABC: Gray Window Glazing - 3 EA
  - Vent Stack
  - HA-7ABC: Gray Vent Stack Insulator - 2 EA
  - HA-16ABC: Red 9" X 9" Floor Tile (Bottom Layer) - 300 SF
  - HA-17ABC: Black Floor Tile Mastic Associated with HA-16 - 300 SF

ACMs identified at the site that may be disturbed during demolition activities, must be removed by a licensed asbestos abatement contractor utilizing industry standard work procedures in accordance with all federal, state, and local regulations governing asbestos.

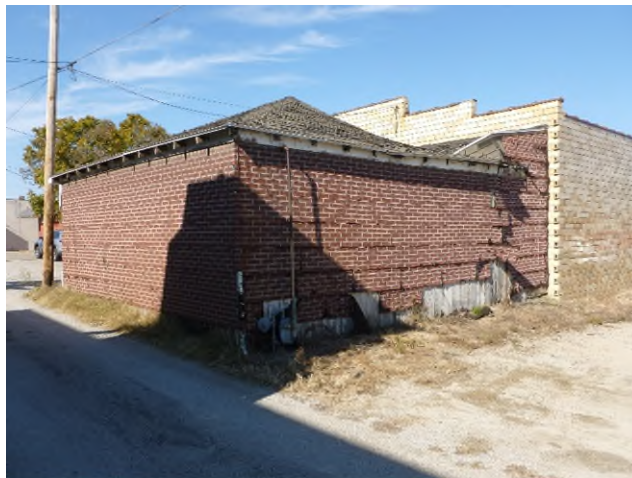
| HA No. | Material Description | Material Location | Sample Number | Condition | Friability | Asbestos Content | Estimated Quantity | Unit | Notes |
|---|---|---|---|---|---|---|---|---|---|
| 1 | Red/Black Asphalt Siding | South Garage Addition | 1A, 1B, 1C | Significantly Damaged | Non-Friable | NAD | 450 | SF | Asphalt roll siding with a cellulose type backing |

**HA-1: Red/Black Asphalt Siding**

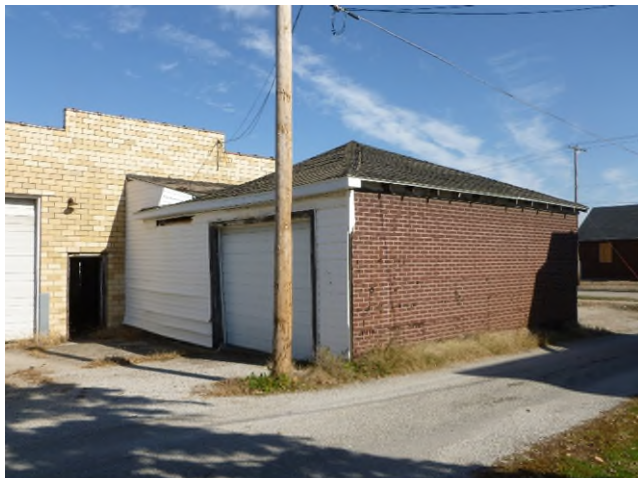
| HA No. | Material Description | Material Location | Sample Number | Condition | Friability | Asbestos Content | Estimated Quantity | Unit | Notes |
|---|---|---|---|---|---|---|---|---|---|
| 2 | Black Felt Paper Vapor Barrier | South Garage Addition | 2A, 2B, 2C | Good | Non-Friable | NAD | 250 | SF | Behind vinyl siding on the west side of the garage addition |

**HA-2: Black Felt Paper Vapor Barrier behind Vinyl Siding**

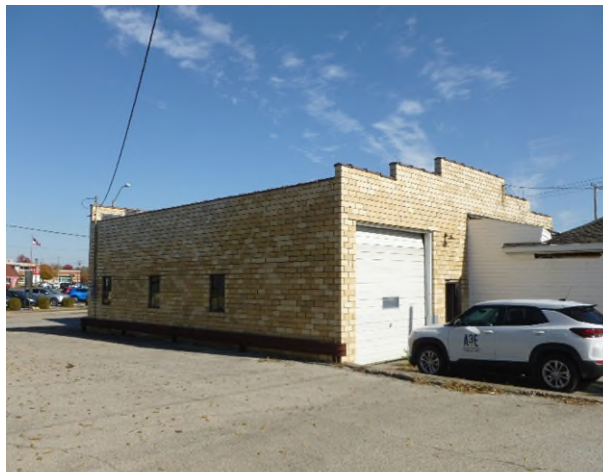
| HA No. | Material Description | Material Location | Sample Number | Condition | Friability | Asbestos Content | Estimated Quantity | Unit | Notes |
|---|---|---|---|---|---|---|---|---|---|
| 3 | Tan Exterior Glazed Block | Around Entire Building | 3A, 3B, 3C | Good | Non-Friable | NAD | 3,180 | SF | |
| 4 | Gray Mortar associated with HA-3 | Around Entire Building | 4A, 4B, 4C | Good | Non-Friable | NAD | 3,180 | SF | |

**HA-3: Tan Exterior Glazed Block  
HA-4: Gray Mortar associated with HA-3**

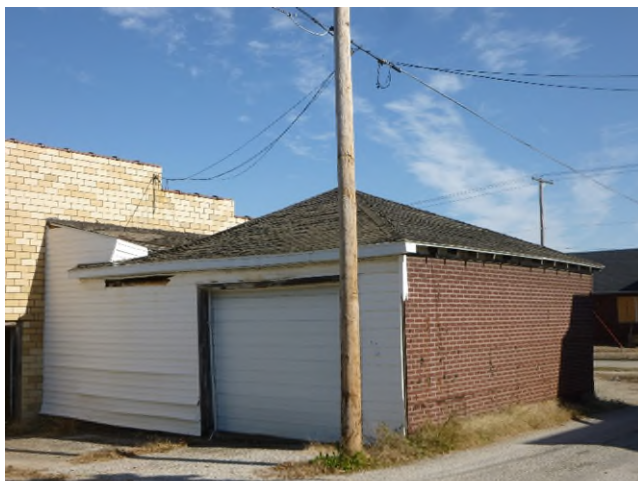
| HA No. | Material Description | Material Location | Sample Number | Condition | Friability | Asbestos Content | Estimated Quantity | Unit | Notes |
|---|---|---|---|---|---|---|---|---|---|
| 5 | Black Asphalt Roof Shingle | South Garage Addition Only | 5A, 5B, 5C | Significantly Damaged | Non-Friable | NAD | 650 | SF | Over plywood substrate |
| 6 | Black Roof Felt Vapor Barrier associated with HA-5 | South Garage Addition Only | 6A, 6B, 6C | Significantly Damaged | Non-Friable | NAD | 650 | SF | |

**HA-5: Black Asphalt Roof Shingle  
HA-6: Black Felt Vapor Barrier associated with HA-5**

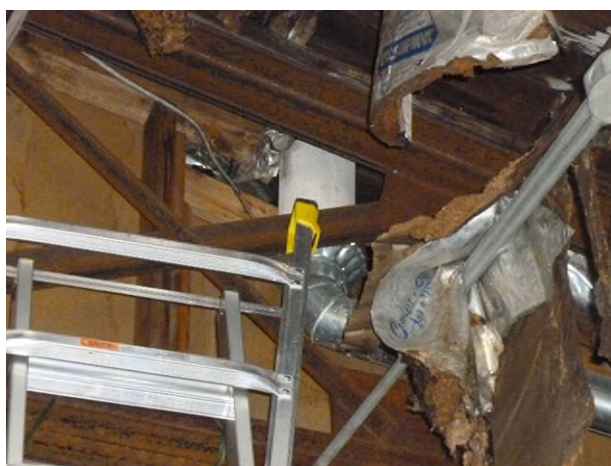
| HA No. | Material Description | Material Location | Sample Number | Condition | Friability | Asbestos Content | Estimated Quantity | Unit | Notes |
|---|---|---|---|---|---|---|---|---|---|
| 7 | Gray Vent Stack Insulator | At Split Furnace and Hanging Furnace in Warehouse Area | 7A, 7B, 7C | Good | Non-Friable | Chrysotile 10-15% | 2 | EA | Cementitious collar at vent pipe roof penetration |

**HA-7: Gray Vent Stack Insulator**

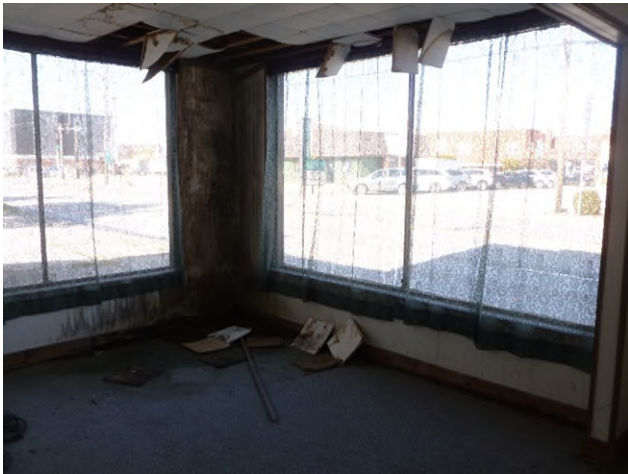
| HA No. | Material Description | Material Location | Sample Number | Condition | Friability | Asbestos Content | Estimated Quantity | Unit | Notes |
|---|---|---|---|---|---|---|---|---|---|
| 8 | Gray Window Glazing | Large Plate Glass Windows in Front Office | 8A, 8B, 8C | Good | Non-Friable | NAD | 75 | LF | 3 windows |

**HA-8: Gray Window Glazing**

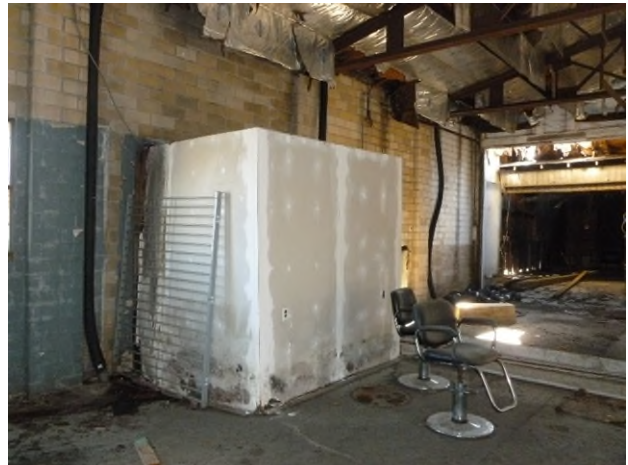
| HA No. | Material Description | Material Location | Sample Number | Condition | Friability | Asbestos Content | Estimated Quantity | Unit | Notes |
|---|---|---|---|---|---|---|---|---|---|
| 9 | White Gypsum Board | Front Office, Warehouse Restroom, Two Walls in Mezzanine | 9A, 9B, 9C | Significantly Damaged | Friable | NAD | 800 | SF | |
| 10 | White Joint Compound | Front Office, Warehouse Restroom, Two Walls in Mezzanine | 10A, 10B, 10C | Significantly Damaged | Friable | NAD | 800 | SF | |

**HA-9: White Gypsum Board  
HA-10: White Joint Compound**

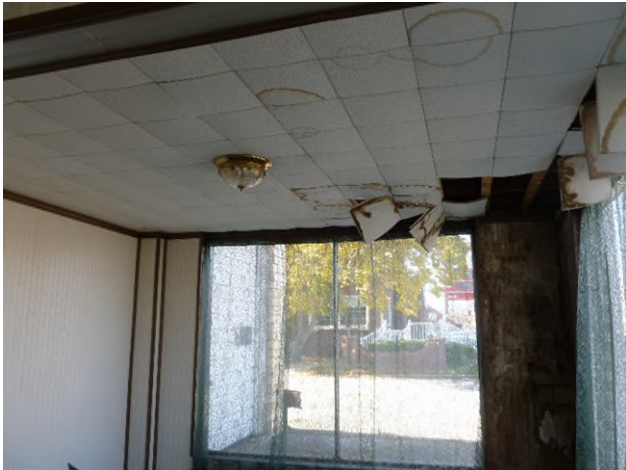
| HA No. | Material Description | Material Location | Sample Number | Condition | Friability | Asbestos Content | Estimated Quantity | Unit | Notes |
|---|---|---|---|---|---|---|---|---|---|
| 11 | White 1' x 1' Tongue and Groove Ceiling Tile | Front Office West Side Only | 11A, 11B, 11C | Good | Significantly Damaged | Friable | 150 | SF | No adhesive, tiles are nailed to wood joists |

**HA-11: White 1' x 1' Tongue and Groove Ceiling Tile**

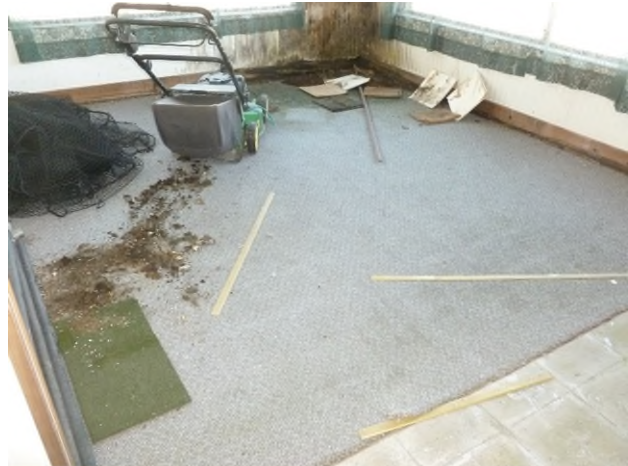
| HA No. | Material Description | Material Location | Sample Number | Condition | Friability | Asbestos Content | Estimated Quantity | Unit | Notes |
|---|---|---|---|---|---|---|---|---|---|
| 12 | Yellow Carpet Glue/Adhesive | Front Offices | 12A, 12B, 12C | Good | Non-Friable | NAD | 275 | SF | |

**HA-12: Yellow Carpet Adhesive**

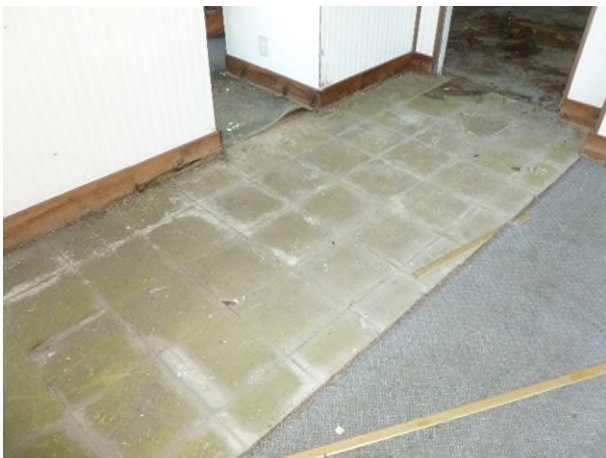
| HA No. | Material Description | Material Location | Sample Number | Condition | Friability | Asbestos Content | Estimated Quantity | Unit | Notes |
|---|---|---|---|---|---|---|---|---|---|
| 13 | Gray 12' x 12" Floor Tile (top layer) | Front Office Hallway/Entry | 13A, 13B, 13C | Good | Non-Friable | NAD | 75 | SF | Peel and stick floor tile type |
| 14 | Gray 12" x 12" Floor Tile (second layer under HA-13) | Front Office Hallway/Entry | 14A, 14B, 14C | Good | Non-Friable | NAD | 75 | SF | |
| 15 | Yellow Floor Tile Mastic associated with HA-14 | Front Office Hallway/Entry | 15A, 15B, 15C | Good | Non-Friable | NAD | 75 | SF | |

**HA-13: Gray 12" x 12" Floor Tile (top layer)  
HA-14: Gray 12" x 12" Floor Tile (second layer)  
HA-15: Yellow Mastic associated with HA-14**

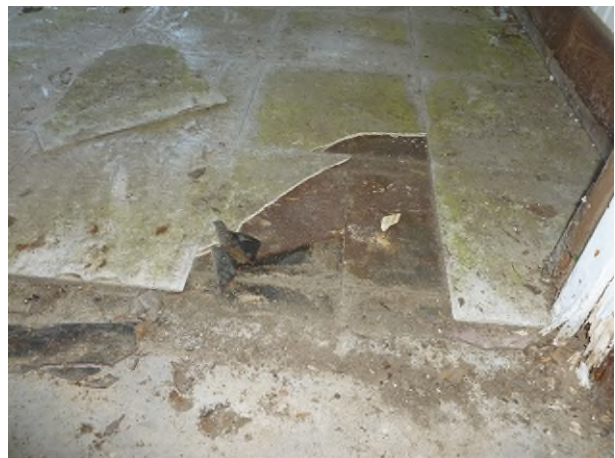
| HA No. | Material Description | Material Location | Sample Number | Condition | Friability | Asbestos Content | Estimated Quantity | Unit | Notes |
|---|---|---|---|---|---|---|---|---|---|
| 16 | Red 9" x 9" Floor Tile | Front Office Area East and West, Office Hallway/Entry | 16A, 16B, 16C | Good | Non-Friable | Chrysotile 5-10% | 300 | SF | Beneath carpet in front offices and beneath floor tile (HA-13 & HA-14) in hallway |
| 17 | Black Floor Tile Mastic associated with HA-16 | Front Office Area East and West, Office Hallway/Entry | 17A, 17B, 17C | Good | Non-Friable | Chrysotile 1-5% | 300 | SF | Beneath carpet in front offices and beneath floor tile (HA-13 & HA-14) in hallway |

**HA-16: Red 9" x 9" Floor Tile  
HA-17: Black Mastic associated with HA-16**

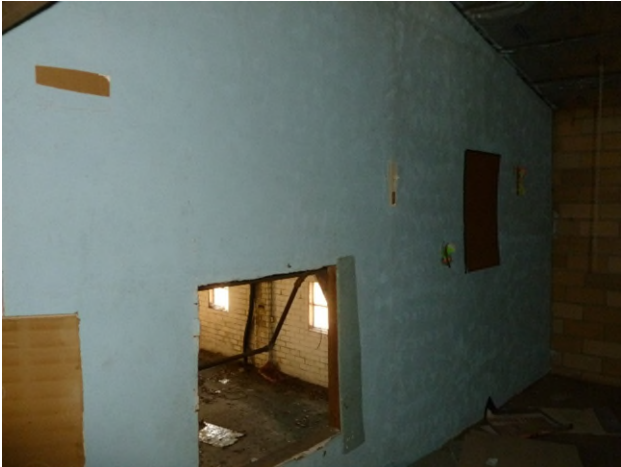
| HA No. | Material Description | Material Location | Sample Number | Condition | Friability | Asbestos Content | Estimated Quantity | Unit | Notes |
|---|---|---|---|---|---|---|---|---|---|
| 18 | White Wall Texture | Two Walls in Mezzanine | 18A, 18B, 18C | Good | Friable | NAD | 100 | SF | Troweled on joint compound |

**HA-18: White Wall Texture**

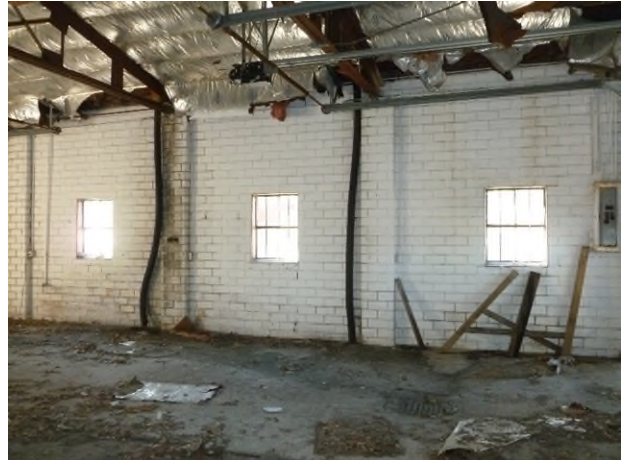
| HA No. | Material Description | Material Location | Sample Number | Condition | Friability | Asbestos Content | Estimated Quantity | Unit | Notes |
|---|---|---|---|---|---|---|---|---|---|
| 19 | Gray Window Glazing | West Side Warehouse Windows | 19A, 19B, 19C | Good | Non-Friable | Chrysotile 1-5% | 3 | EA | |

**HA-19: Gray Window Glazing**

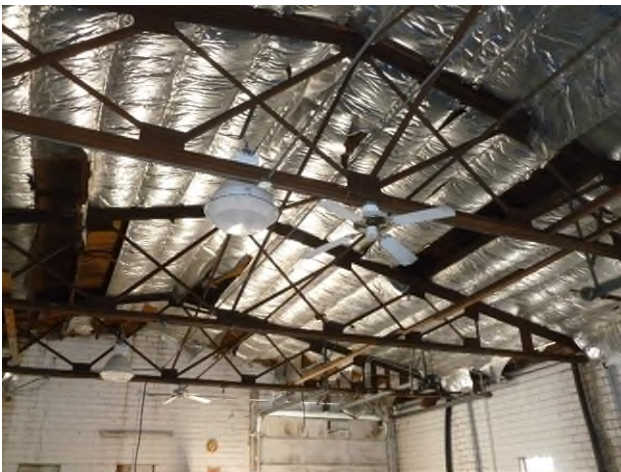
| HA No. | Material Description | Material Location | Sample Number | Condition | Friability | Asbestos Content | Estimated Quantity | Unit | Notes |
|---|---|---|---|---|---|---|---|---|---|
| 20 | Ceiling Deck Insulation | Underside of Ceiling Deck | 20A, 20B, 20C | Good | Friable | NAD | 2,760 | SF | Balsam Wool brand by Weyerhaeuser |

**HA-20: Ceiling Deck Insulation**

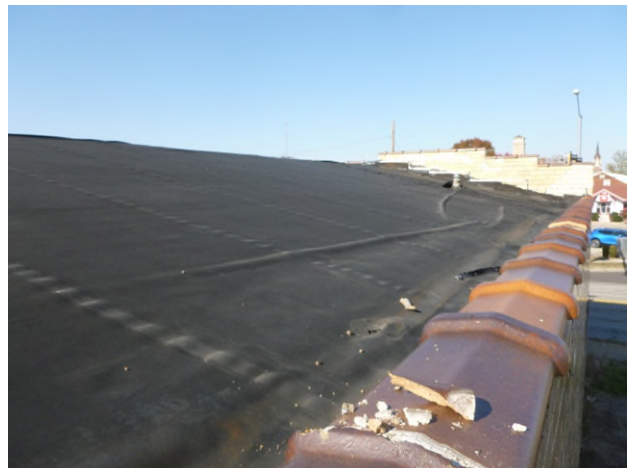
| HA No. | Material Description | Material Location | Sample Number | Condition | Friability | Asbestos Content | Estimated Quantity | Unit | Notes |
|---|---|---|---|---|---|---|---|---|---|
| 21 | Black Roofing Material | Main Building Roof | 21A, 21B, 21C | Good | Non-Friable | Chrysotile 1-5% | 2,760 | SF | Built up base roofing material beneath non-suspect rubber membrane |
| 22 | Black Roof Flashing Mastic | Main Building Roof | 22A, 22B, 22C | Good | Non-Friable | Chrysotile 5-10% | 250 | SF | Flashing and roof penetrations |

**HA-21: Black Roofing Material**  
**HA-22: Black Roof Flashing Mastic**

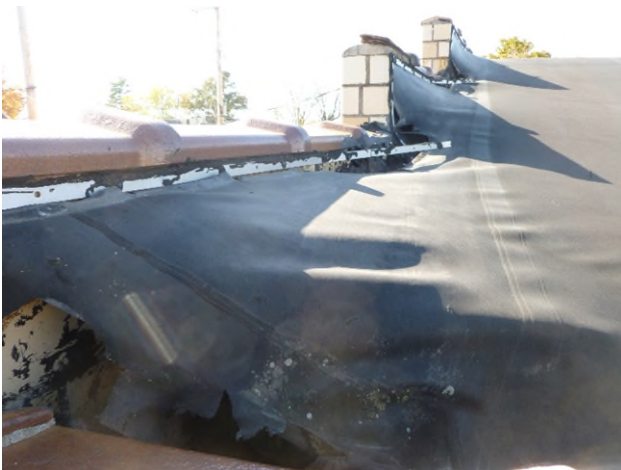
| HA No. | Material Description | Material Location | Sample Number | Condition | Friability | Asbestos Content | Estimated Quantity | Unit | Notes |
|---|---|---|---|---|---|---|---|---|---|
| 23 | Black Roof Mastic | Along Parapets to Secure Anchor Bar to Rubber Membrane | 23A, 23B, 23C | Good | Non-Friable | NAD | 250 | SF | |

**HA-23: Black Roof Mastic**

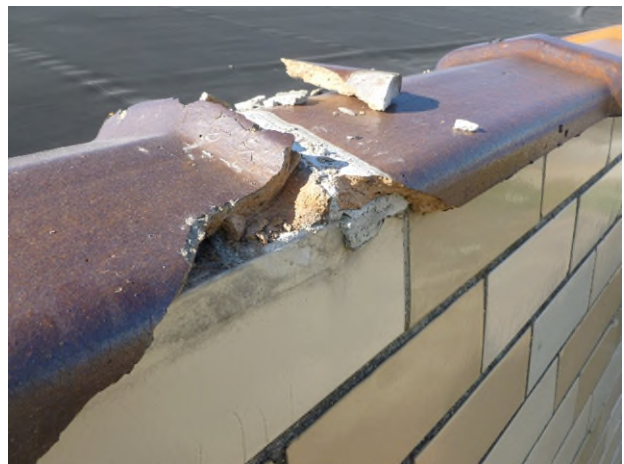
| HA No. | Material Description | Material Location | Sample Number | Condition | Friability | Asbestos Content | Estimated Quantity | Unit | Notes |
|---|---|---|---|---|---|---|---|---|---|
| 24 | Gray Coping Tile Grout | Coping Tiles along Roof Perimeter | 24A, 24B, 24C, | Good | Non-Friable | NAD | 250 | SF | |

**HA-24: Gray Coping Tile Grout**

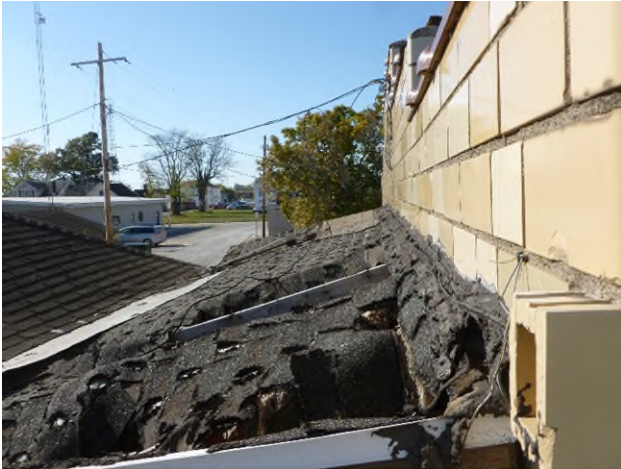
| HA No. | Material Description | Material Location | Sample Number | Condition | Friability | Asbestos Content | Estimated Quantity | Unit | Notes |
|---|---|---|---|---|---|---|---|---|---|
| 25 | Black Roof Flashing Mastic | South Garage Addition | 25A, 25B, 25C | Good | Non-Friable | NAD | 35 | SF | |

**HA-25: Black Roof Flashing Mastic**

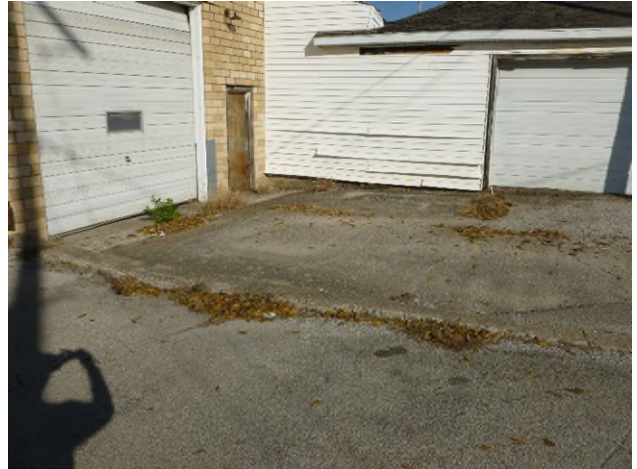
| HA No. | Material Description | Material Location | Sample Number | Condition | Friability | Asbestos Content | Estimated Quantity | Unit | Notes |
|---|---|---|---|---|---|---|---|---|---|
| 26 | Gray Concrete | Building Floors, Sidewalk, Rear Driveway | 26A, 26B, 26C | Good | Non-Friable | NAD | 3,500 | SF | No exposed foundation wall |

**HA-26: Gray Concrete**
