FLOORBEAM WEB REPAIRS

**STATE OF ILLINOIS
DEPARTMENT OF TRANSPORTATION**

**MAIN SPANS FLOORBEAM WEB REPAIRS - 5
S.N. 082-6001 MLK BRIDGE OVER MISSISSIPPI RIVER**

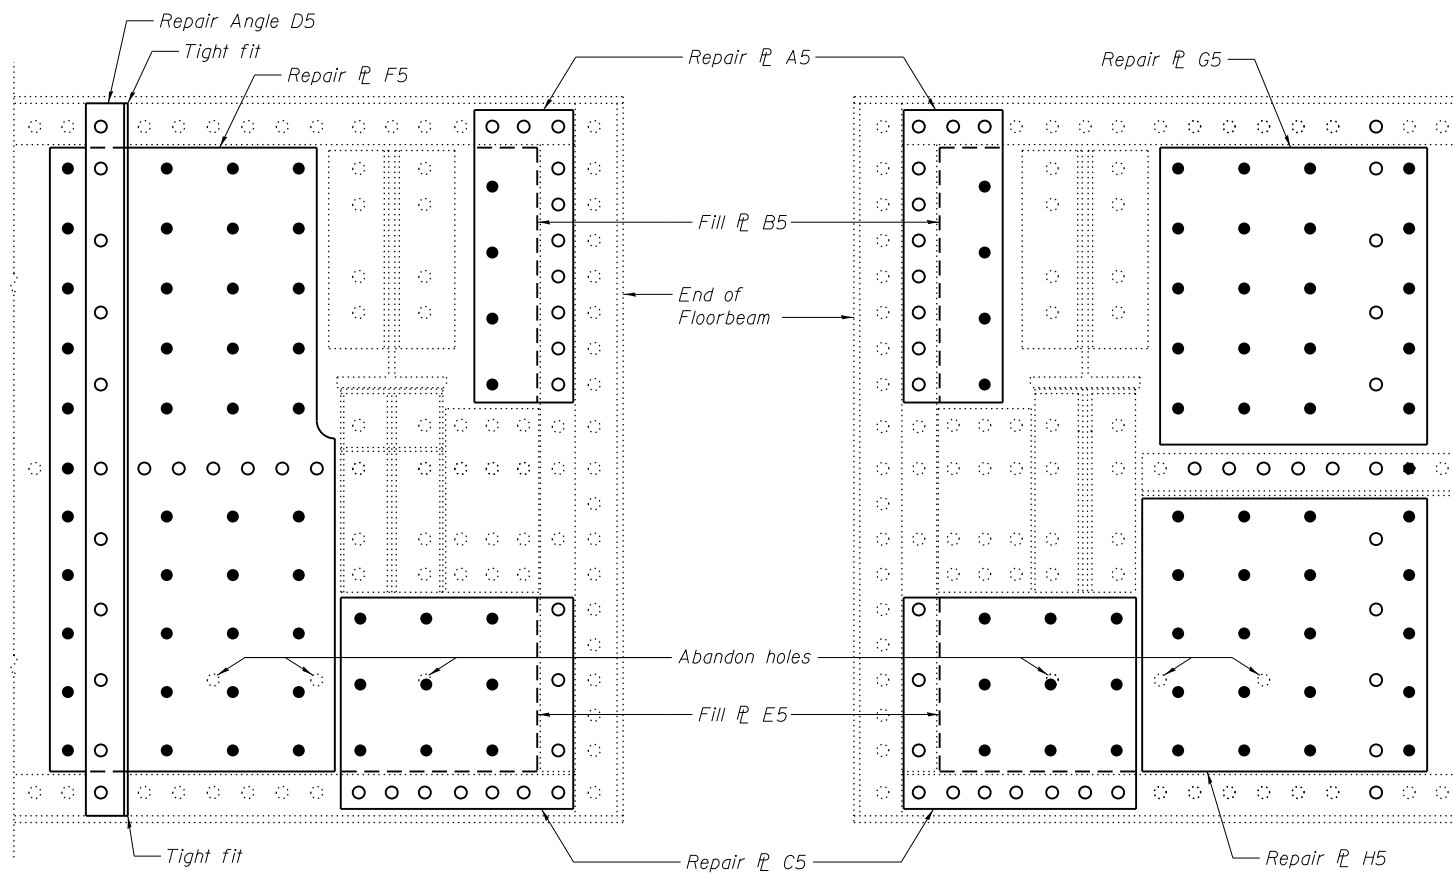
**SOUTH END AT PANEL POINT L11
WEST FACE**
Span 9

**SOUTH END AT PANEL POINT L11
EAST FACE**
Span 9

Note A:
Field drill holes using existing holes as template.
Remainder of holes may be shop or field drilled.
