STATE OF ILLINOIS
 DEPARTMENT OF TRANSPORTATION

MAIN SPANS FLOORBEAM WEB REPAIRS - 8
 S.N. 082-6001 MLK BRIDGE OVER MISSISSIPPI RIVER

SHEET NO. S72 OF S138 SHEETS

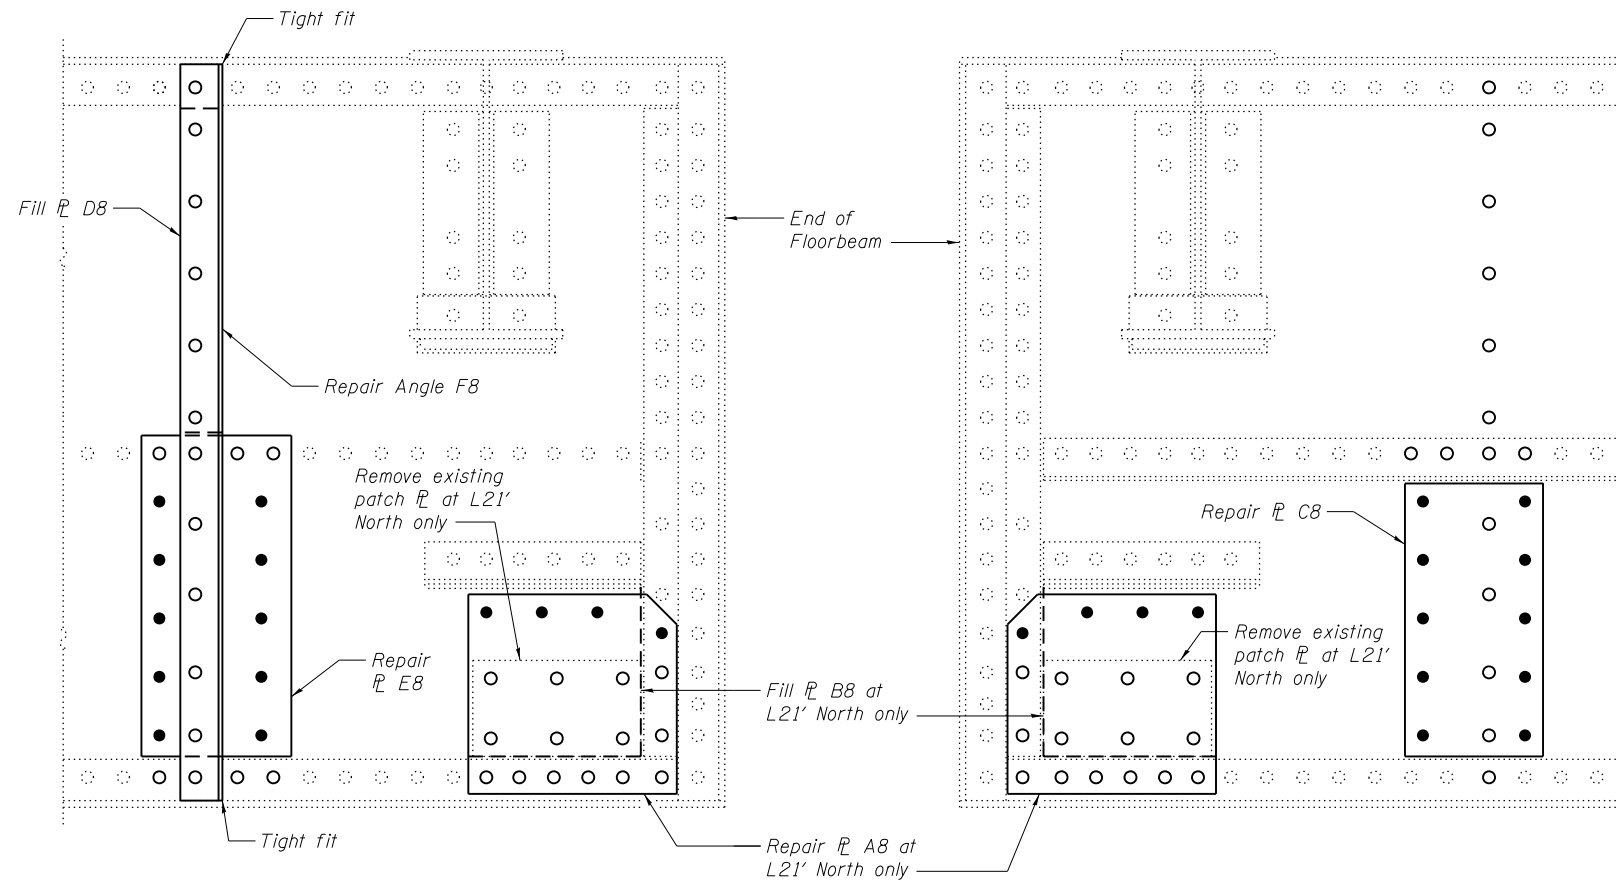
FLOORBEAM WEB REPAIRS

NORTH END AT PANEL POINT L21' AND L23'
EAST FACE
 (Span 10)

NORTH END AT PANEL POINT L21' AND L23'
WEST FACE
 (Span 10)

Note: L21' shown, L23' similar

Note A:
 Field drill holes using existing holes as template.
 Remainder of holes may be shop or field drilled.
