STATE OF ILLINOIS  
DEPARTMENT OF TRANSPORTATION

MAIN SPANS FLOORBEAM WEB REPAIRS - 15  
S.N. 082-6001 MLK BRIDGE OVER MISSISSIPPI RIVER

SHEET NO. S79 OF S138 SHEETS

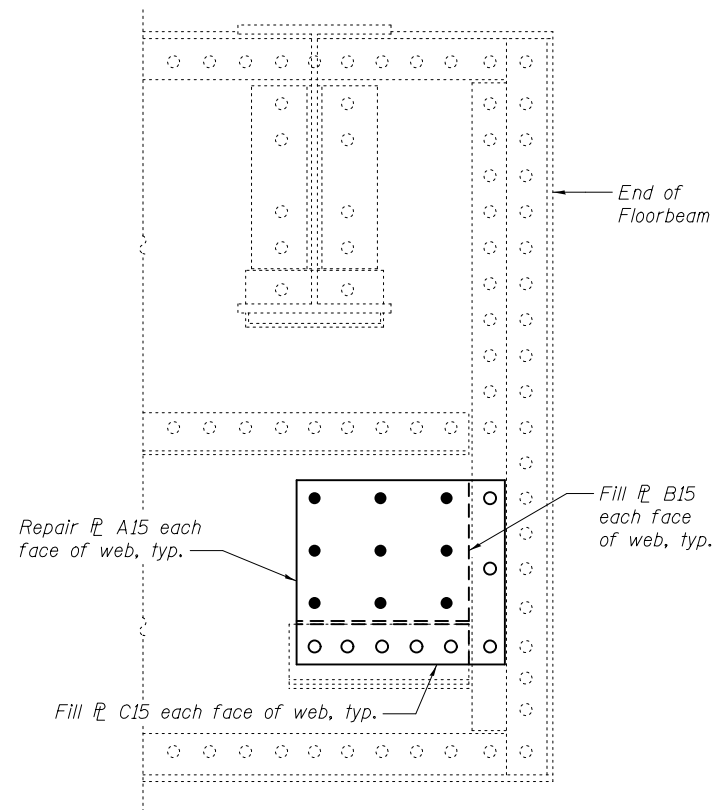
**NORTH END AT PANEL POINT L24**

East face shown  
(Span 10)

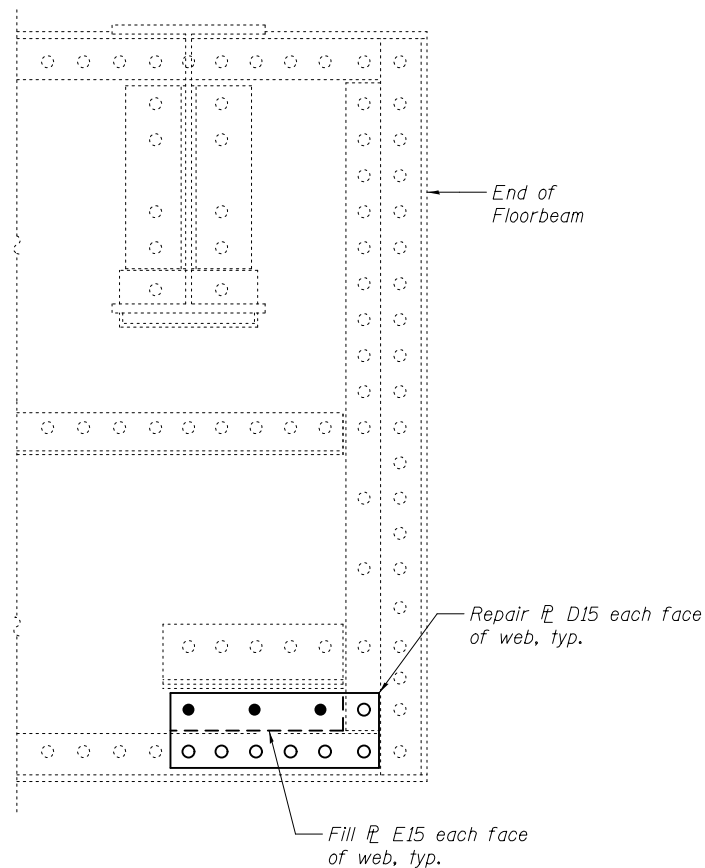
**SOUTH END AT PANEL POINT L23'**

West face shown  
(Span 10)

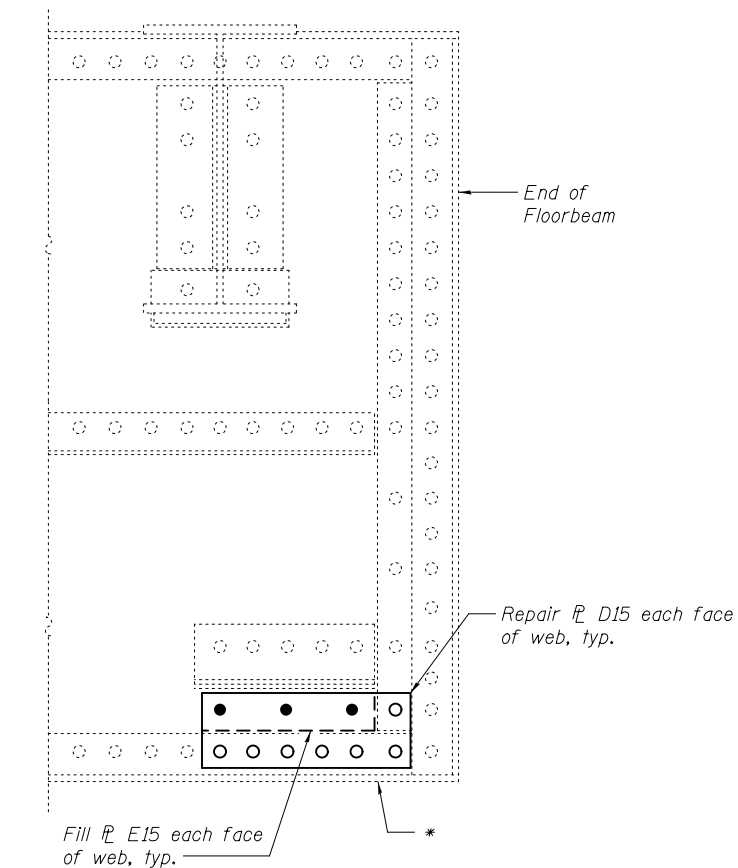
**NORTH END AT PANEL POINT L23**

East face shown  
(Span 10)

\* Remove delamination from bottom angle at floorbeam 23, north end. Grind smooth to an ANSI 250 finish. Cost included with Structural Steel Repair.
