**STATE OF ILLINOIS
DEPARTMENT OF TRANSPORTATION**

**DECK REPAIRS
STRUCTURE NO. 084-0160**

PART B - SHEET 47 of 67

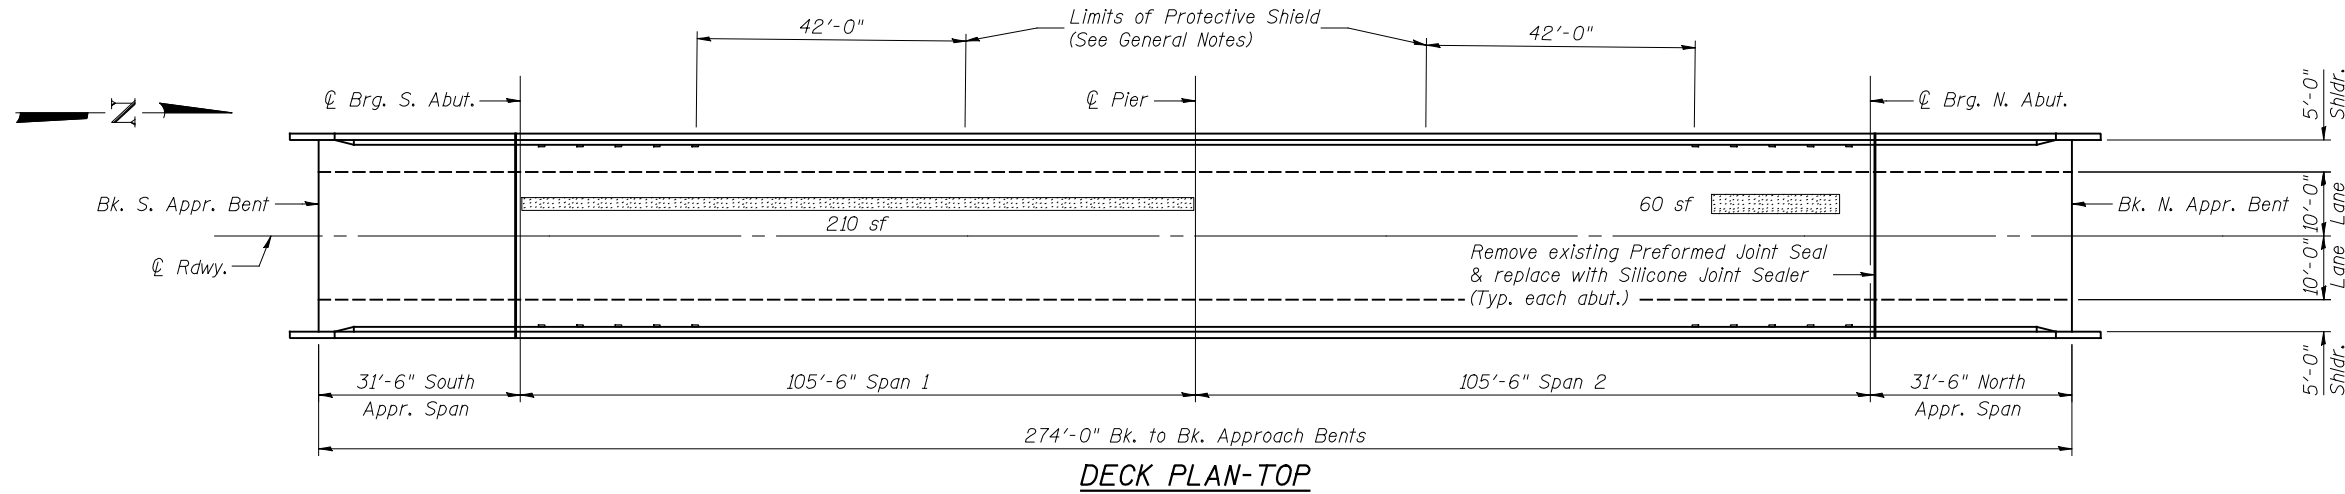
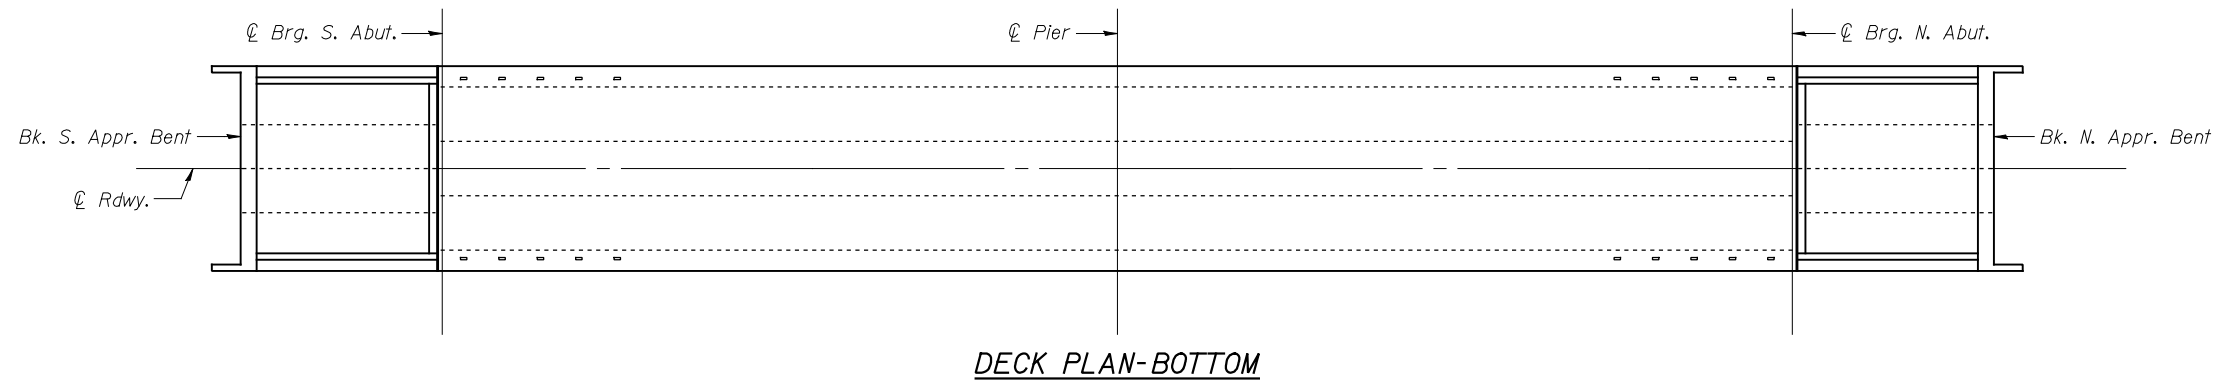
Deteriorated asphalt wearing surface (assumed Deck Slab Repair-Partial)

Notes:
Deck Condition Survey performed 12/22/2010 (by IDOT-D6).
Repair areas are estimated, the Engineer shall determine actual repair locations and record them on the As-Built plans.

Item	Unit	Total
Deck Slab Repair (Partial)	Sq. Yd.	30
Silicone Joint Sealer, 2 3/4"	Foot	59
