STATE OF ILLINOIS
DEPARTMENT OF TRANSPORTATION

DECK REPAIRS
STRUCTURE NO. 084-0162

F.A.I. RTE.	SECTION	COUNTY	TOTAL SHEETS	SHEET NO.
72	(84-10-3)RS-5	SANGAMON	95	77
STA. 721+28.56			CONTRACT NO. 72C88

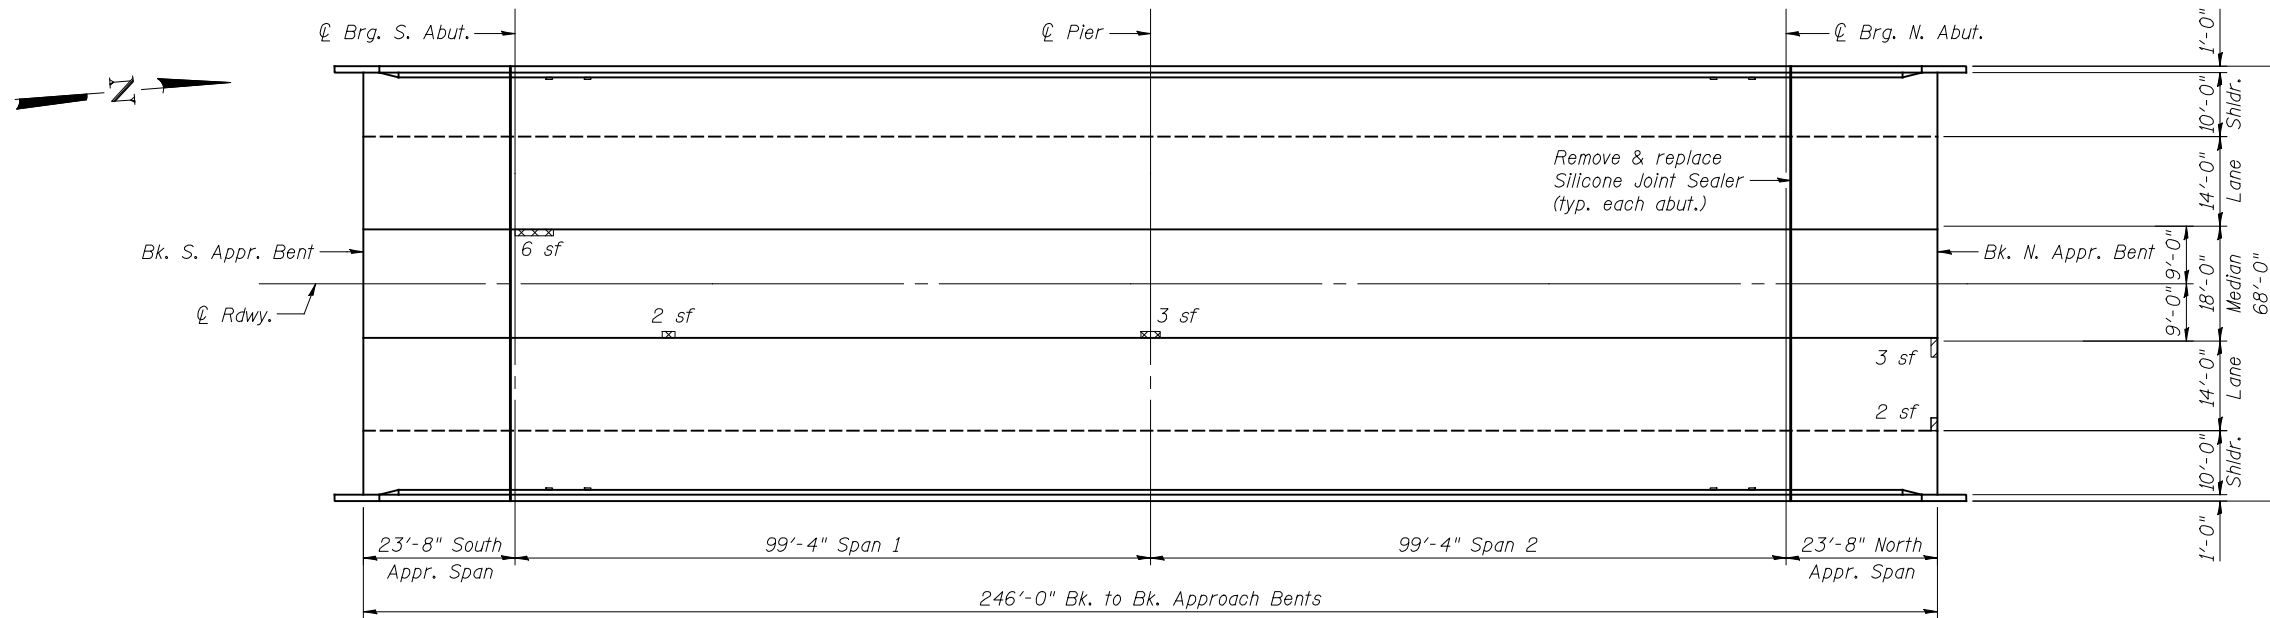
DECK PLAN-TOP

Notes:
Deck Condition Survey performed 2/07/2011 (by IDOT-D6).
Repair areas are estimated, the Engineer shall determine actual repair locations and record them on the As-Built plans.
