**STATE OF ILLINOIS  
DEPARTMENT OF TRANSPORTATION**

**10' x 5' BOX CULVERT REPAIRS  
AT STA. 636+00 (+/-)**

F.A.I. RTE.	SECTION	COUNTY	TOTAL SHEETS	SHEET NO.
55	60-1,2(RS-3)	MADISON	212	106
STA. 636+00 (+/-)		CONTRACT NO. 76D99

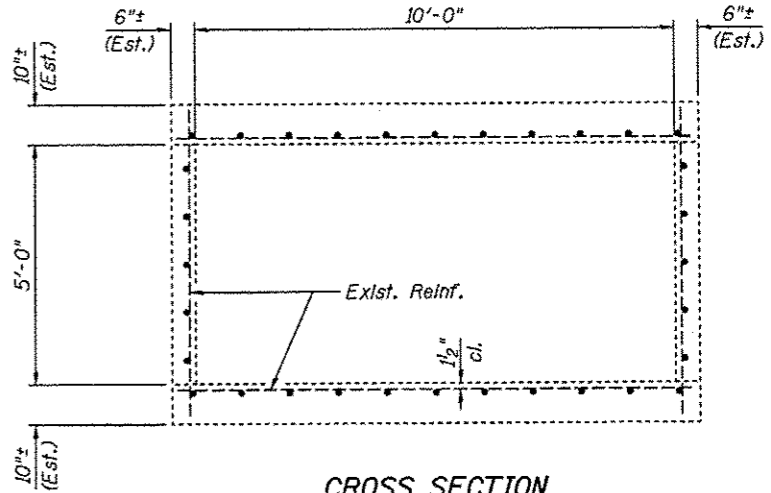
**PLAN OF BOTTOM SLAB**

Spalled concrete with exposed reinf.

40 sf

80 sf

Notes:  
Repair areas are estimated, the Engineer shall determine actual repair locations and record them on the As-Built plans.

If the depth of the concrete removal exceeds about 5" (measured from the estimated original top of concrete before spalling), over an area extending more than 4 feet measured parallel to the sidewalls, then Temporary Bracing between the bottom of the sidewalls may be required to prevent the bottom slab from buckling and/or the sidewalls from moving inward due to lateral soil pressure on the sidewalls. The possible need for this bracing shall be addressed during construction, as discussed in the Special Provision for Structural Repair of Concrete.

Item	Unit	Total
Structural Repair of Concrete (Depth > 5")	Sq Ft	40
Structural Repair of Concrete (Depth ≤ 5")	Sq Ft	80
