**LOAD RATING
INSPECTION REPORT**

Structure Number: 016-0195 District: 1 Date: 02/28/20
 Carried/Crossed: IL 1 over IHB RR Proposed Year of Improvement: FY20
 Inspection Date: 10/9/19 Inspector(s): M.V. Reviewed by: RAD

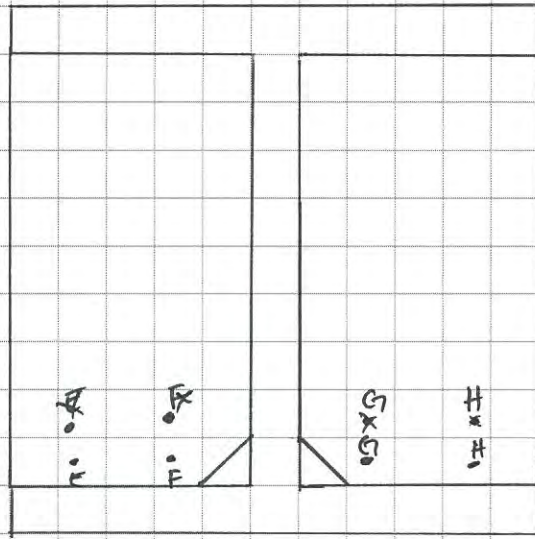
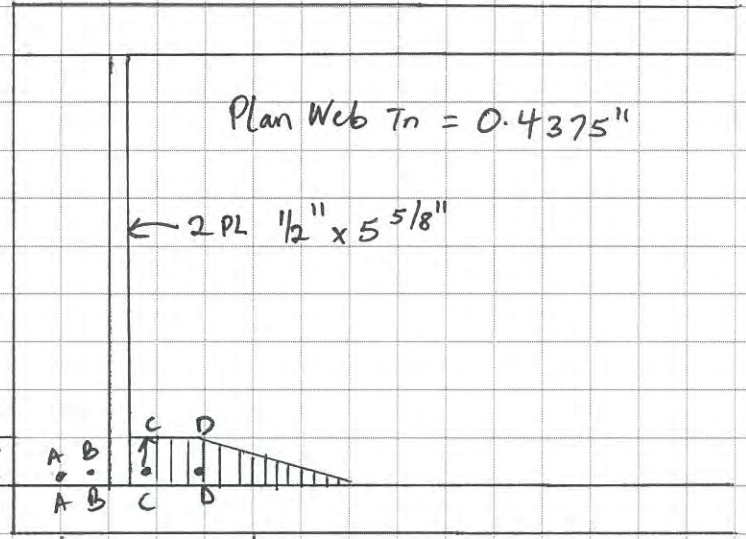
BEAM 9 @ P8-S

% Loss = $\frac{\text{FULL} - \text{REM}}{\text{FULL}} \times 100\% = \frac{9.558 - 7.933}{9.558}$

= 17.0%

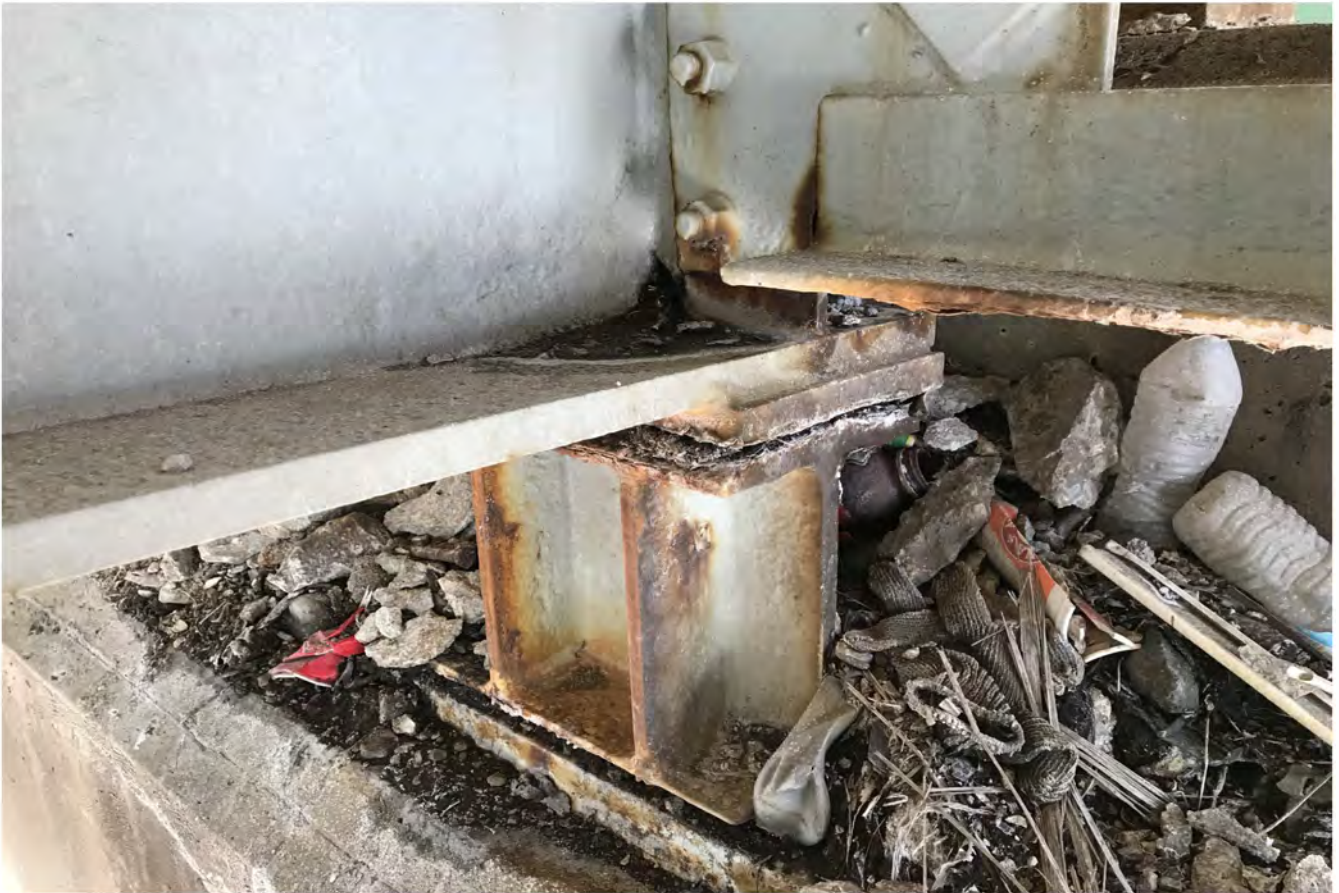
BEAM 9- E FACE-PIER 8S

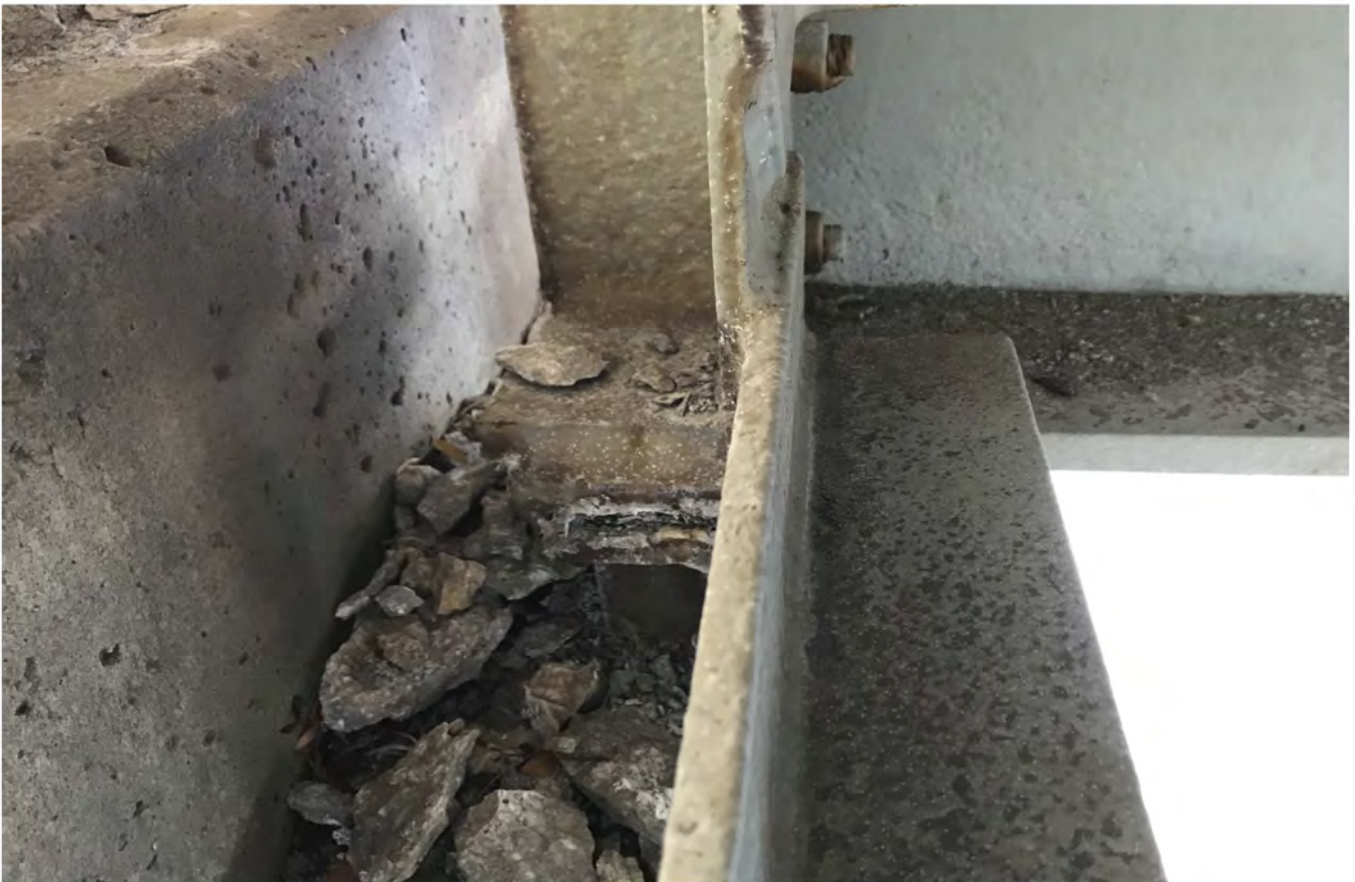
BEAM 9- W FACE- PIER 8S

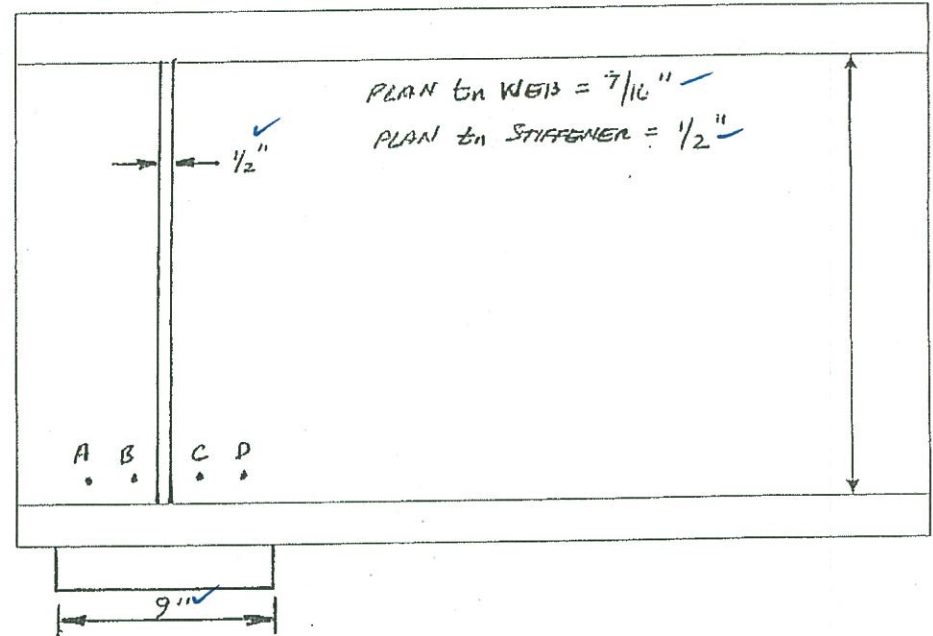
BEAM 8 -
PIER 8 -
SPAN 8 -

2020 beam end section loss measurements for beam 8, Pier 8, Span 8 yielded section loss of 44%, please see enclosed section loss calculations. Beam 2 and beam 9 beam end repairs have been included in the upcoming contract.

Location	Thickness	Location	Thickness	Location	Thickness	Location	Thickness
Bm A	.158"	RS: WEB =	.232" x 9" = 2.088 in ²				
B	.148"	STIFFENERS =	.292" x 10.75" = 3.139 in ²				
C	.317"	RS TOTAL	= 5.227 in ²				
D	.304"						43.8%
WEB AVR =	.232" ✓	% Loss =	FS - RS x 100 = 45.3, ≈ 45.0%				
FIELD th WEB =							
E =	.360"						
F =	.310"						
G =	.272"						
H =	.226"						
STIFF. AVR =	.292" ✓						
FIELD th STIFF =

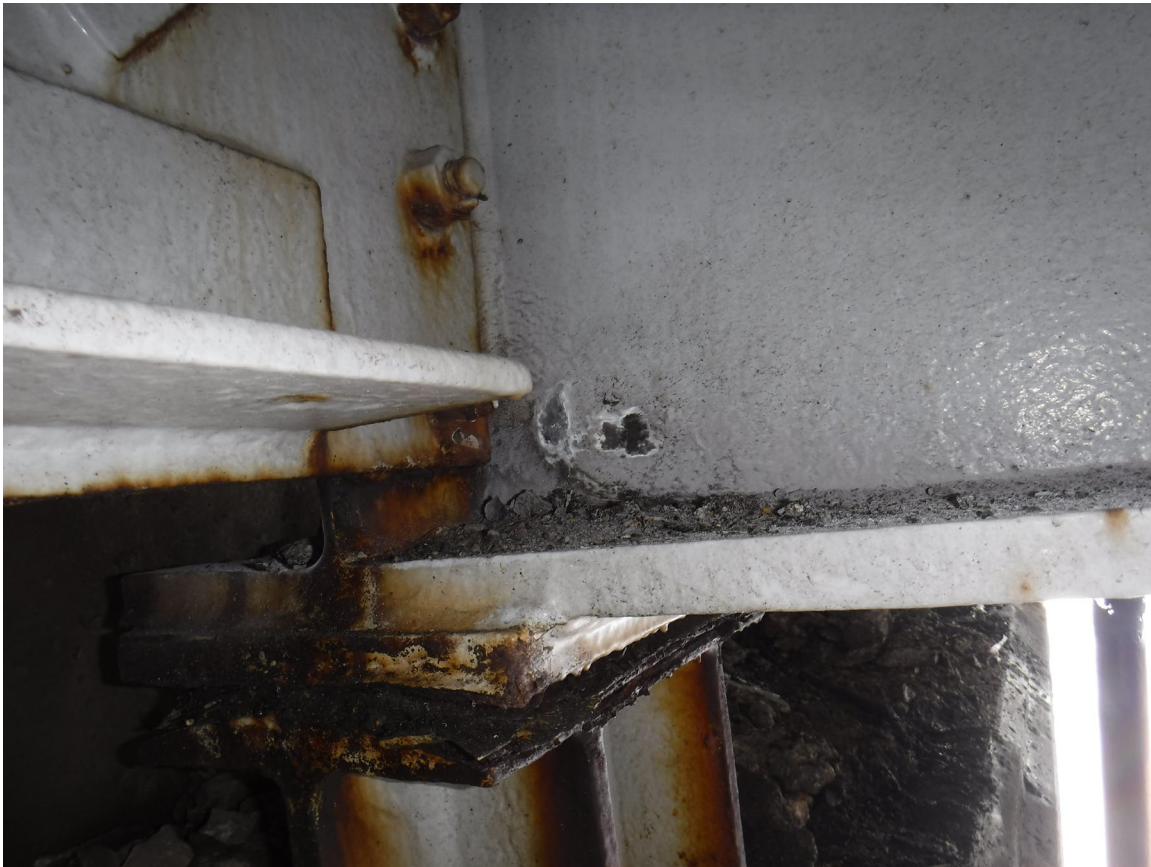
P8; Beam 8; Span 8 Side - Picture 1: West face looking NE

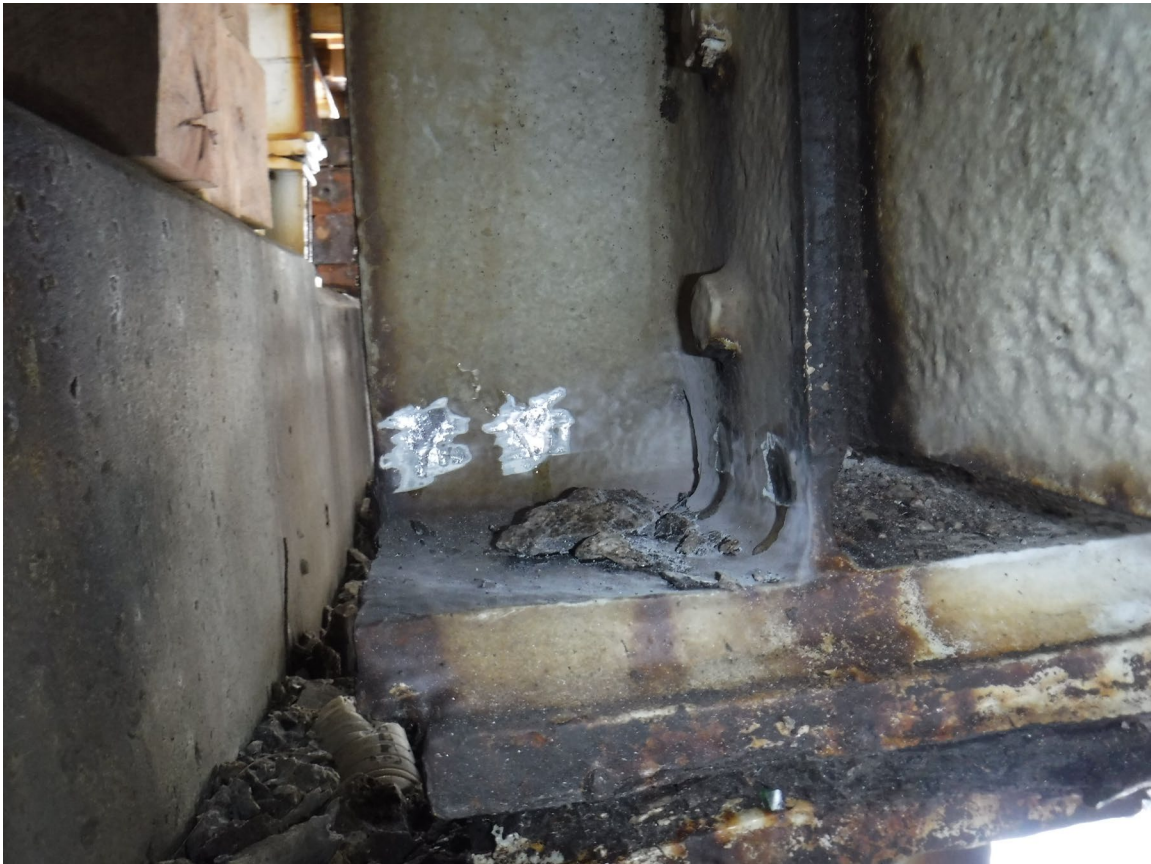
P8; Beam 8; Span 8 side - Picture 2: West face Looking SE

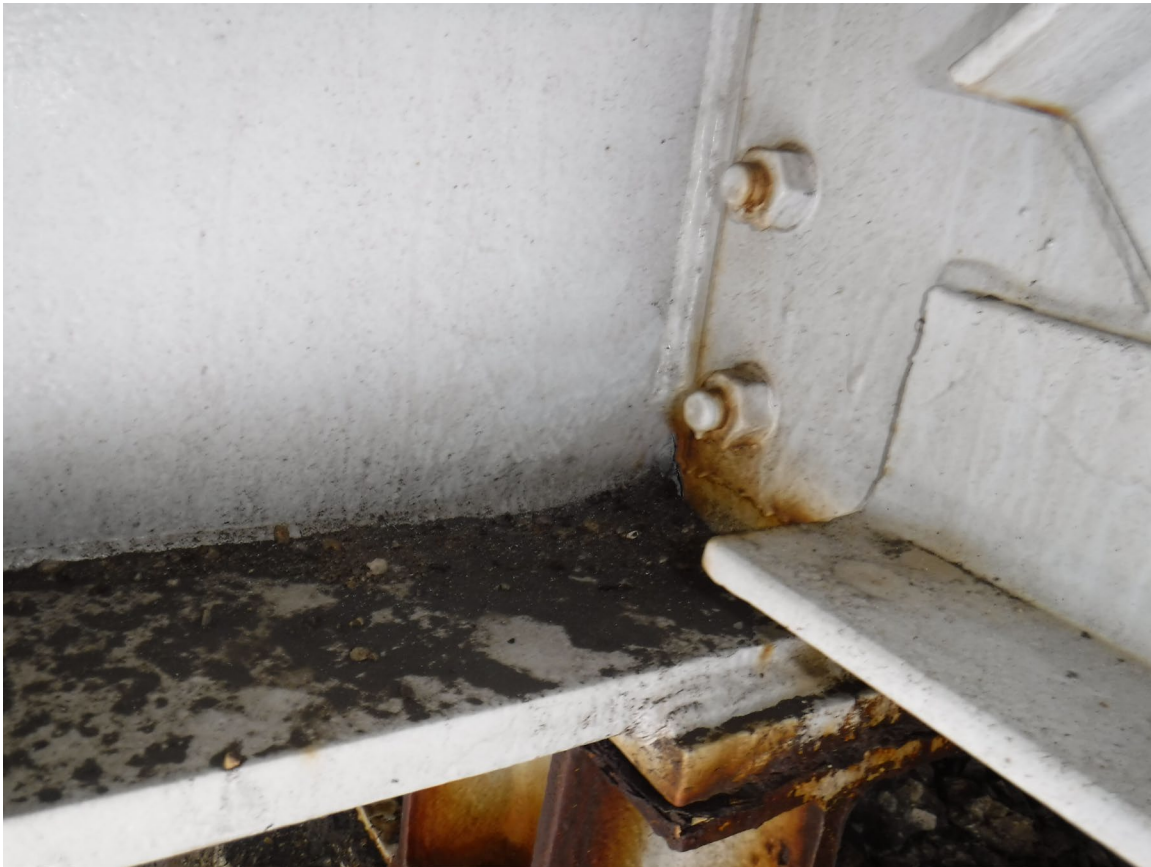
P8; Beam 8; Span 8 side - Picture 3: East face looking NW

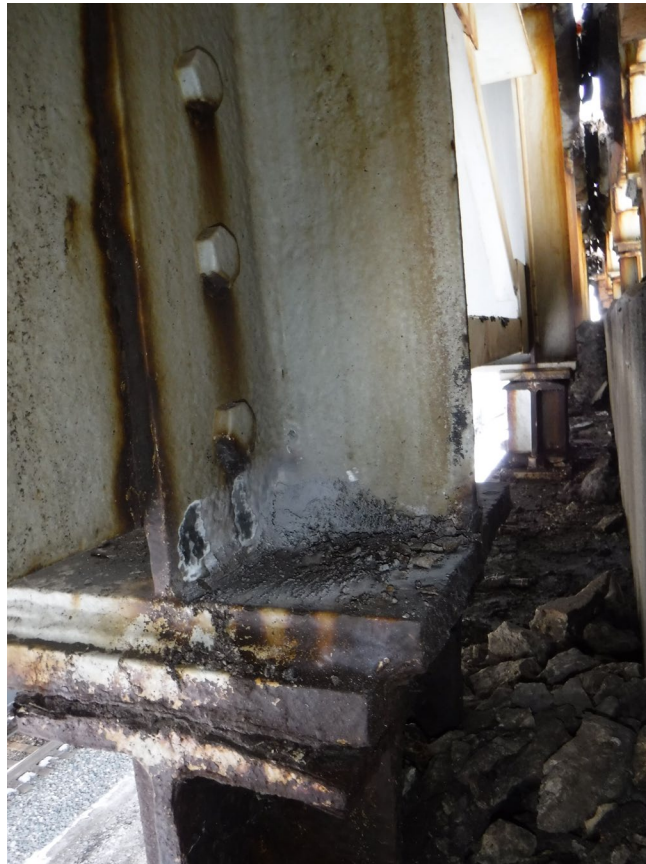
P8; Beam 8; Span 8 side - Picture 4: East face looking SW

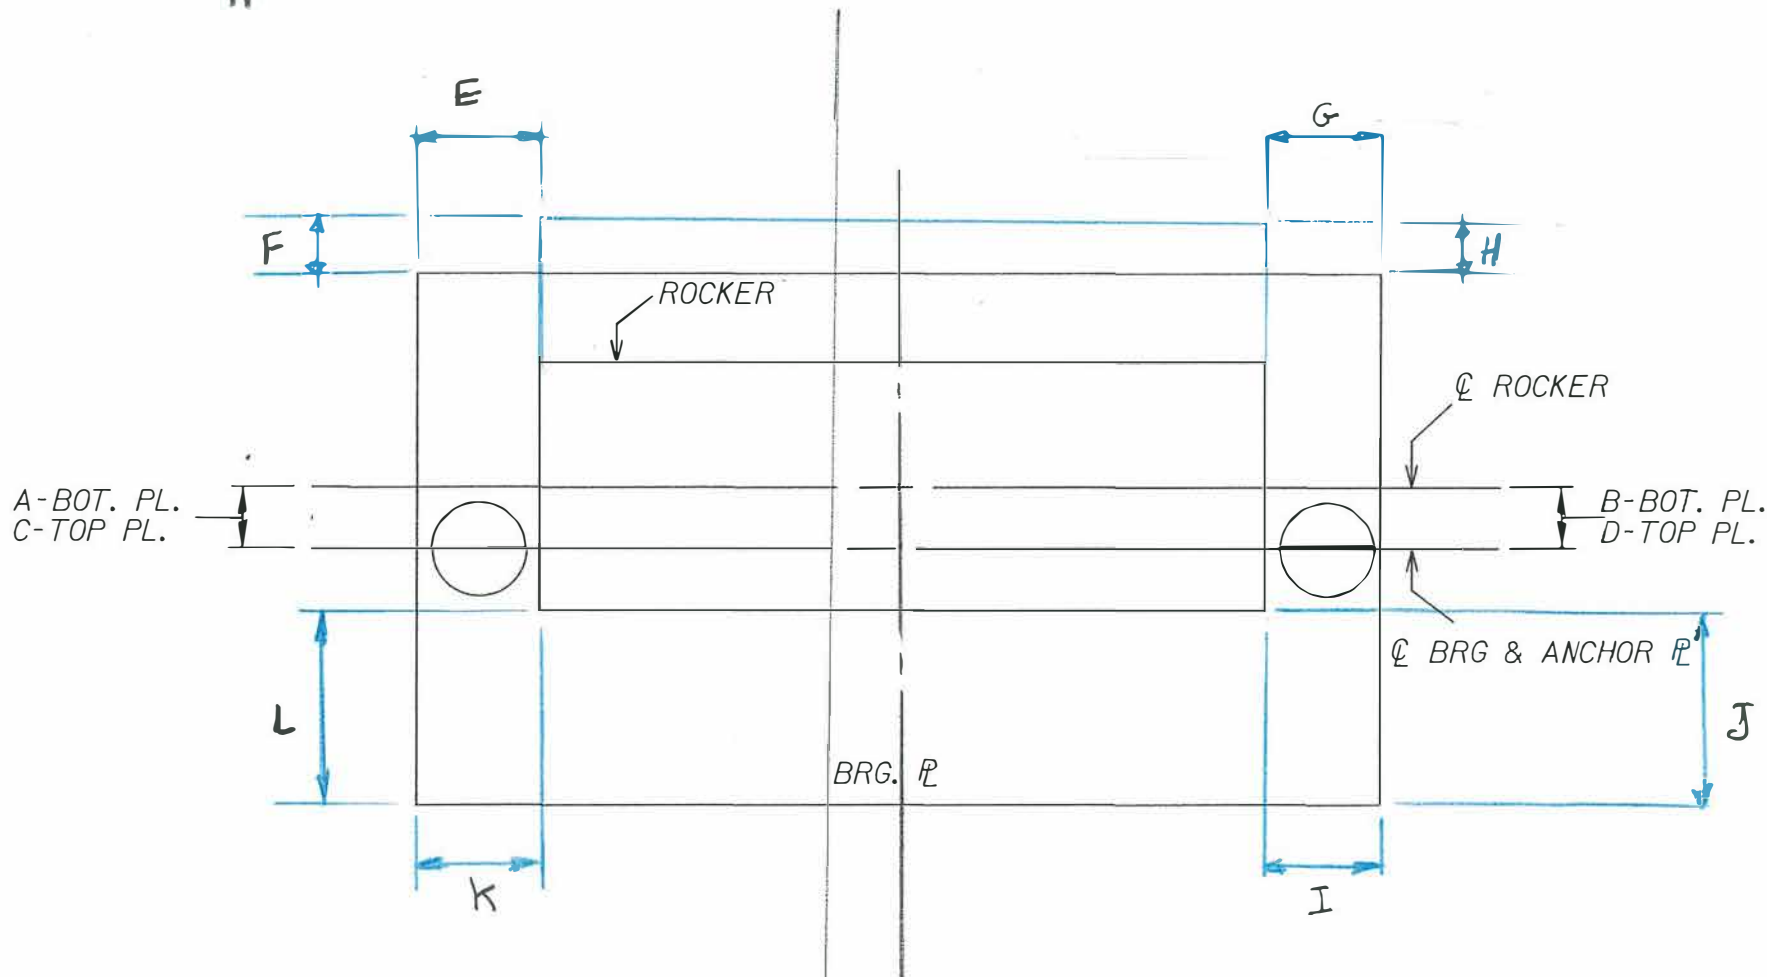
Bearing movement
measurement legend

Bearings at Pier 8, Span 9: Rocker bearings are moving independent of the top and bottom bearing plates. included please see movement measurements for beams 1 through 5. Cribbing has been installed near the bearings between the concrete cap and diaphragms near beams 1, 2, 3, 8 and 10 at Pier 8, span 9 side. a special feature at 3 months interval has been started to verify that cribbing is staying in place.

SPAN	PIER	BRG #	BOTTOM PLATE										TOP PLATE	
			A	B	E	F	G	H	I	J	K	L	C	D
9	8	1	2.25"	1 1/2"	4"	1.75"	3 7/16"	1"	4"	2"	3.625"	2.75"	1"	-
9	8	2	1 13/16"	1"	4"	1 5/16"	3.5"	0.625"	1.125"	1.5"	3.625"	2 3/16"	0.75"	0.5"
9	8	3	1.75"	0.875"	4.125"	1.25"	3.375"	0.375"	4"	1.5"	3.5"	2.875"	1.375"	1.125"
9	8	4	0.75"	0.125"	4"	0.625"	3.5"	0.25"	3 13/16"	1.25"	3.75"	1.5"	0.375"	0.5"
9	8	5	0.75"	0.75"	3.5"	0.375"	4"	0.625"	3.75"	1.5"	3.875"	1.375"	0.5"	0.625"

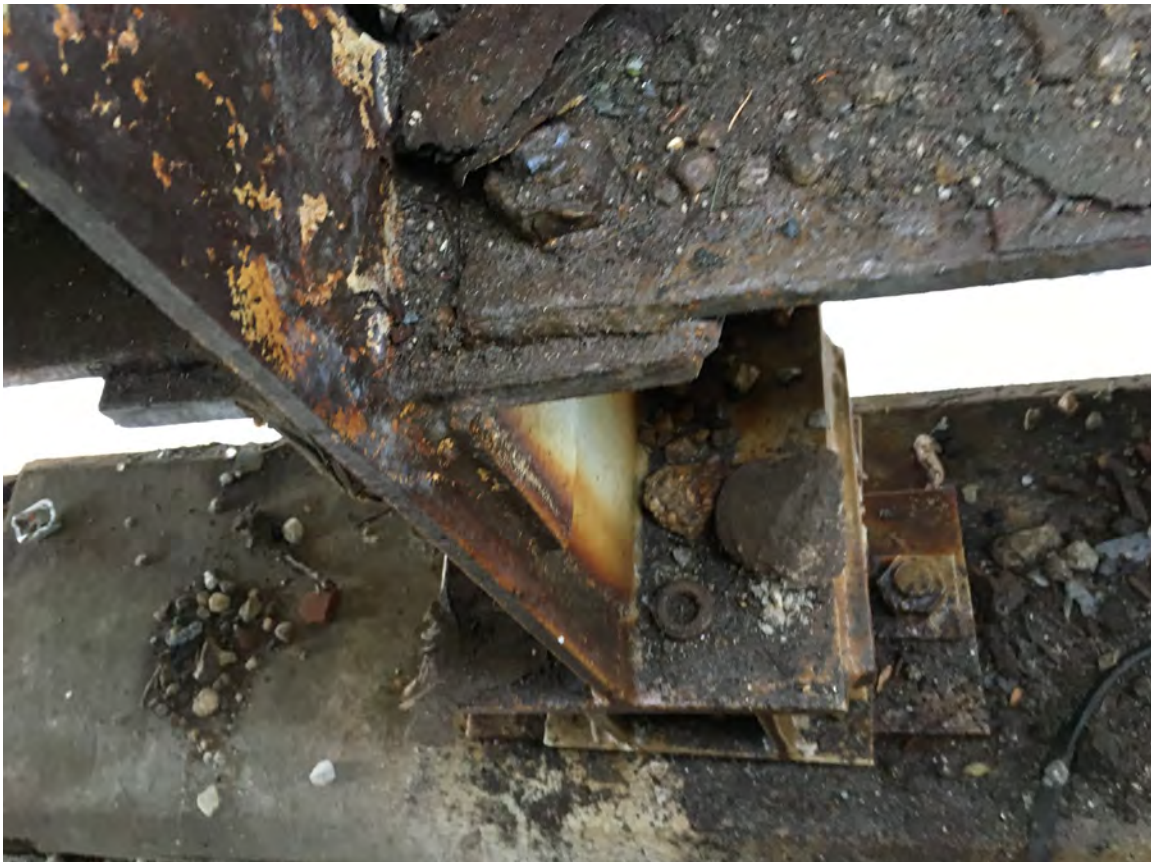
Picture 2: P8; Span 9; Beam 2 end

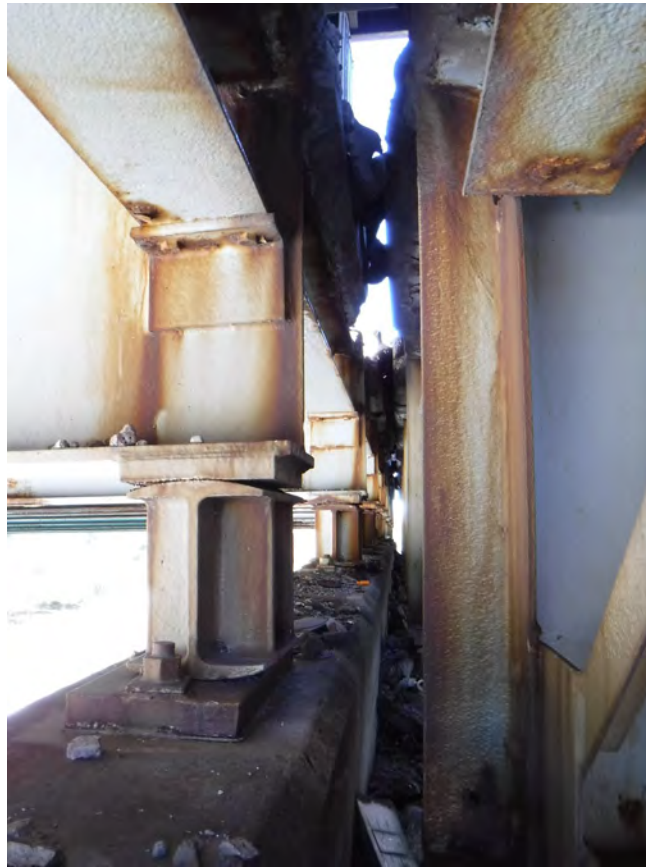
Picture 3: P8; Span 9; Beam 2 end west face.

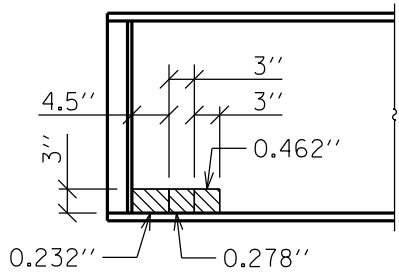
BEAM 9 NORTH END
 SPAN 8 AT PIER 8
 PHOTO 19
 (LOOKING EAST)

18% Loss
 Note added 10-11-19 by MV

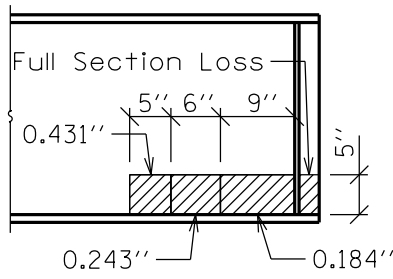
BEAM 2 NORTH END
 SPAN 8 AT PIER 8
 PHOTOS 7-9
 (LOOKING WEST)

Additional Comments: 2015 LRI did show measured steel thickness, but percentages were not noted. Section loss percentages were requested, please see included email with percentages noted along with 2015 LRI. Due to section loss of 53% at beam 2, Pier 8, Span 8, superstructure rating was lowered to a 2.

53% Loss
 Note added 10-11-19 by MV
