**LIN ENGINEERING, LTD.**  
200 W. Chestnut  
Channah, Illinois 62629  
(618) 483-4668  
Fax: (618) 483-4706  
Designed By: STG  
Checked By: WTH  
Date: 01/05  
Drawn By: JMD  
File: 0470046.DWG

ILLINOIS DEPARTMENT OF TRANSPORTATION  
**DECK REPAIR-2**  
**F.A.P. 326 (IL RTE. 47)**  
**OVER FOX RIVER**  
**SECTION (108,109)RS-4**  
**KENDALL COUNTY**  
**S.N. 047-0048**

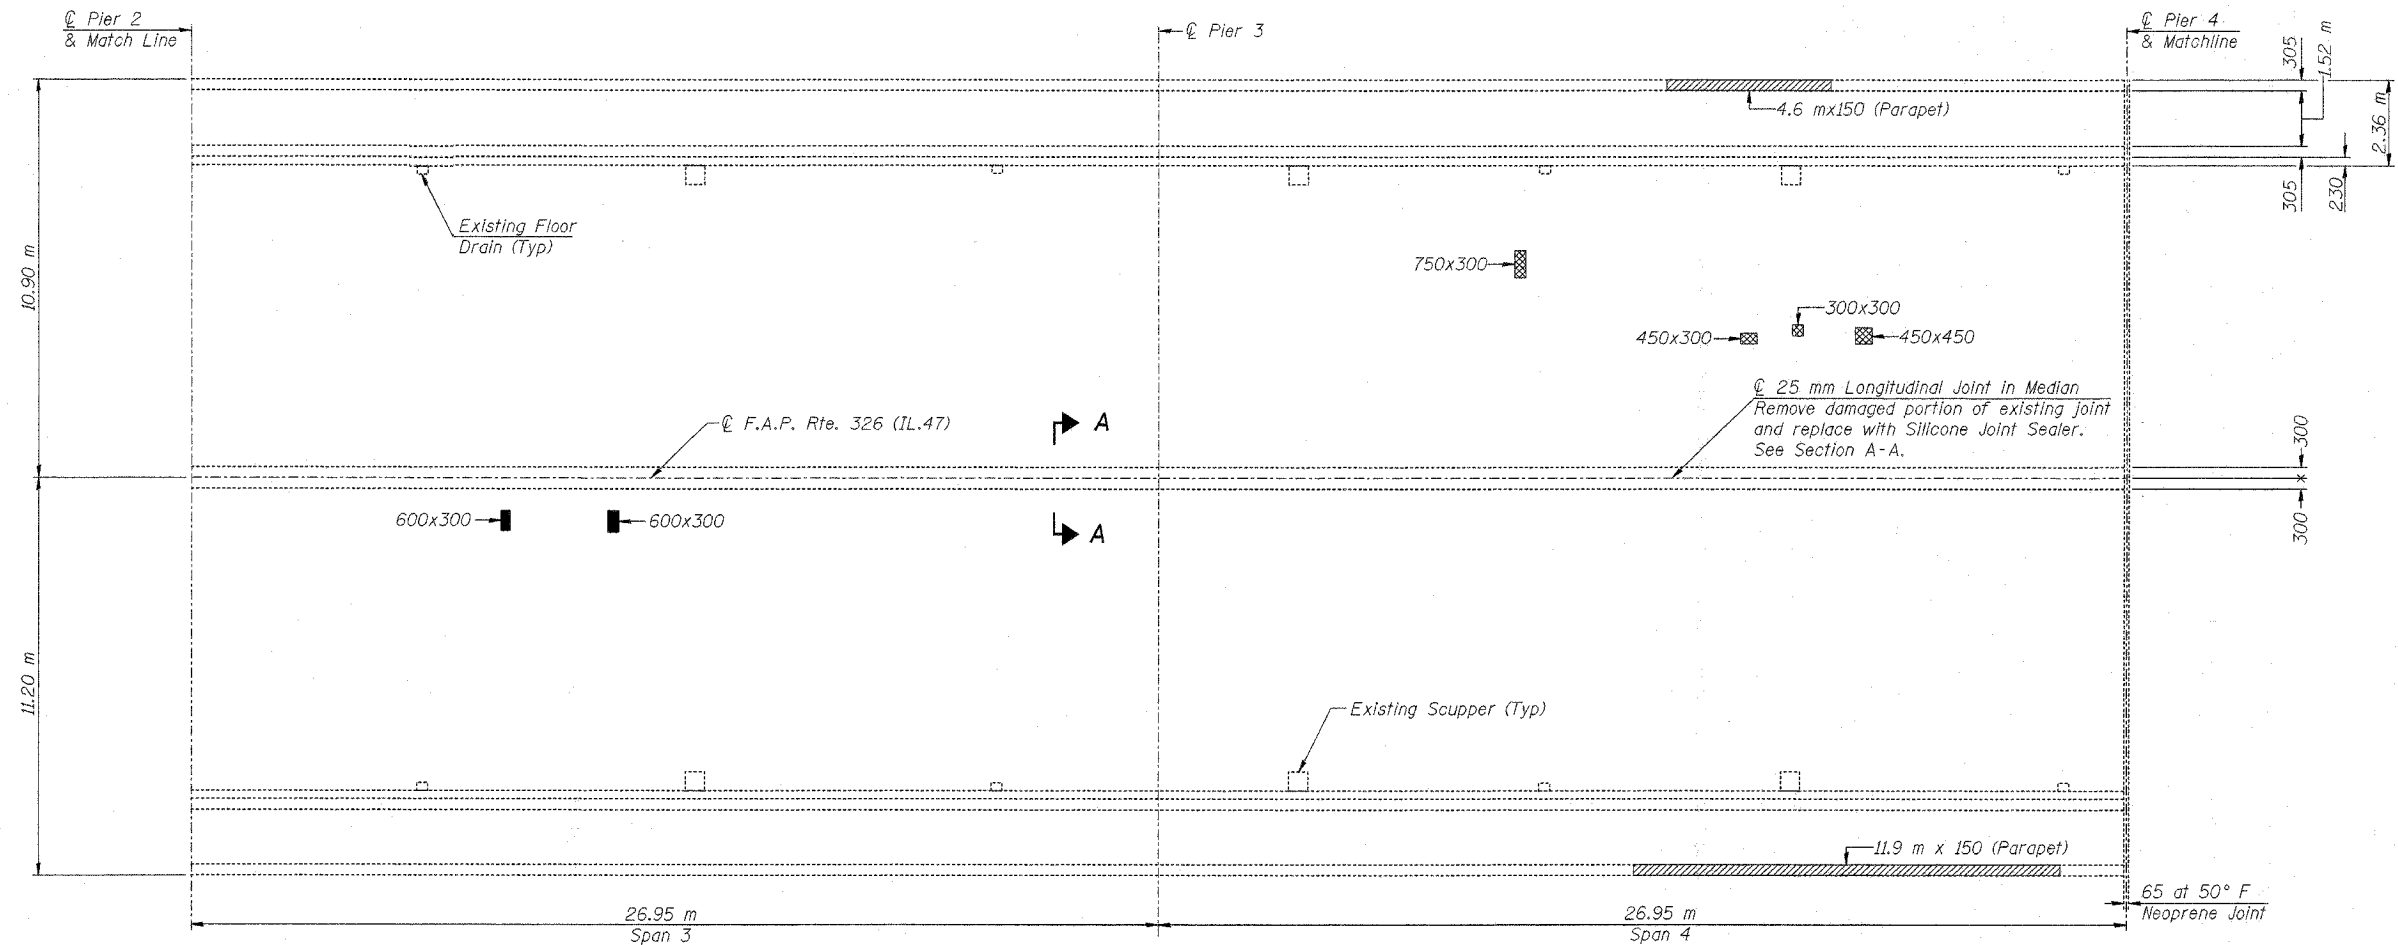
**PARTIAL PLAN**

Deck Survey Date: 11/22/04

Notes: For details of Deck Slab Repair see Special Provision for "Deck Slab Repair."  
See Sheet #6 of 8 for Cross Section.  
The quantities shown for estimating purposes only. Area to be repaired will be determined by the Engineer at the time of Construction. Actual repair locations shall be shown on the same as-built plans.
