Subject: **FINAL Asbestos Assessment and Report
PTB No. 191-013, WOOD 2
Work Order 002
Supplemental Authorization No. 11
14-16 South Main Street and 2 East Water Street, Pinckneyville, Illinois
Wood Project No. 3160190038.02**

FINAL ASBESTOS SURVEY REPORT

Route: FAP 42/841 (IL 13/127 & IL 154)

Project No. 3160190038.02

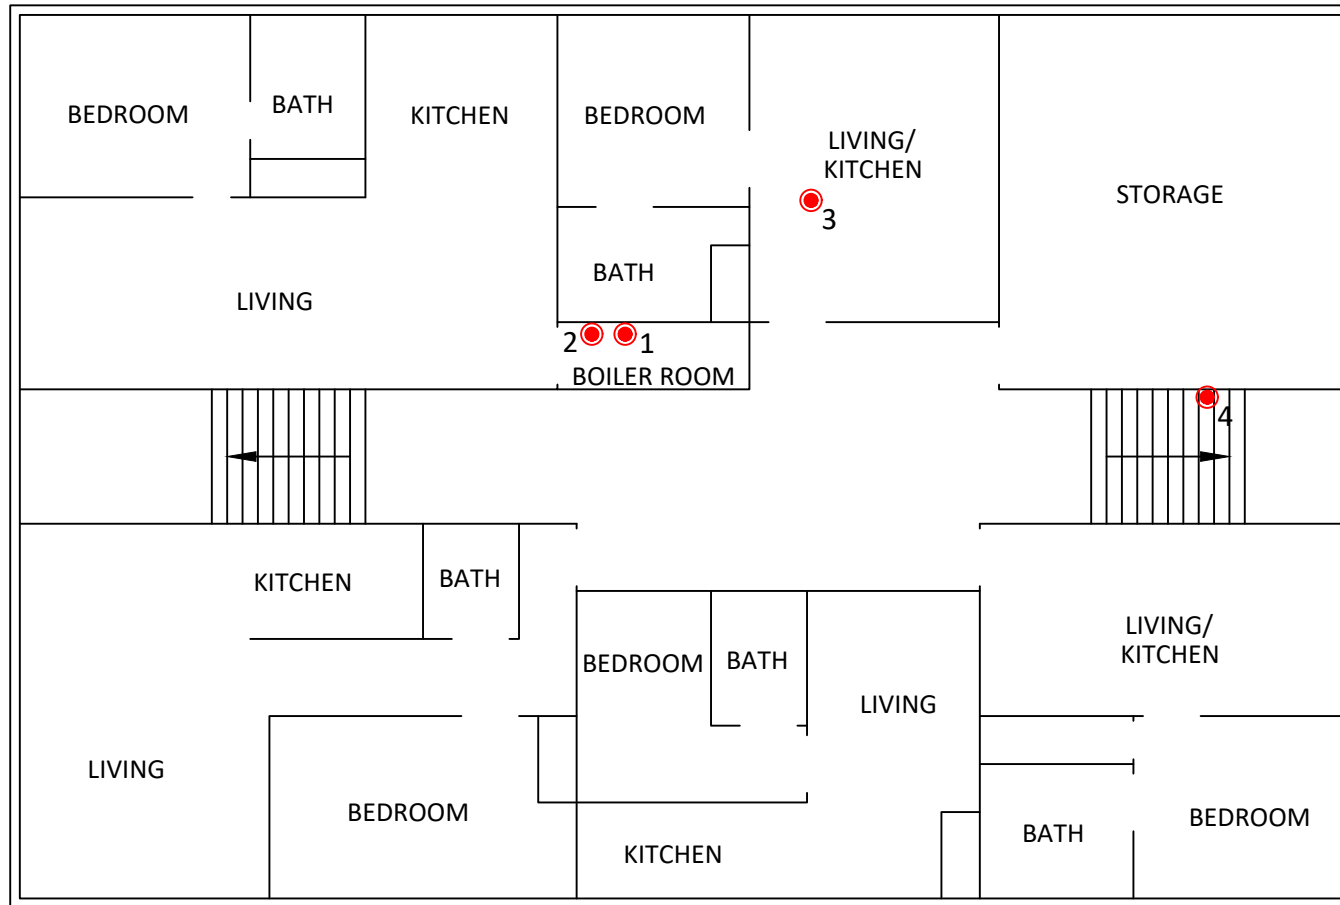
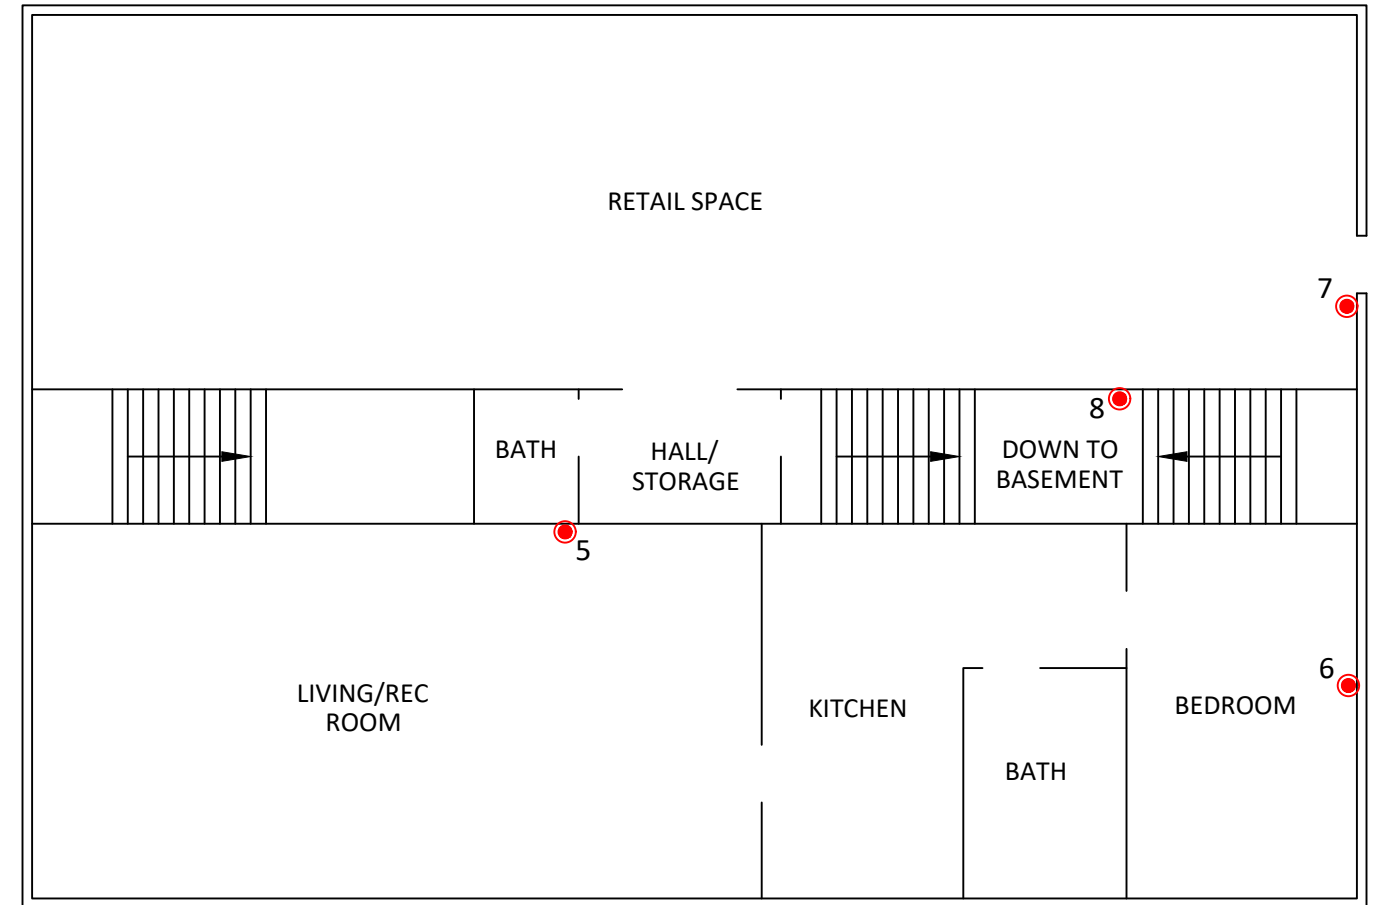
**FIGURE 1
SAMPLE LOCATIONS MAP**

14-16 S. Main St.
District 9
Pinckneyville, Illinois

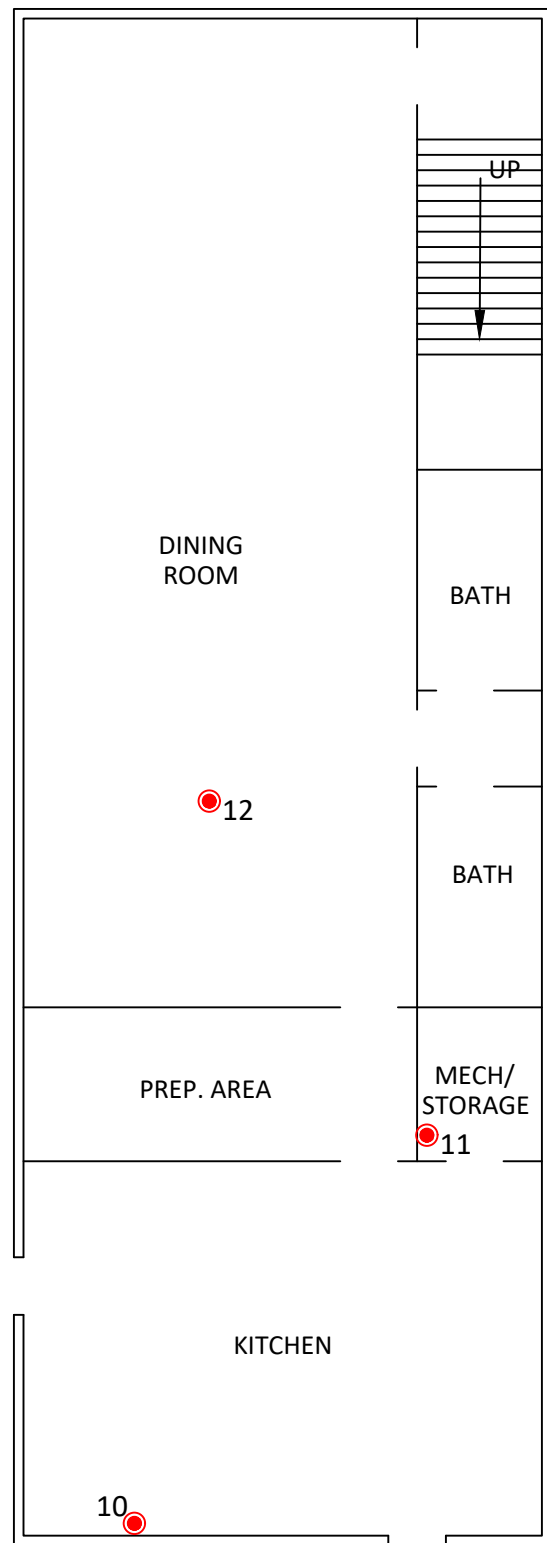
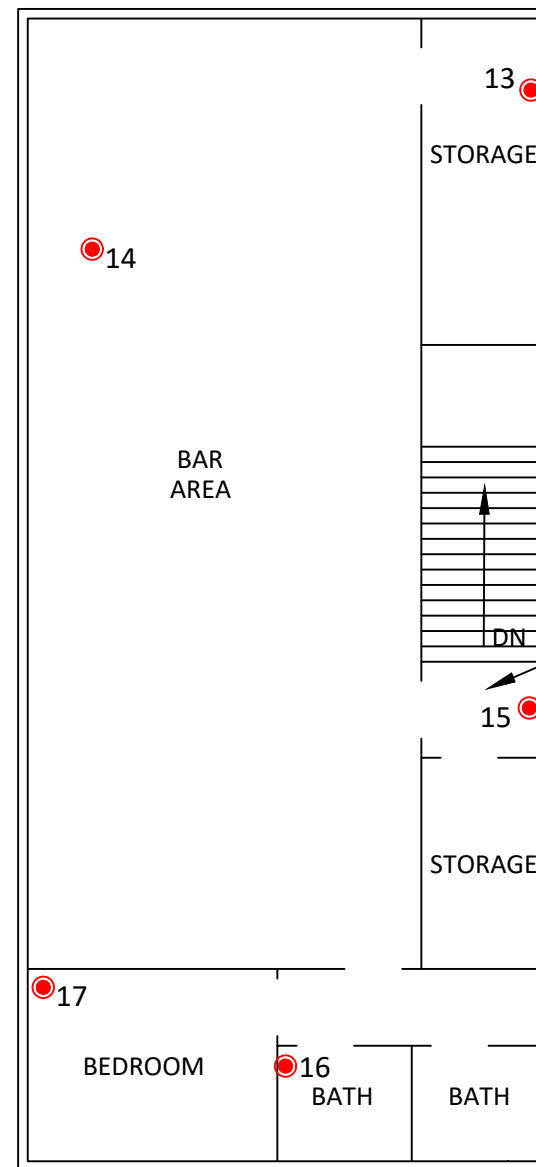
FIGURE 2
SAMPLE LOCATIONS MAP

2 East Water St.
 District 9
 Pinckneyville, Illinois

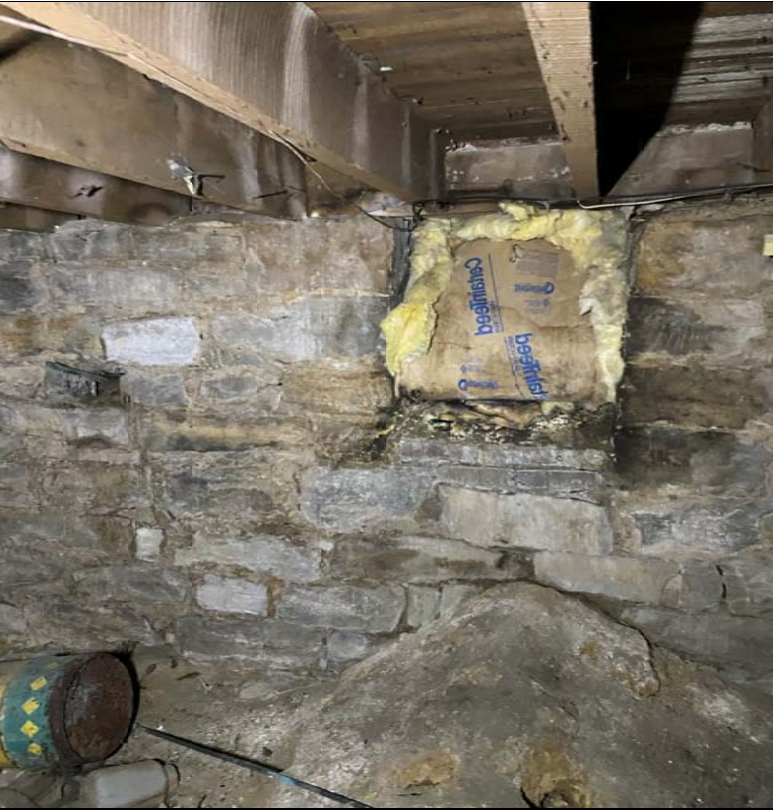
Photograph #1	Remarks

14-16 S Main Street Basement

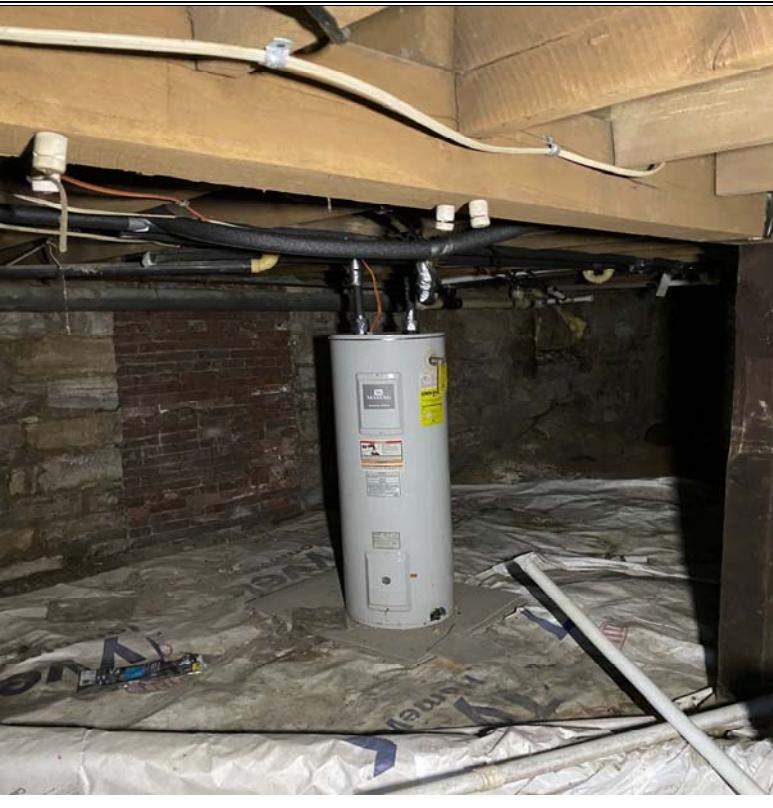
Photograph #2	Remarks

14-16 S Main Street Basement Water heater

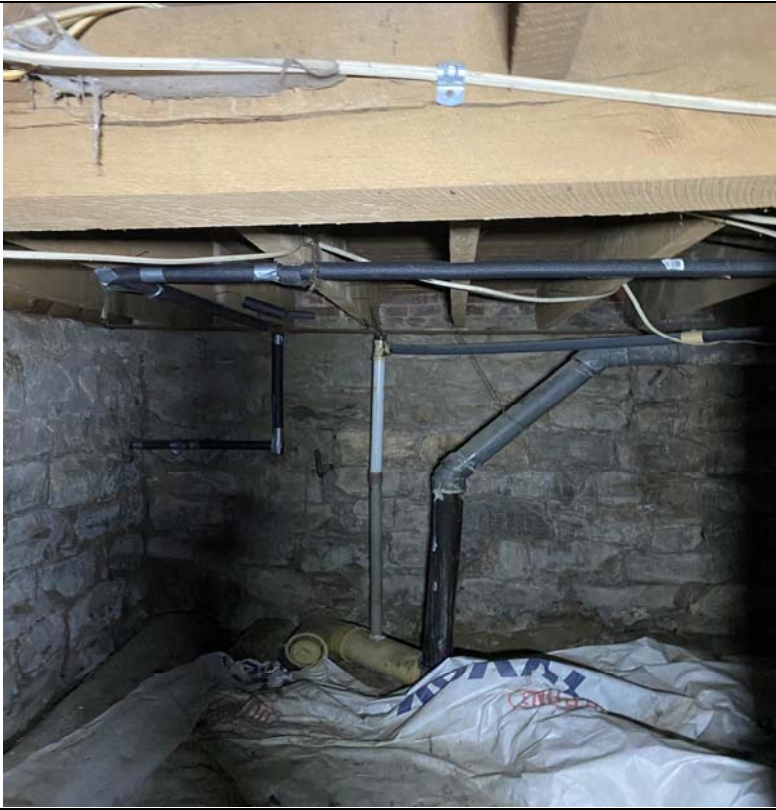
Photograph #3	Remarks

14-16 S Main Street Basement piping

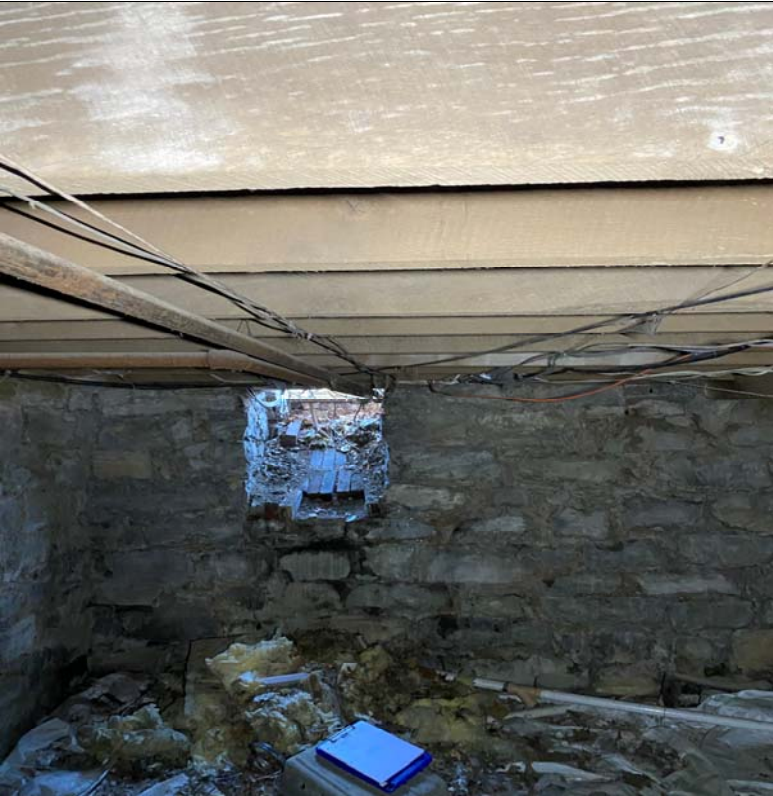
Photograph #6	Remarks

14-16 S Main Street Basement back wall

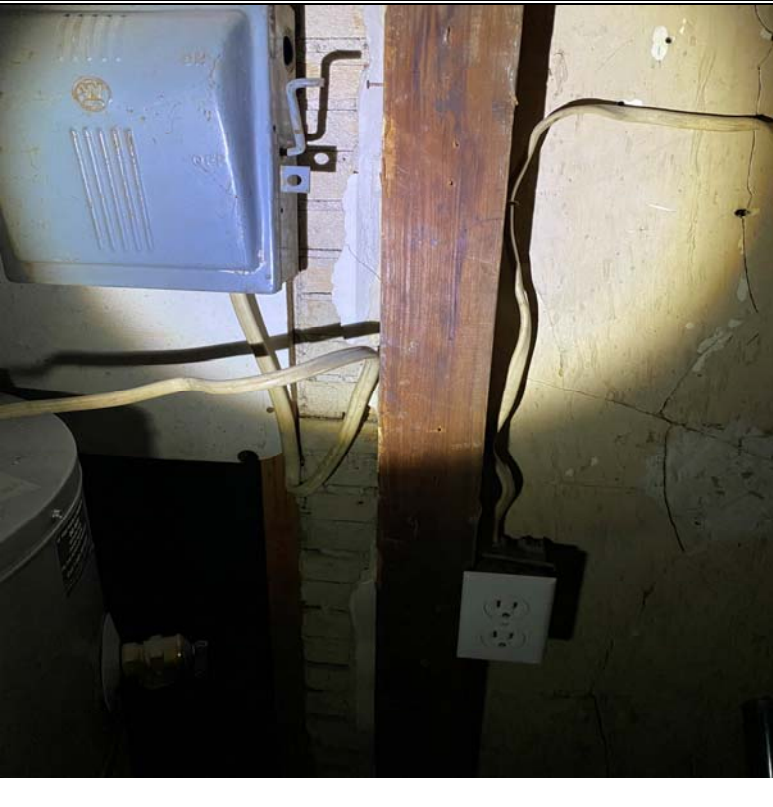
Photograph #8	Remarks

14-16 S. Main Street Second Floor Utility/boiler room

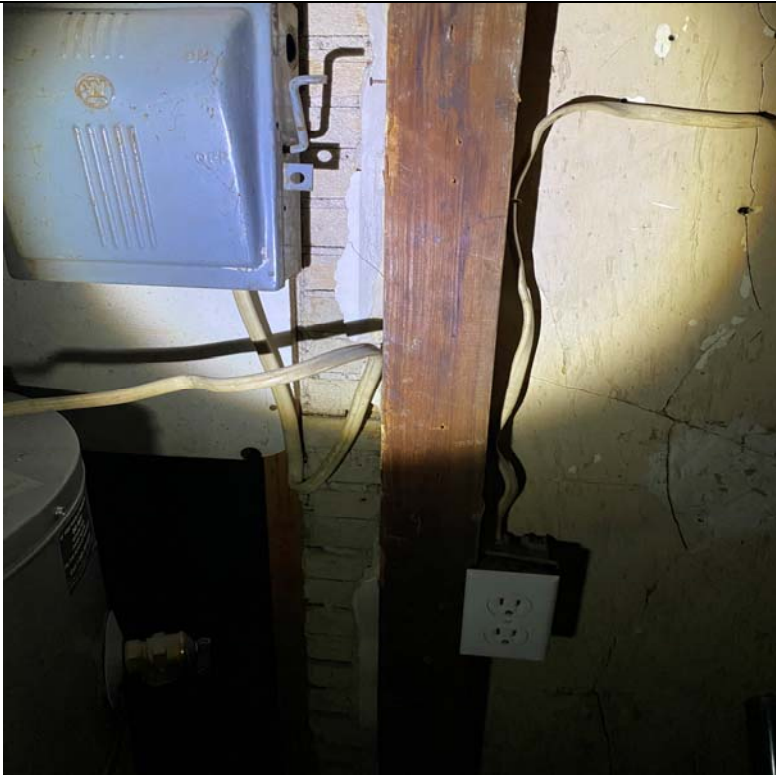
Photograph #9	Remarks

14-16 S. Main Street Second Floor Utility/boiler room

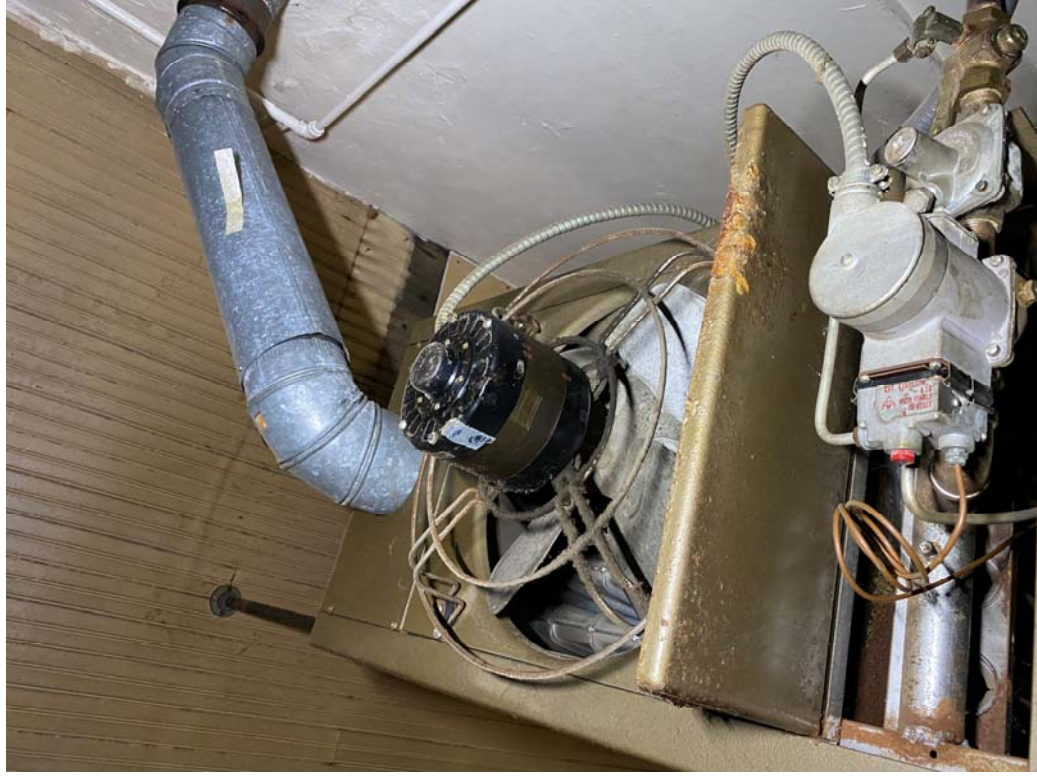
Photograph #13	Remarks

14-16 S. Main Street Room 14 Art Room Backside of Wall Furnace

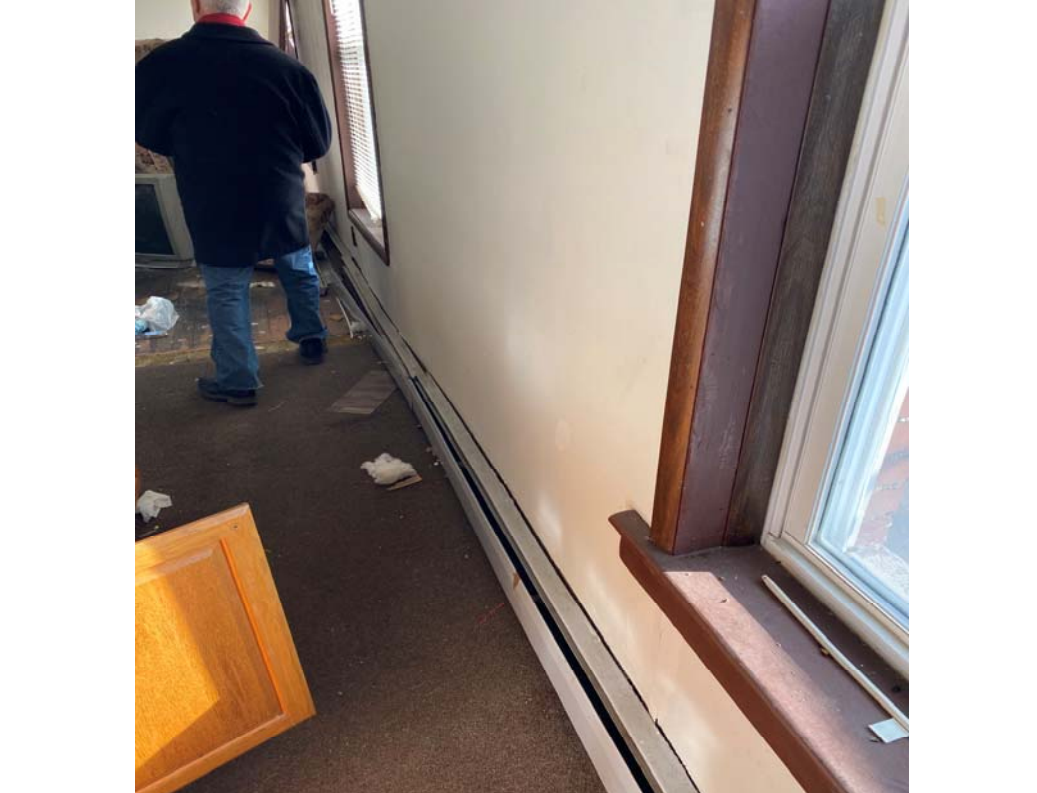
Photograph #14	Remarks

2 East Water Street Second Floor Bar Area

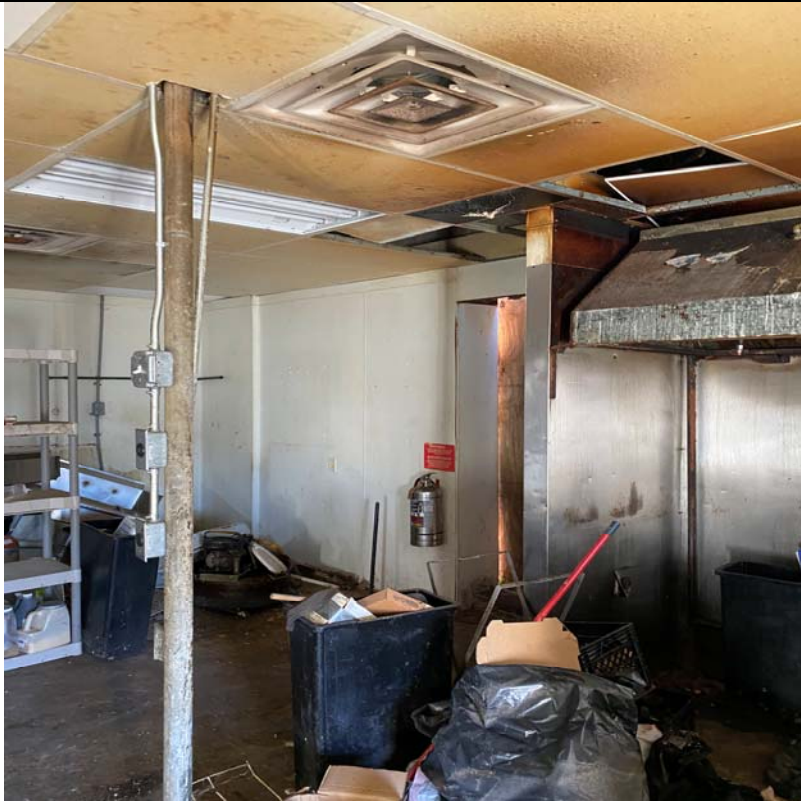
Photograph #15	Remarks

2 East Water Street Fryer Vent

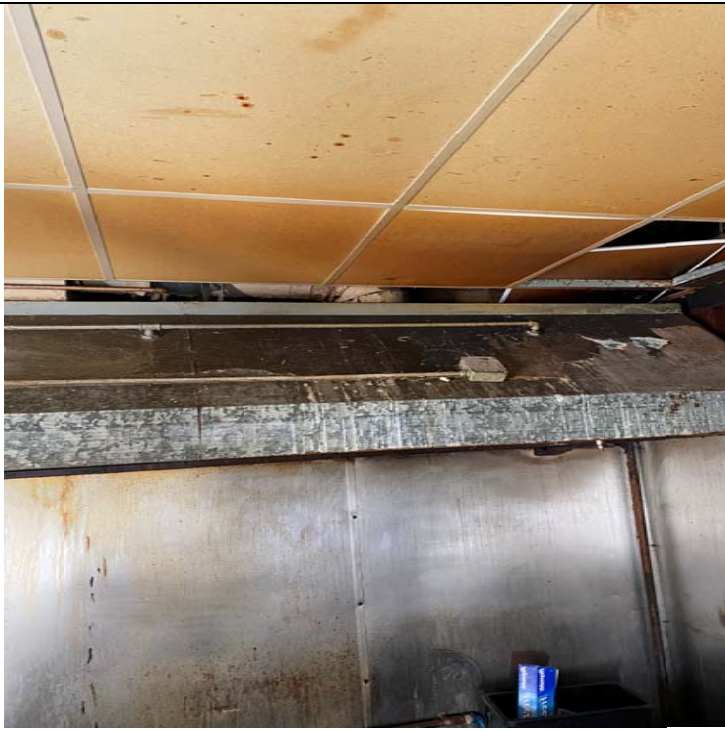
Photograph #16	Remarks

2 East Water Street Fryer Vent

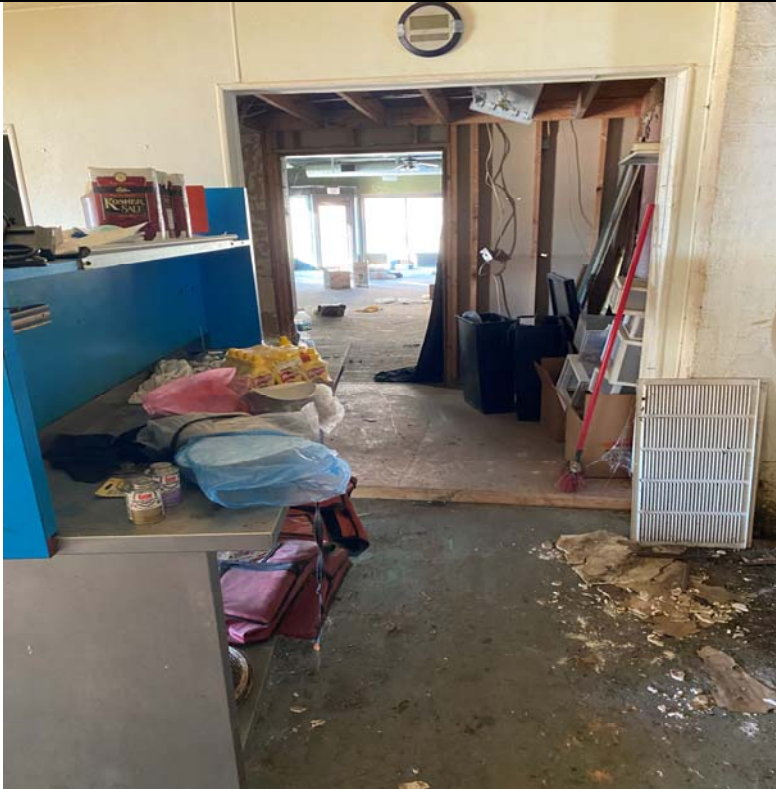
Photograph #19	Remarks

2 East Water Street Kitchen 1st Floor

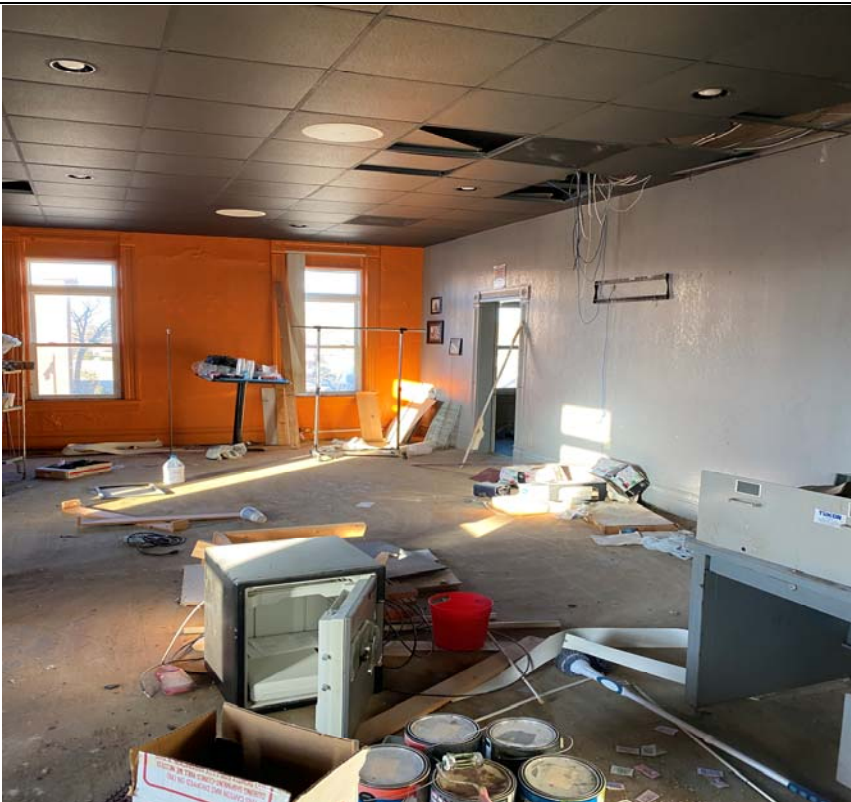
Photograph #22	Remarks

Based on their analysis, EMSL reported one result for 9 x 9" green floor tile in the second floor bar area of 2 East Water Street at 3% chrysotile asbestos. Three other samples (for wall plaster, ceiling tile and wall mortar) from 14 -16 S. Main were reported for contain less than 1% chrysotile. Since the quantity of asbestos in these samples was an unknown (they could contain more than 1% asbestos and be considered regulated ACBM), Wood requested point counting for these samples. Point counting is an allowed method under NESHAP that, when used, supersedes the initial PLM results. Each sample that is taken and analyzed by visual PLM as greater than one percent asbestos is ACBM, unless that sample is rebutted through additional analysis (i.e. point counting).

2 East Water Street Floor tile in bar area 9 x 9" green tile

As the floor tile identified as asbestos containing is a Category I non-friable material which is not likely to become friable during demolition, it does not need to be removed prior to demolition.

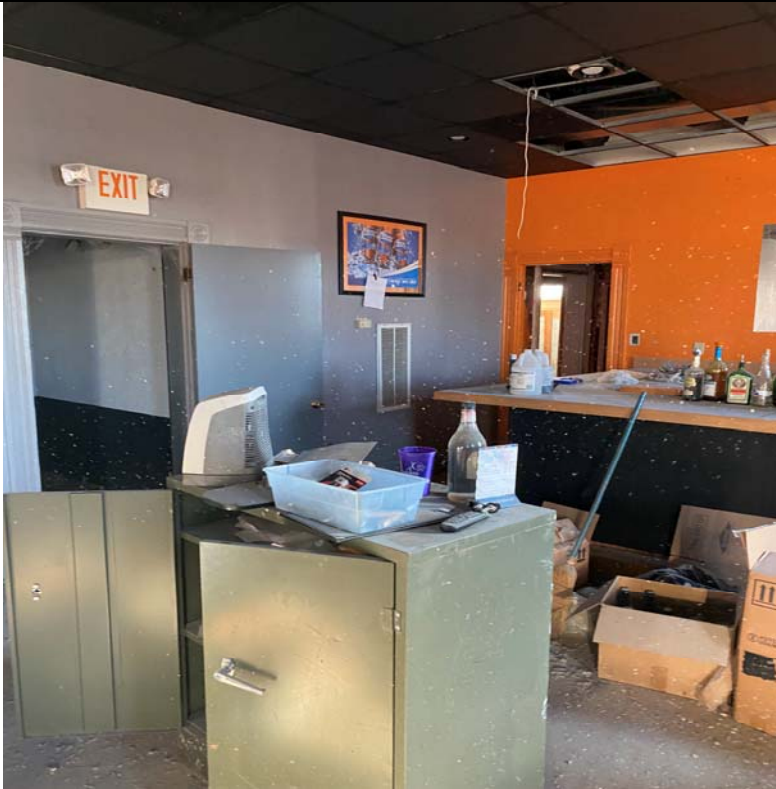
Photograph #23	Remarks

2 East Water Street 2 nd Floor Bar Area

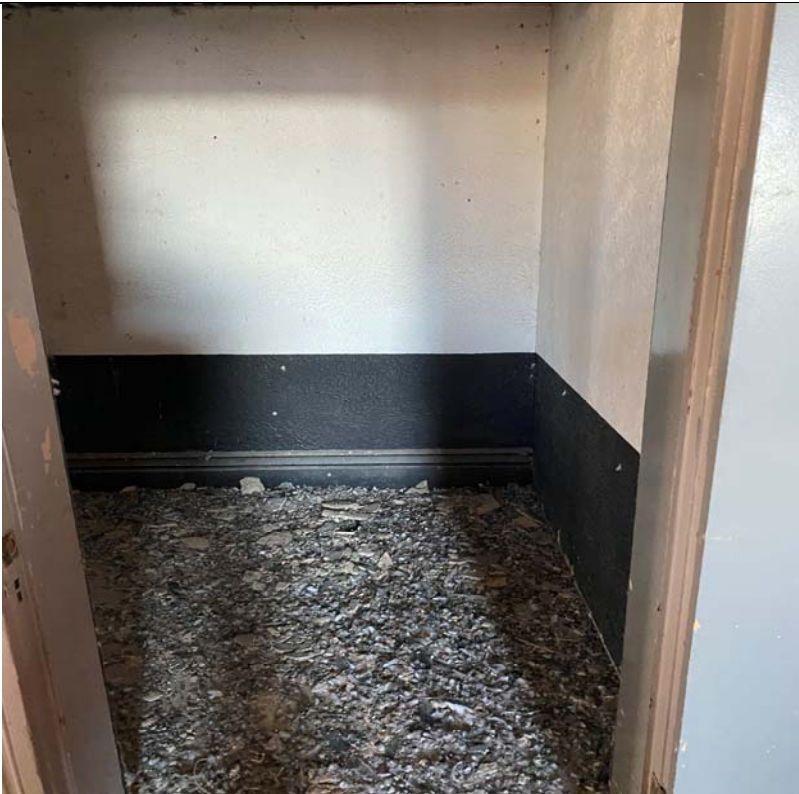
Photograph #24	Remarks

***Important note: In the 2 East Main Street building, a hallway leading to a stairway to the second floor contains large amounts of pigeon excrement. Animal droppings create an environment favorable to the development of microbiological organisms potentially harmful to humans. Animal droppings should be removed by personnel trained in personnel protection procedures.

2 East Water Street Pigeon excrement (biological hazard) in hallway under exit sign (previous picture)

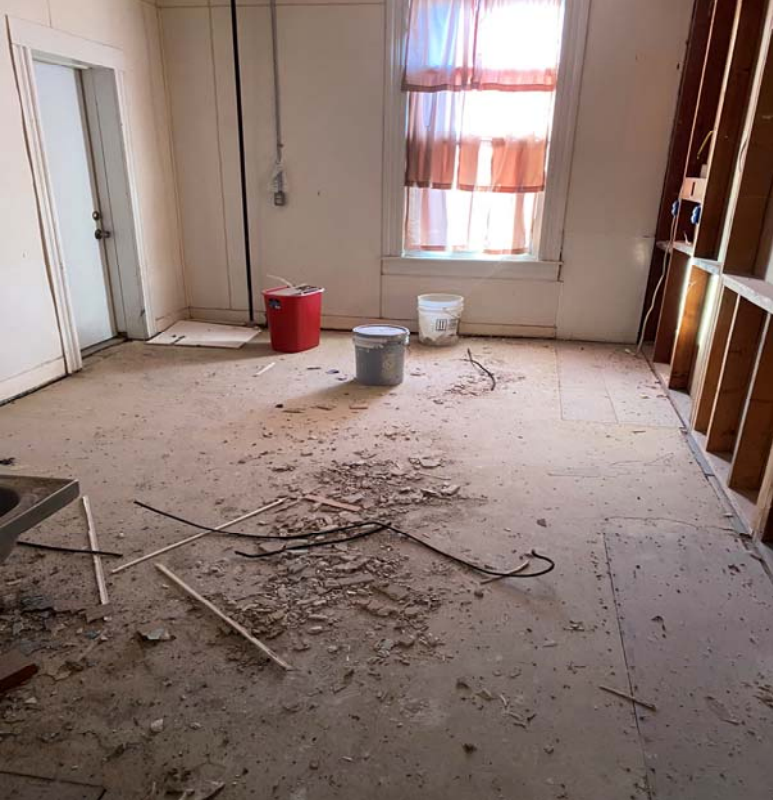
Photograph #25	Remarks

A photograph of a room under renovation. The floor is covered in debris, including wood shavings and small pieces of wood. A red bucket, a grey bucket, and a white bucket are on the floor. A window with orange and white curtains is on the right wall. A white door is on the left wall. The walls are light-colored.	2 East Water Street 2nd Floor Bedroom

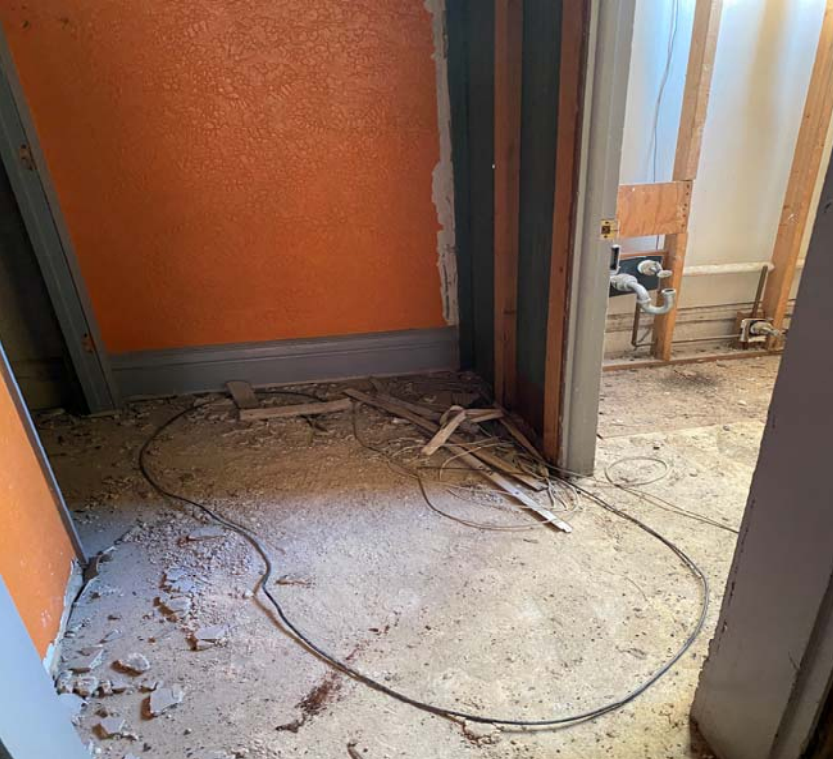
Photograph #26	Remarks

A photograph of a hallway under renovation. The floor is covered in debris, including wood shavings and small pieces of wood. A doorway is on the right, leading to another room. The walls are orange and white. A black pipe is on the floor.	2 East Water Street Hallway on 2nd Floor
