STATE OF ILLINOIS
DEPARTMENT OF TRANSPORTATION

**SOUTH ABUTMENT
IL 34 OVER
MIDDLE FORK SALINE RIVER OVERFLOW
FAP ROUTE 869 - SECTION 105BR-1
SALINE COUNTY
STATION 1542+00.00
STRUCTURE NO. 083-0037**

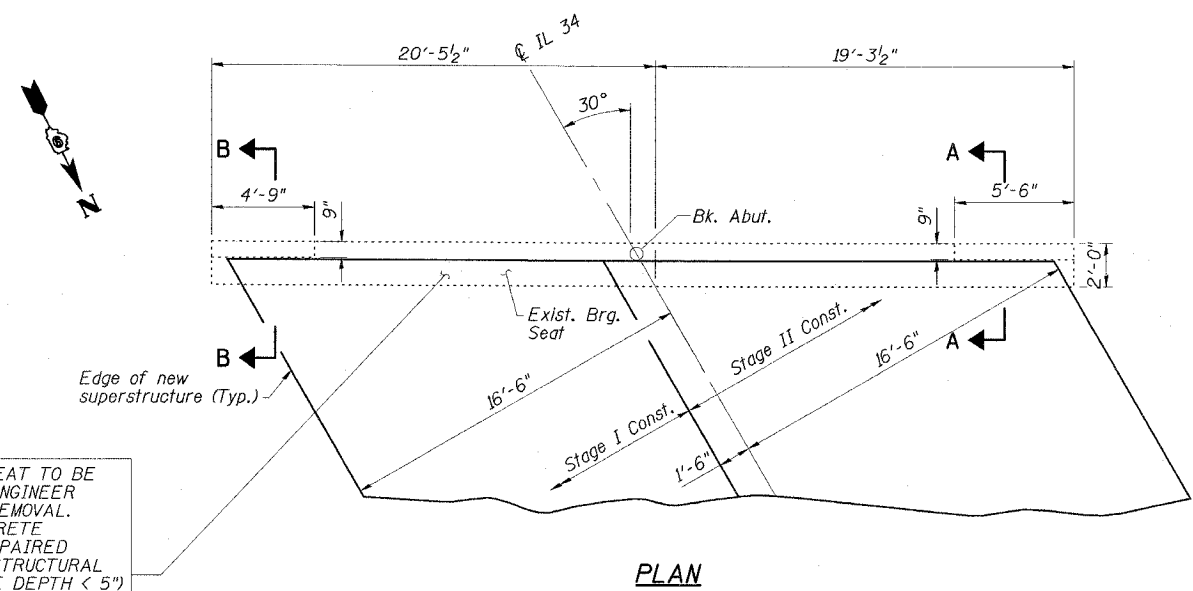
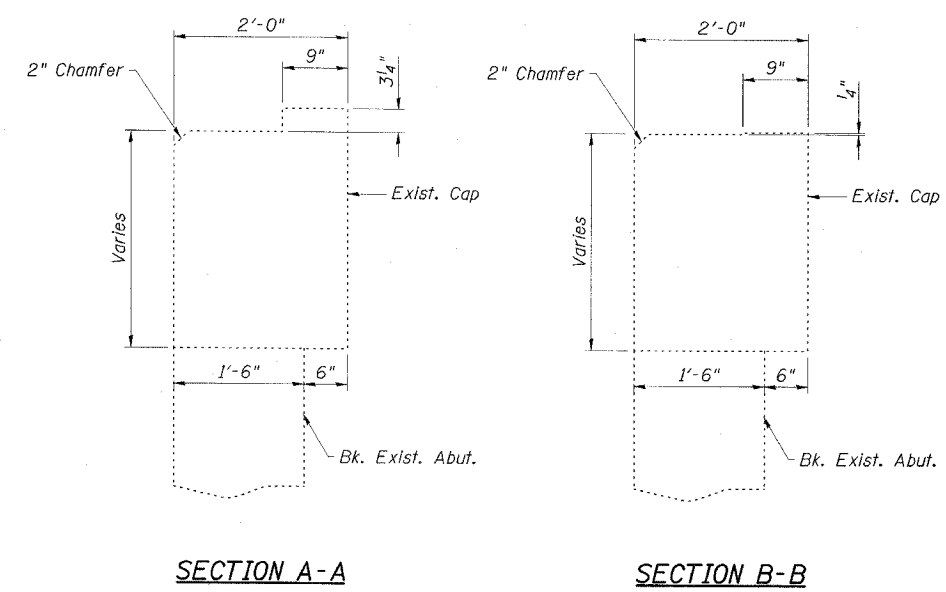
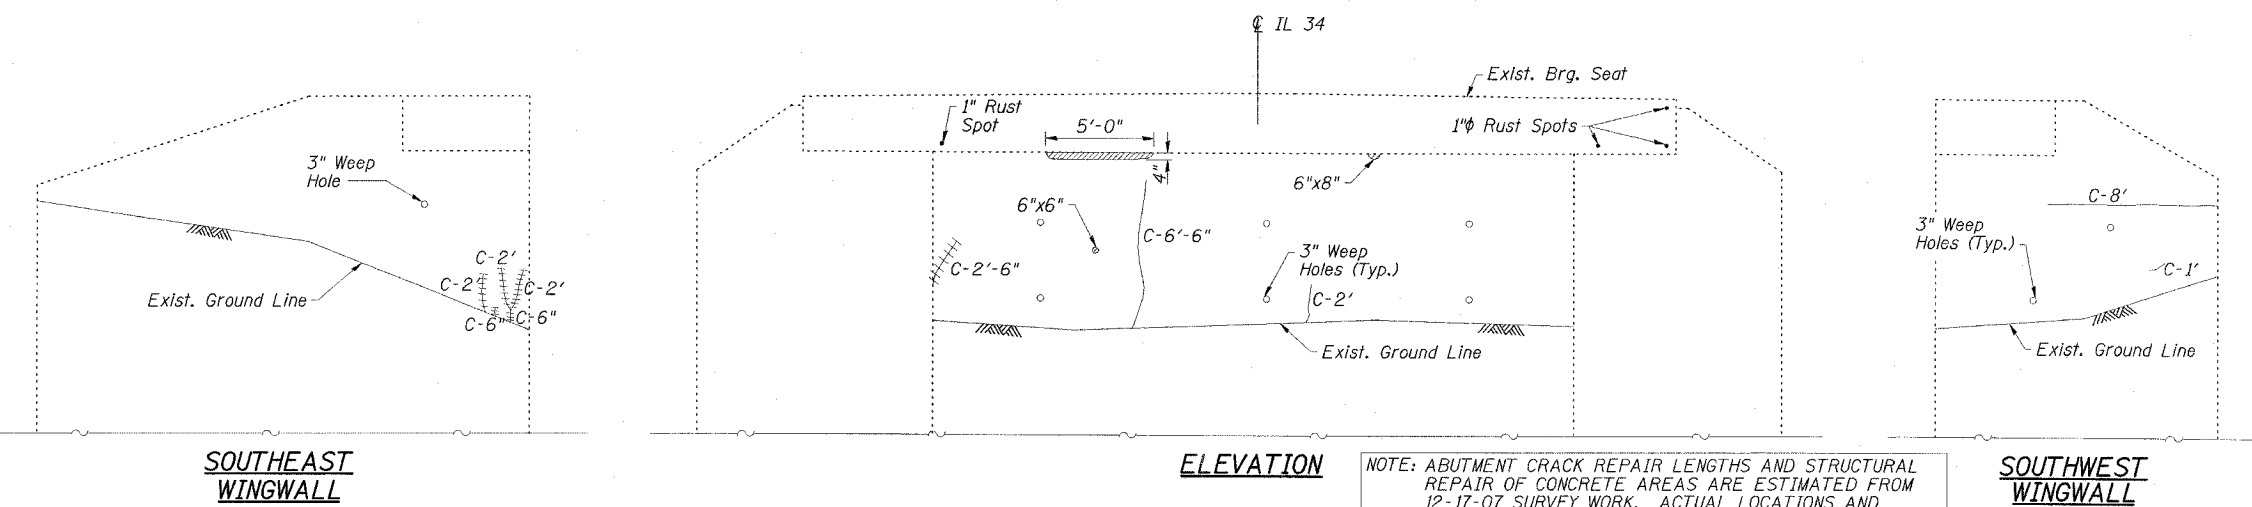
EXISTING BEARING SEAT TO BE INSPECTED BY THE ENGINEER AFTER DECK BEAM REMOVAL. DETERIORATED CONCRETE AREAS SHALL BE REPAIRED (ESTIMATED 15 S.F. STRUCTURAL REPAIR OF CONCRETE DEPTH < 5") AND CRACKS SHALL BE SEALED (ESTIMATED 20' EPOXY CRACK INJECTION) IF FOUND. CONCRETE SEALER SHALL BE APPLIED TO CONCRETE REPAIR AREAS.
