STATE OF ILLINOIS
DEPARTMENT OF TRANSPORTATION

Inspection Date: 12/10/07

NORTH ABUTMENT
IL 34 OVER
MIDDLE FORK SALINE RIVER
FAP ROUTE 869 - SECTION 105BR-2
SALINE COUNTY
STATION 1561+70.00
STRUCTURE NO. 083-0038

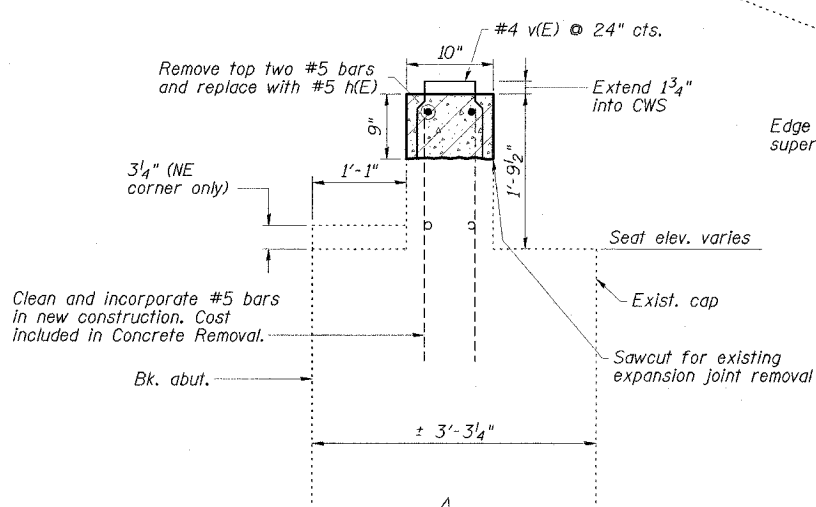
SECTION THRU ABUTMENT

EXISTING BEARING SEAT TO BE INSPECTED BY THE ENGINEER AFTER DECK BEAM REMOVAL. DETERIORATED CONCRETE AREAS SHALL BE REPAIRED (ESTIMATED 15 S.F. STRUCTURAL REPAIR OF CONCRETE DEPTH < 5") AND CRACKS SHALL BE SEALED (ESTIMATED 20' EPOXY CRACK INJECTION) IF FOUND. CONCRETE SEALER SHALL BE APPLIED TO CONCRETE REPAIR AREAS.
