ROUTE NO.	SECTION	COUNTY	JOB NO.	SHEET NO.	SHEET NO. 17 23 SHEETS
FAP 869	105BR-2	SALINE	118	66	
FED. ROAD DIST. NO. 1	ILLINOIS	FED. AID PROJECT - RD

SOUTH ABUTMENT
IL 34 OVER
MIDDLE FORK SALINE RIVER
FAP ROUTE 869 - SECTION 105BR-2
SALINE COUNTY
STATION 1561+70.00
STRUCTURE NO. 083-0038

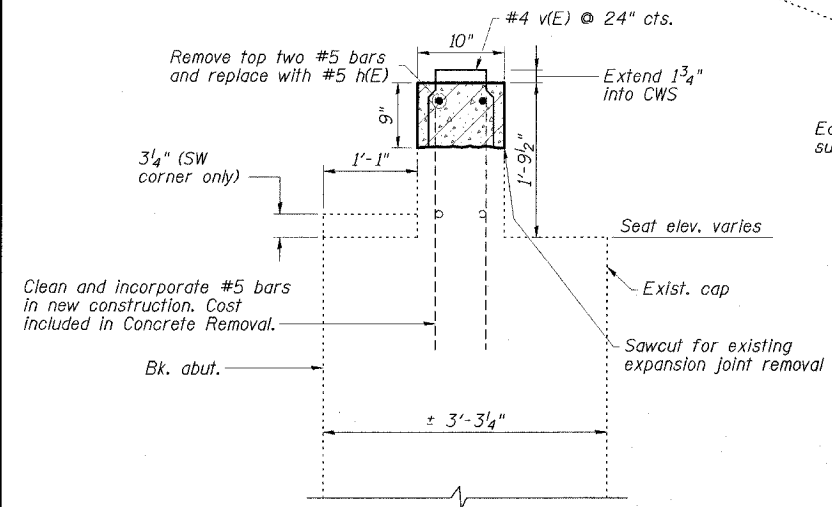
SECTION THRU ABUTMENT

EXISTING BEARING SEAT TO BE INSPECTED BY THE ENGINEER AFTER DECK BEAM REMOVAL. DETERIORATED CONCRETE AREAS SHALL BE REPAIRED (ESTIMATED 15 S.F. STRUCTURAL REPAIR OF CONCRETE DEPTH < 5") AND CRACKS SHALL BE SEALED (ESTIMATED 20' EPOXY CRACK INJECTION) IF FOUND. CONCRETE SEALER SHALL BE APPLIED TO CONCRETE REPAIR AREAS.

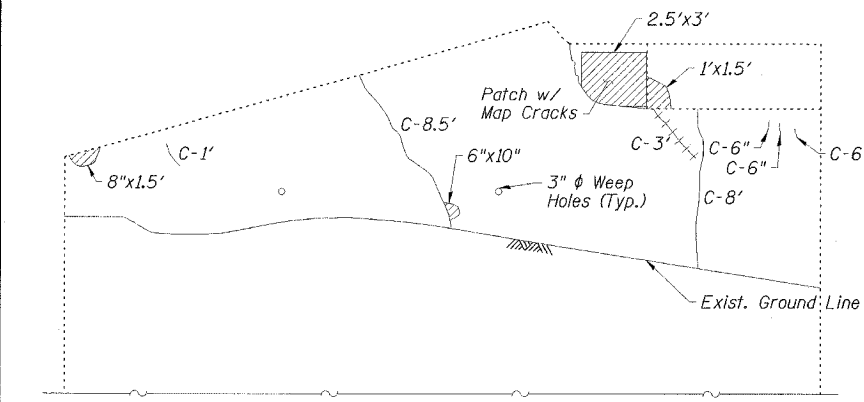
SOUTHEAST WING
ELEVATION

- C-6' Crack to be epoxy injected
- Delaminated or spalled area - use Structural Repair of Concrete
- Rust spot

NOTE: ABUTMENT CRACK REPAIR LENGTHS AND STRUCTURAL REPAIR OF CONCRETE AREAS ARE ESTIMATED FROM 12-10-07 SURVEY WORK. ACTUAL LOCATIONS AND QUANTITIES OF REPAIRS SHALL BE SHOWN BY THE ENGINEER ON THE AS-BUILT PLANS FOR THIS SECTION.
