STATE OF ILLINOIS  
DEPARTMENT OF TRANSPORTATION

**PIER 2**  
**BILL OF MATERIAL**

**PIER 2**  
**IL 34 OVER**  
**MIDDLE FORK SALINE RIVER**  
**FAP ROUTE 869 - SECTION 105BR-2**  
**SALINE COUNTY**  
**STATION 1561+70.00**  
**STRUCTURE NO. 083-0038**

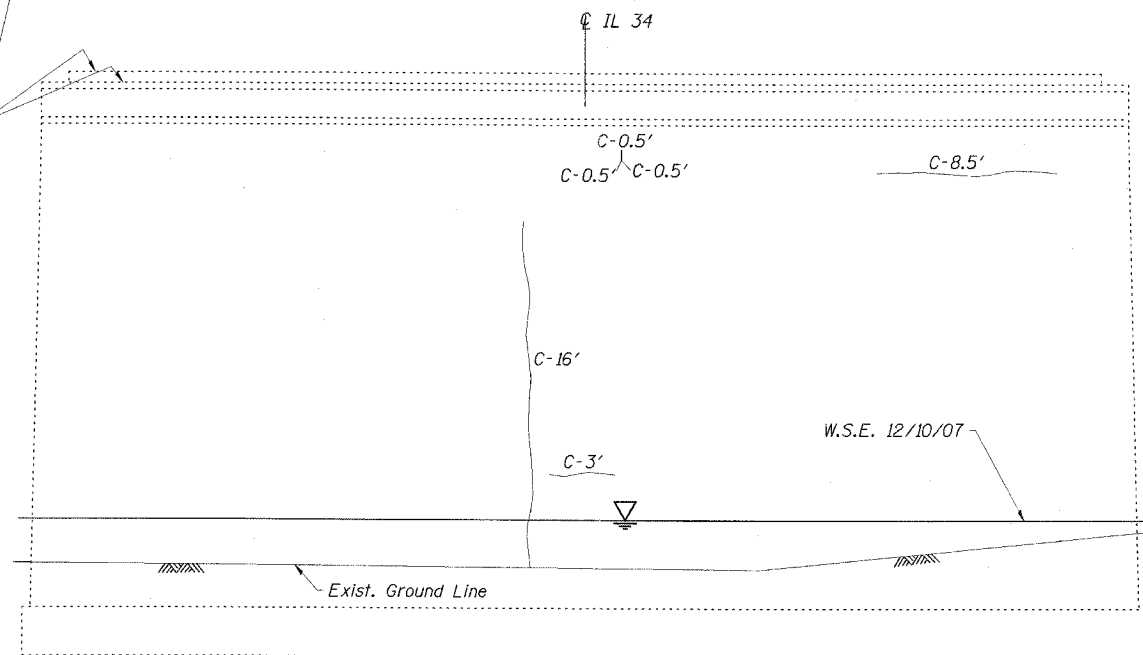
**NORTH ELEVATION**

NOTE: PIER CRACK REPAIR LENGTHS AND STRUCTURAL REPAIR OF CONCRETE AREAS ARE ESTIMATED FROM 12-10-07 SURVEY WORK. ACTUAL LOCATIONS AND QUANTITIES OF REPAIRS SHALL BE SHOWN BY THE ENGINEER ON THE AS-BUILT PLANS FOR THIS SECTION.
