ROUTE NO.	SECTION	COUNTY	SHEET NO.	SHEET
FAP 869	105BR-3	SALINE	118	95
SHEET NO. 13				
17 SHEETS

**SOUTH ABUTMENT  
BILL OF MATERIAL**

**SOUTH ABUTMENT  
IL 34 OVER BANKSTON FORK AND  
SALINE RIVER OVERFLOW  
FAP ROUTE 869 - SECTION 105BR-3  
SALINE COUNTY  
STATION 1574+00.00  
STRUCTURE NO. 083-0039**

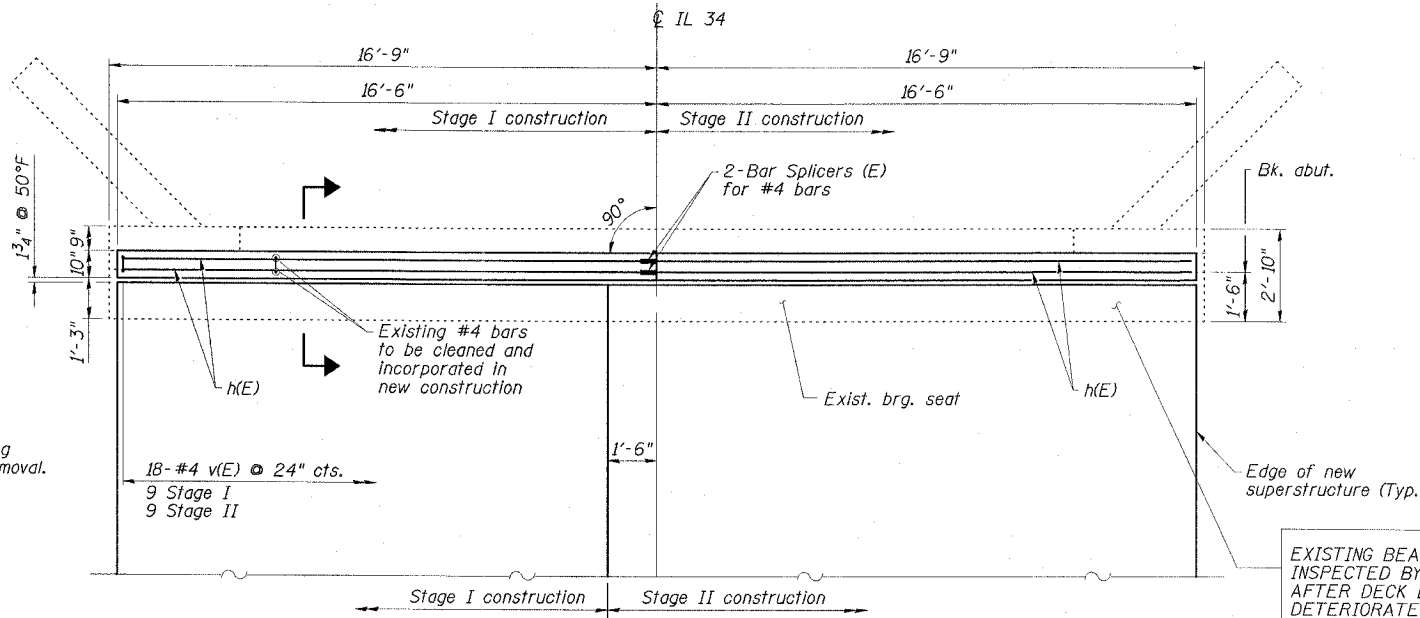
**PLAN**

EXISTING BEARING SEAT TO BE INSPECTED BY THE ENGINEER AFTER DECK BEAM REMOVAL. DETERIORATED CONCRETE AREAS SHALL BE REPAIRED (ESTIMATED 15 S.F. STRUCTURAL REPAIR OF CONCRETE DEPTH ≤ 5") AND CRACKS SHALL BE SEALED (ESTIMATED 20' EPOXY CRACK INJECTION) IF FOUND. CONCRETE SEALER SHALL BE APPLIED TO CONCRETE REPAIR AREAS.

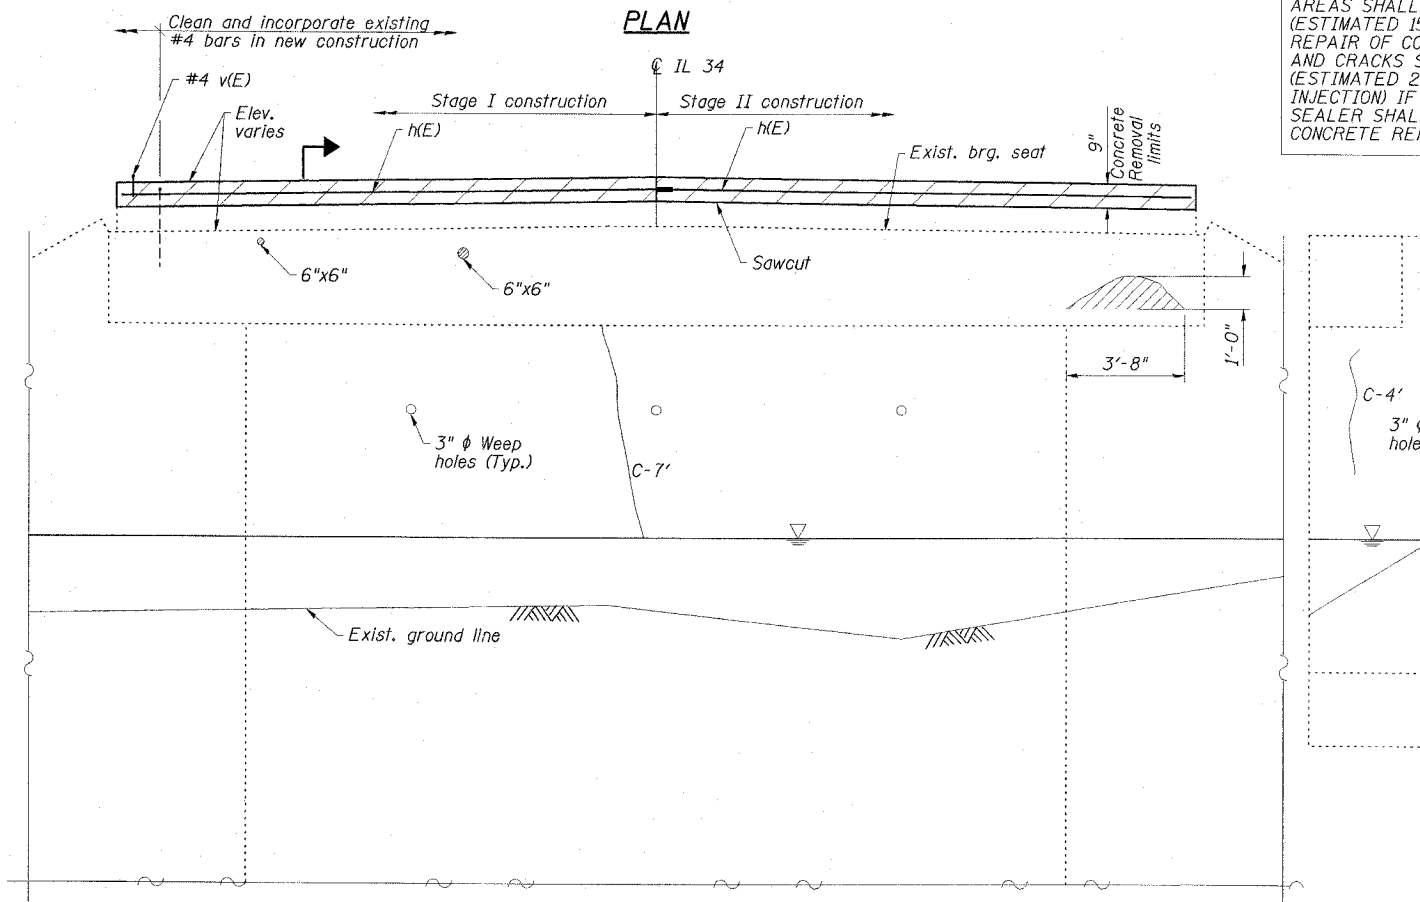
**ELEVATION**

NOTE: ABUTMENT CRACK REPAIR LENGTHS AND STRUCTURAL REPAIR OF CONCRETE AREAS ARE ESTIMATED FROM 12-18-07 SURVEY WORK. ACTUAL LOCATIONS AND QUANTITIES OF REPAIRS SHALL BE SHOWN BY THE ENGINEER ON THE AS-BUILT PLANS FOR THIS SECTION.
