ROUTE NO.	SECTION	COUNTY	POST MILE	SHEET NO.	SHEET NO. 11
FAP 328	*	WHITE	42	22	17 SHEETS
FED. ROAD DIST. NO.	ILLINOIS	FED. AID PROJECT	*(105X)BR		
98997

**SOUTH ABUTMENT
BILL OF MATERIAL**

**SOUTH ABUTMENT
US 45 OVER SKILLET FORK OVERFLOW
FAP ROUTE 328 - SECTION (105X)BR
WHITE COUNTY
STATION 598+76.00
STRUCTURE NO. 097-0019**

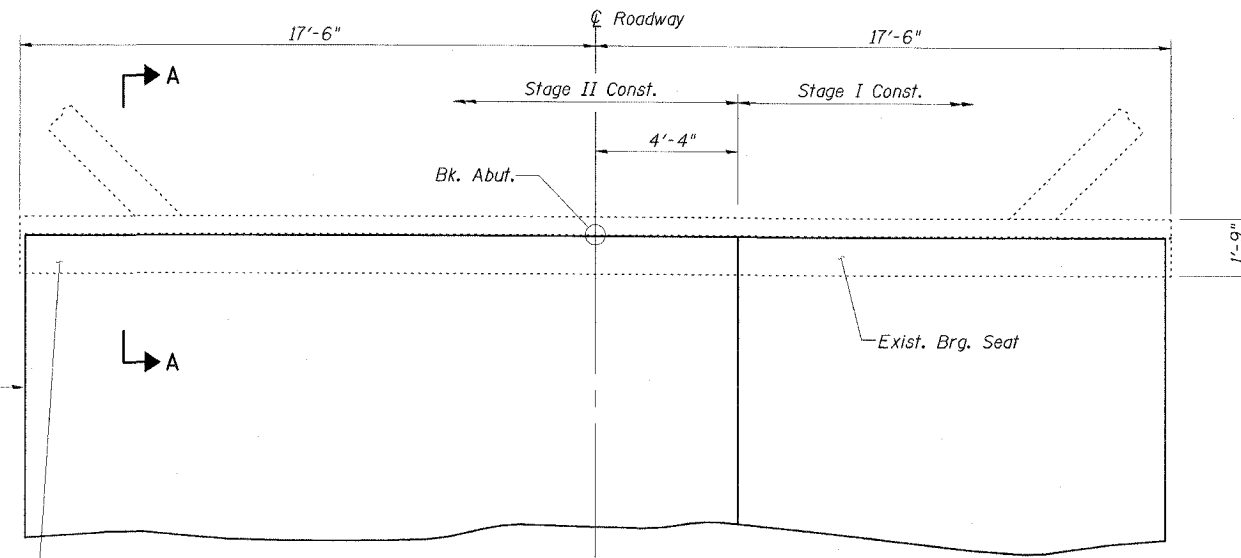
PLAN

EXISTING BEARING SEAT TO BE INSPECTED BY THE ENGINEER AFTER DECK BEAM REMOVAL. DETERIORATED CONCRETE AREAS SHALL BE REPAIRED (ESTIMATED 15 S.F. STRUCTURAL REPAIR OF CONCRETE DEPTH ≤ 5") AND CRACKS SHALL BE SEALED (ESTIMATED 20' EPOXY CRACK INJECTION) IF FOUND. CONCRETE SEALER SHALL BE APPLIED TO CONCRETE REPAIR AREAS.

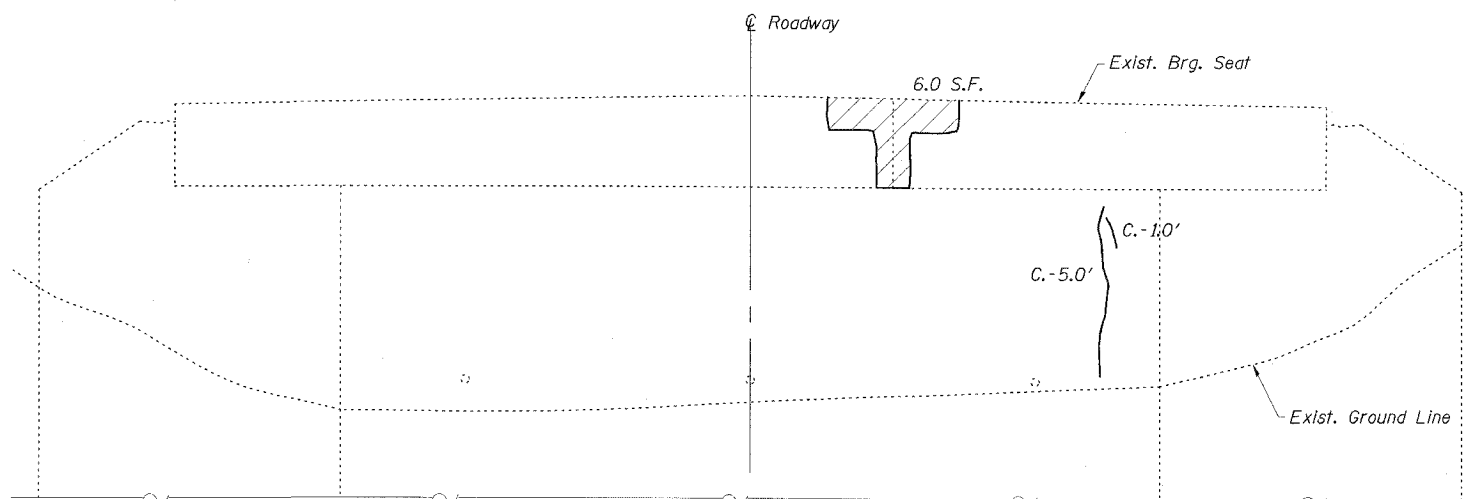
ELEVATION

- C.-6' Crack to be epoxy injected
- S.F. Delaminated or Spalled Area - Use Structural Repair of Concrete

NOTE: ABUTMENT CRACK REPAIR LENGTHS AND STRUCTURAL REPAIR OF CONCRETE AREAS ARE ESTIMATED FROM 12-14-06 SURVEY WORK. ACTUAL LOCATIONS AND QUANTITIES OF REPAIRS SHALL BE SHOWN BY THE ENGINEER ON THE AS-BUILT PLANS FOR THIS SECTION.
