SHEET NO. 4
6 SHEETS

**PARTIAL PLANS
SUGGESTED BEAM STRAIGHTENING METHODS**

**BRIDGE REPAIRS
FAI 64 (WB) OVER US 45
WAYNE COUNTY
SN 096-0053 (WB)**

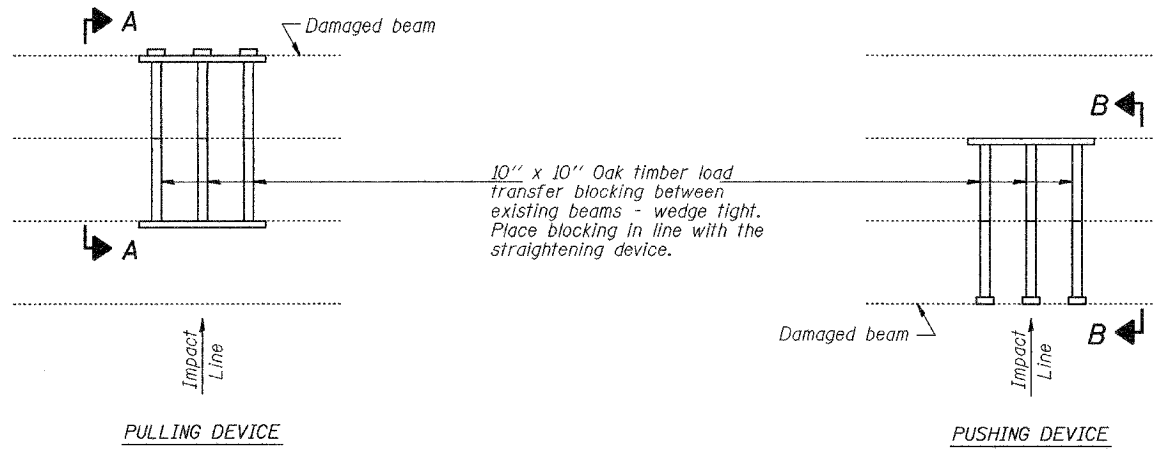
**EXISTING DEFORMATION
TO BE STRAIGHTENED**

(Looking East)
(Approximate max. deflections)
Deflected length of beam to be straightened is approximately 10'-0".
