STATE OF ILLINOIS DEPARTMENT OF TRANSPORTATION

PARTIAL PLANS SUGGESTED BEAM STRAIGHTENING METHODS

BEAM STRAIGHTENING DETAILS FAI 64 (EB) OVER US 45 WAYNE COUNTY SN 096-0059 (EB)

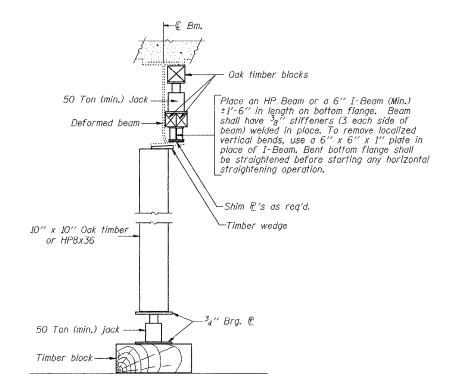
SUGGESTED VERTICAL STRAIGHTENING DETAIL

(To correct flange rotation.)

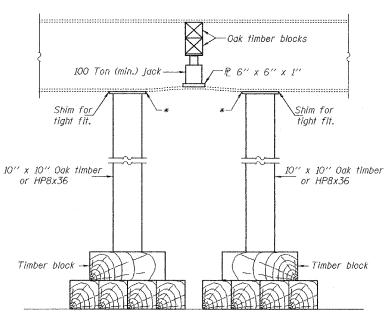
SUGGESTED VERTICAL STRAIGHTENING DETAIL

(To correct localized vertical flange deformations.)

* Edge of plate shall line up with edge of deformation.

Braces and jack assembly shall be placed on same side of web. Bent bottom flange shall be straightened before starting any horizontal straightening operations.
