STATE OF ILLINOIS DEPARTMENT OF TRANSPORTATION

SHEET NO. 3

STRUCTURAL STEEL REPAIR FAI 64 (EB) OVER US 45 WAYNE COUNTY SN 096-0059 (EB)

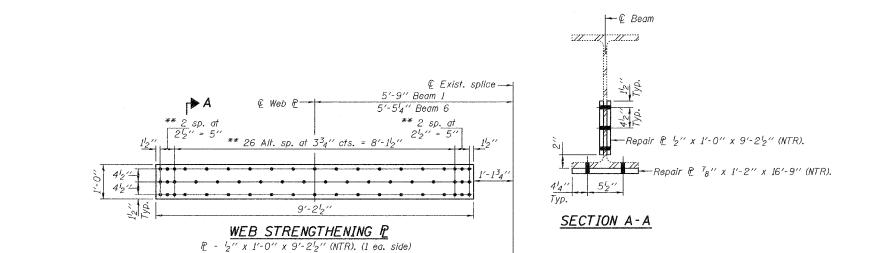
BOTTOM FLANGE STRENGTHENING P

1 £ - 78" x 1'-2" x 16'-9" (NTR). (Looking North)

* Remove existing splice plate. Use existing holes in bottom flange as template to field drill holes in new plate.

*** Use holes in new plate as template to field drill holes in beam. Fasteners for beam strengthening shall be $^34'' \phi$ high strength bolts, in $^{13}_{16}'' \phi$ holes, Cost of removal of existing bottom flange splice plate is included with Structural Steel Repair.

Existing bolts shall not be re-used.

Traffic shall be maintained at least one beam spacing away from Girder 1 and 6 while splice plate is being replaced.
