**TR 112 OVER FAI 70
SN 003-0043**

**STATE OF ILLINOIS
DEPARTMENT OF TRANSPORTATION**

REPAIR DETAILS

SHEET NO. 2 OF 2 SHEETS

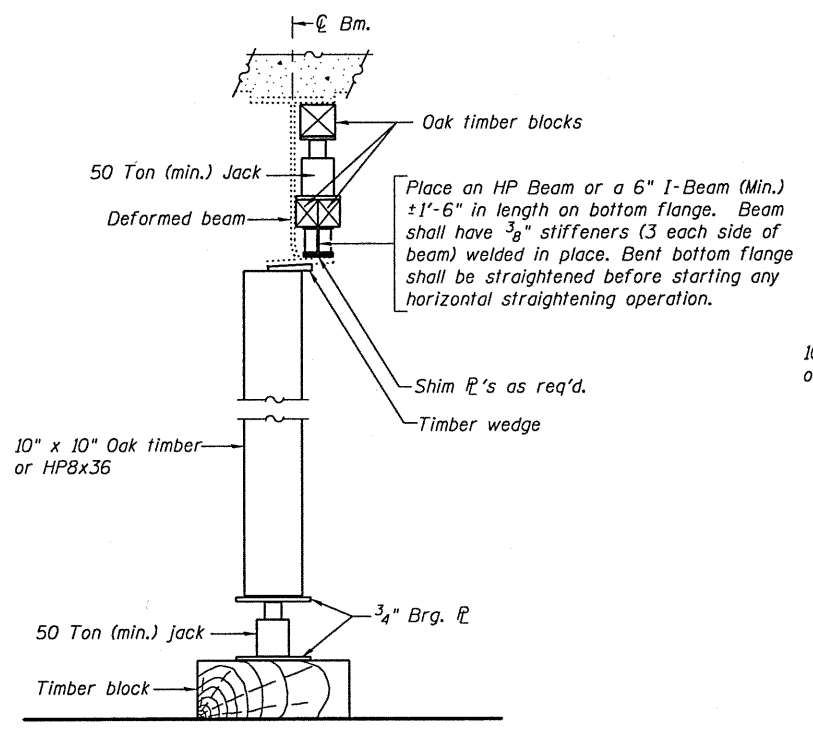
SUGGESTED VERTICAL STRAIGHTENING DETAIL

(To correct flange rotation.)

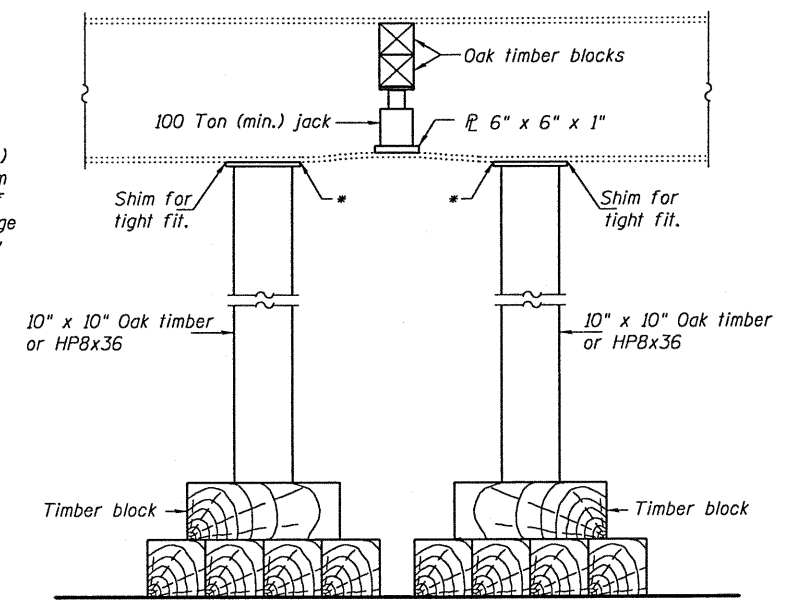
SUGGESTED VERTICAL STRAIGHTENING DETAIL

(To correct localized vertical flange deformations.)

* Edge of plate shall line up with edge of deformation.

Note:
Braces and jack assembly shall be placed on same side of web.
Bent bottom flange shall be straightened before starting any horizontal straightening operations.
