NORTH ABUTMENT

REPAIR LEGEND Inspection Date: 02/01/07

IL 34/145 OVER BRIER CREEK

STRUCTURE NO. 083-0018

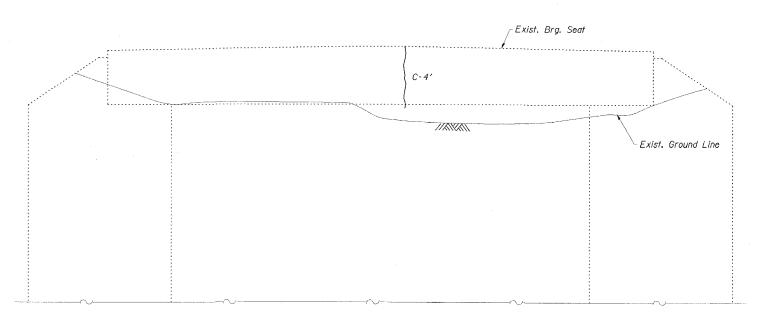
PLAN

C.-6' Crack to be epoxy injected

Delaminated or Spalled Area -Use Structural Repair of Concrete

EXISTING BEARING SEAT TO BE INSPECTED BY THE ENGINEER AFTER DECK BEAM REMOVAL. DETERIORATED CONCRETE AREAS SHALL BE REPAIRED (ESTIMATED 15 S.F. STRUCTURAL REPAIR OF CONCRETE DEPTH < 5") AND CRACKS SHALL BE SEALED (ESTIMATED 20' EPOYY CRACK INJECTION) IF FOUND CONCRETE

INJECTION) IF FOUND. CONCRETE
SEALER SHALL BE APPLIED TO
STRUCTURAL REPAIR OF
CONCRETE AREAS.
