STATE OF ILLINOIS  
DEPARTMENT OF TRANSPORTATION

Inspection Date: 02/01/07

**NORTH ABUTMENT  
IL 34/145 OVER SOUTH FORK  
SALINE RIVER OVERFLOW  
FAP ROUTE 132 - SECTION IBR-3  
SALINE COUNTY  
STATION 244+40.00  
STRUCTURE NO. 083-0020**

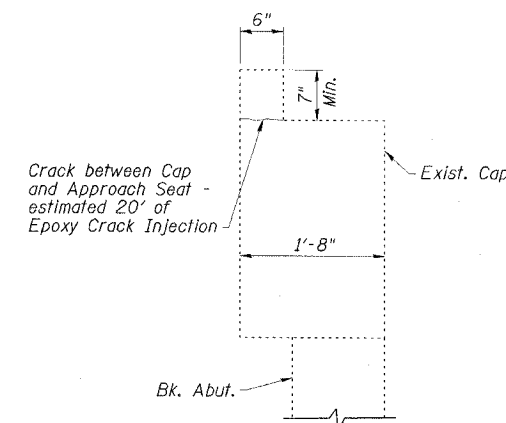
**SECTION THRU EXISTING ABUTMENT**

EXISTING BEARING SEAT TO BE INSPECTED BY THE ENGINEER AFTER DECK BEAM REMOVAL. DETERIORATED CONCRETE AREAS SHALL BE REPAIRED (ESTIMATED 15 S.F. STRUCTURAL REPAIR OF CONCRETE DEPTH < 5") AND CRACKS SHALL BE SEALED (ESTIMATED 20' EPOXY CRACK INJECTION) IF FOUND. CONCRETE SEALER SHALL BE APPLIED TO STRUCTURAL REPAIR OF CONCRETE AREAS.

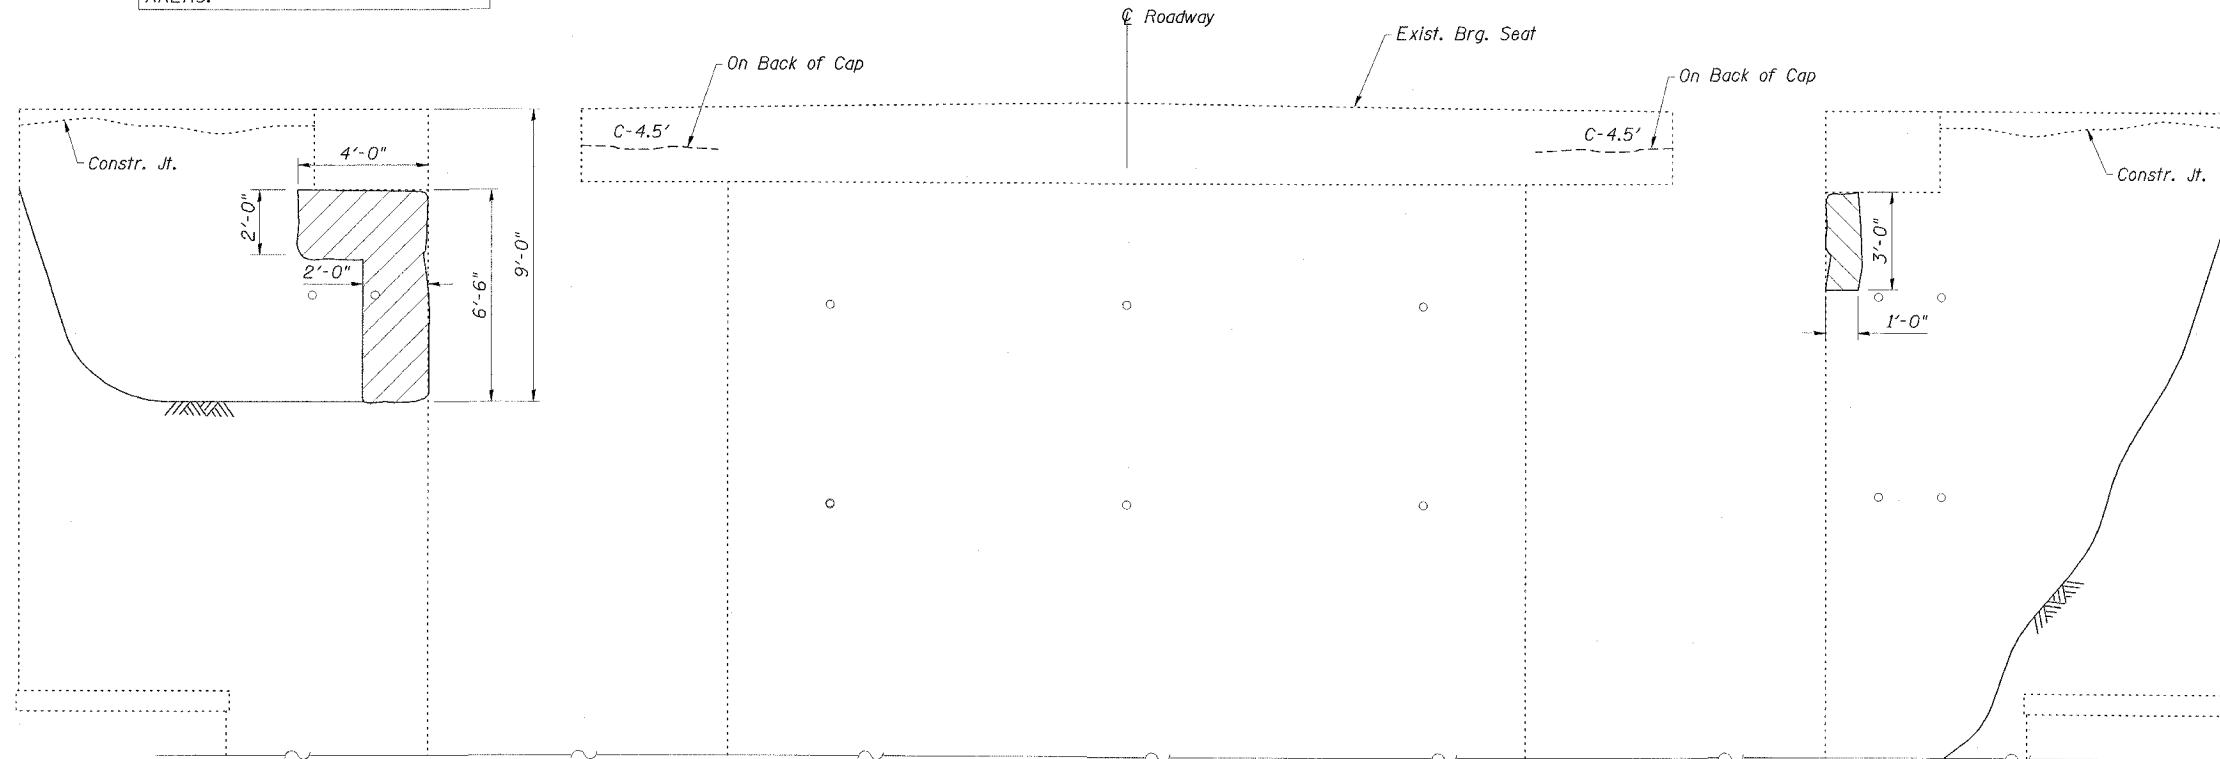
**ELEVATION**

NOTE: ABUTMENT CRACK REPAIR LENGTHS AND STRUCTURAL REPAIR OF CONCRETE AREAS ARE ESTIMATED FROM 02-01-07 SURVEY WORK. ACTUAL LOCATIONS AND QUANTITIES OF REPAIRS SHALL BE SHOWN BY THE ENGINEER ON THE AS-BUILT PLANS FOR THIS SECTION.

C-.5' Crack to be epoxy injected
-

Delaminated or Spalled Area - Use Structural Repair of Concrete
