Contract Number: F6968

**PARTIAL PLANS**  
**SUGGESTED BEAM STRAIGHTENING METHODS**  
Straightening force shall be maintained on all load transfer blocking during beam straightening.

**BEAM STRAIGHTENING DETAILS**  
**ILL. RTE 162 OVER FAI RTE. 70**  
**MADISON COUNTY**  
**S.N. 060-0139**

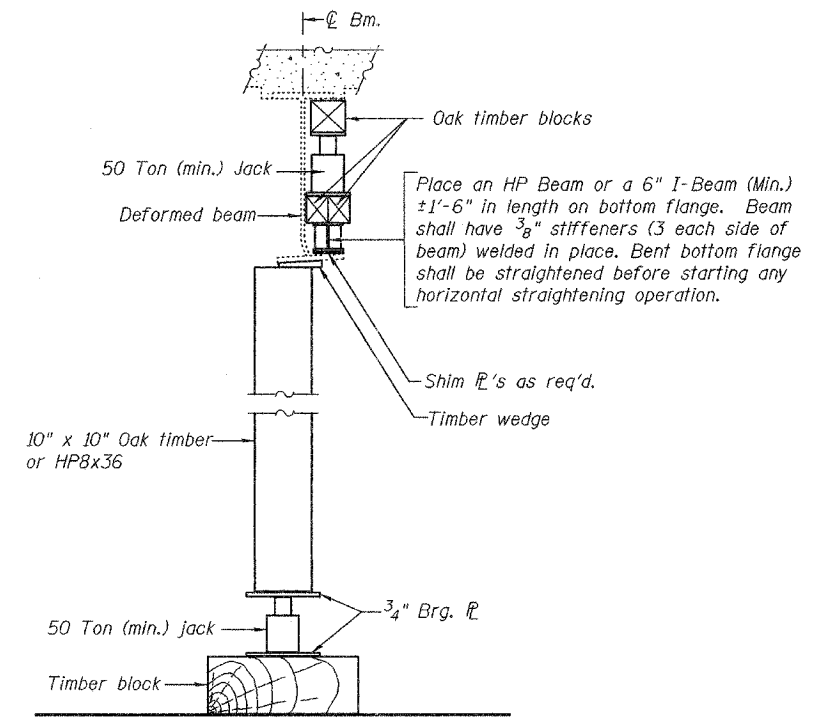
**SUGGESTED VERTICAL STRAIGHTENING DETAIL**  
(To correct flange rotation.)

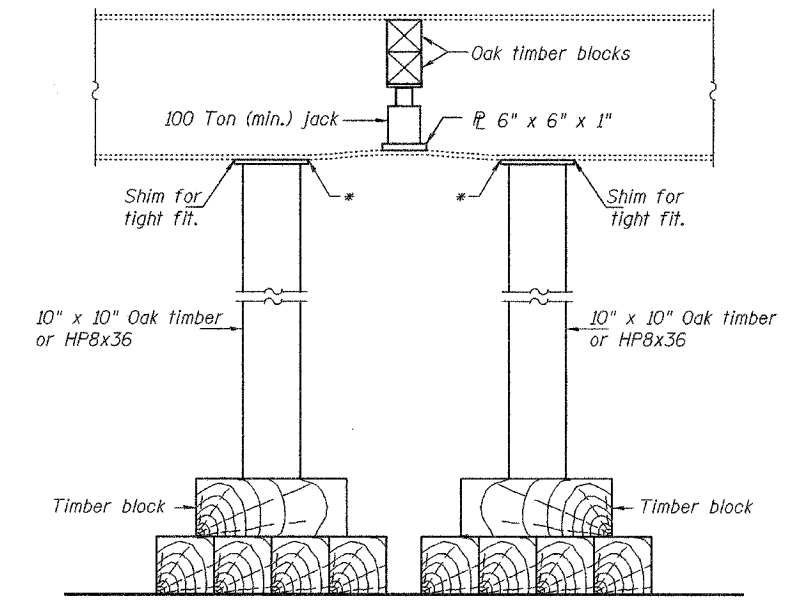
**SUGGESTED VERTICAL STRAIGHTENING DETAIL**  
(To correct localized vertical flange deformations.)

\* Edge of plate shall line up with edge of deformation.  
Note:  
Braces and Jack assembly shall be placed on same side of web.  
Bent bottom flange shall be straightened before starting any horizontal straightening operations.

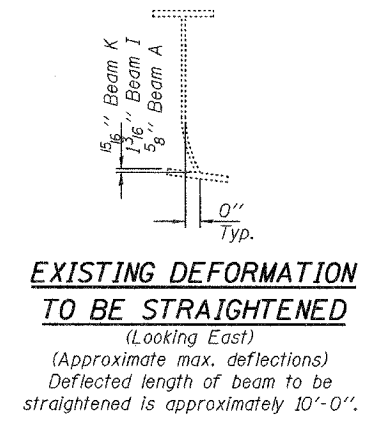
**EXISTING DEFORMATION TO BE STRAIGHTENED**  
(Looking East)  
(Approximate max. deflections)  
Deflected length of beam to be straightened is approximately 10'-0".
