**STATE OF ILLINOIS  
 DEPARTMENT OF TRANSPORTATION**

**REPAIR DETAILS 181, 227, 37, 38, 45,  
 48, 50, 52, 320, 266, 57, 60, 61 & 336  
 SN 099-0057**

SHEET NO. 22 OF 24 SHEETS

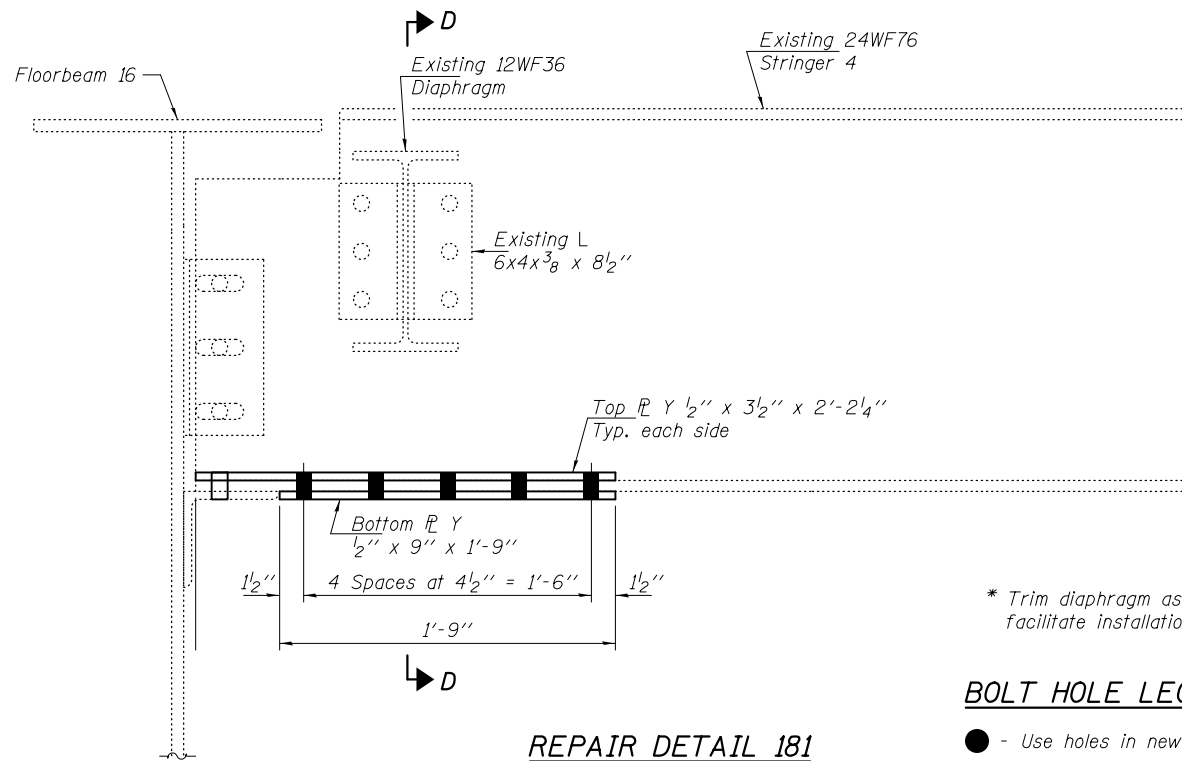
**REPAIR DETAIL 181**

\* Trim diaphragm as required to facilitate installation of Bent P.

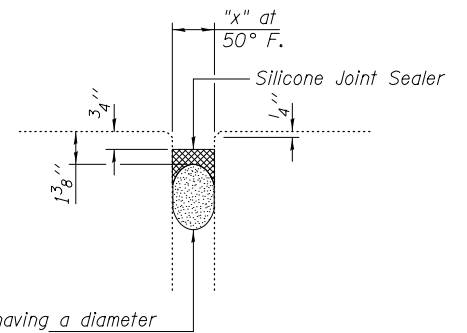
**REPAIR 37, 38, 45, 48, 50, 52, 320, 266, 57, 60, 61 & 336 DETAILS**

Backer Rod having a diameter 25% greater than the joint opening at the time of installation.

See Table TT for Locations and dimension "x".

NBIS #	SPAN	LOCATION	JOINT DEFICIENCY	Dim. "x"
37	1	W. Abut.	20' Leaking	2"
38	4 & 5	Pier 4	15' Leaking	1"
45	8	Panel Point 13	28' of joint failed	2 3/4"
48	8	Panel Point 16	4' of joint failed	1 3/4"
50	8	Panel Point 20	4' of joint failed	1 3/4"
52	8 & 9	Pier 8	4' of joint failed	2 3/4"
320	12 & 13	Pier 12	8' of joint failed	2 3/4"
266	14 & 15	Pier 14	20' of joint failed	2 3/4"
57	18 & 19	Pier 18	Leaking full length	2"
60	21 & 22	Pier 21	6' Leaking	1"
61	22 & 23	Pier 22	8' Leaking	2"
336	24 & 25	Pier 24	Joint failed	2 3/4"
