Illinois Department of Transportation

Memorandum

Subject: Milling/Resurfacing Recommendation *
Date: May 19, 2025

* Route: FAP 587 (US 34)
Section: (19,20)RS-5
LaSalle County
D3 No.: 3583
Contract No. 66P67

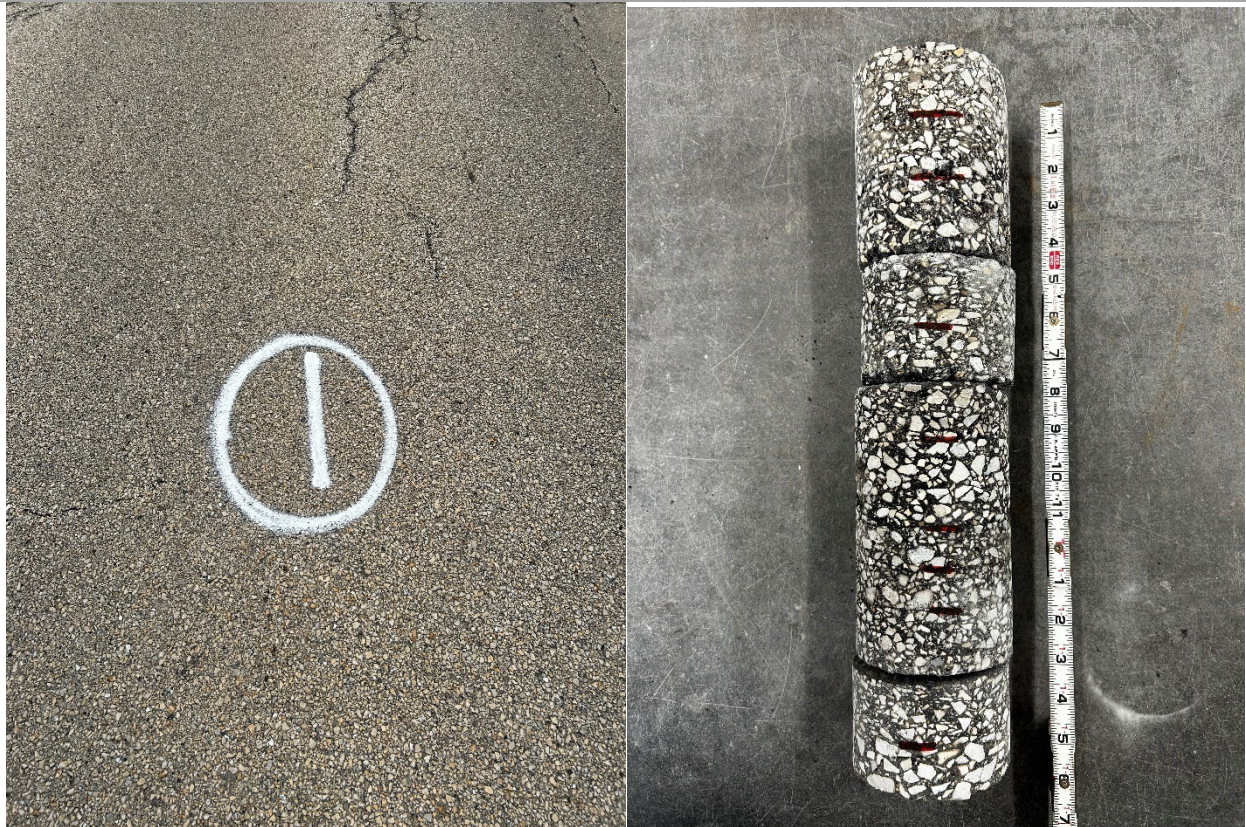
Core #	1	Route:	US 34	Core Date:	5/15/2025	Logged By:	Chad Nelson
Station:	N/A	Latitude:	41.55426000		Longitude:	-89.04313000	
Offset:	Center of lane			Direction:	EB	Lane:	Driving Lane
Comments:	0.3 miles east of HMA/PCC joint at I-39. PCC rubble.

Lift	Thickness	Material	Condition	Pavement Cracks	Aggregate Cracks	Voids	Comments
1	1.625"	HMA Surface	Fair	None	Some	Some	
2	1.50"	HMA Surface	Poor	None	Some	Many	
3	1.625"	HMA Surface	Poor	None	Some	Many	
4	1.50"	HMA Surface	Fair	None	Some	None	
5	1.25"	HMA Surface	Fair	None	Some	None	
6	1.25"	HMA Surface	Poor	None	Some	Many	
7	2.00"	HMA Binder	Fair	None	Some	None	
8	1.00"	HMA Surface	Fair	None	None	None	
9	1.00"	HMA Surface	Fair	None	None	None	
10	1.375"	HMA Surface	Fair	None	None	None	
11	1.25"	HMA Surface	Fair	None	None	None	
12	1.25"	HMA Binder	Poor	None	Some	Some

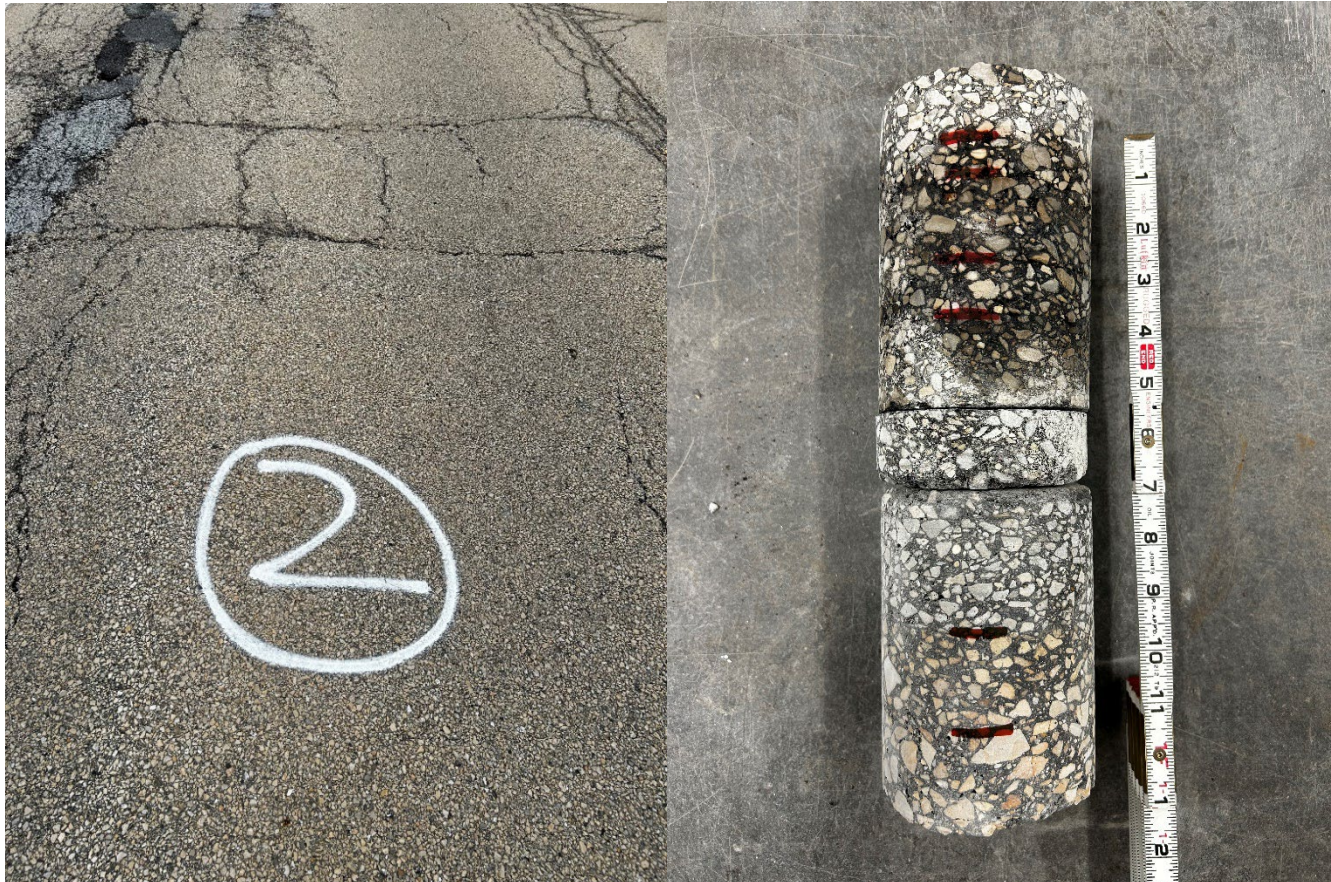
Core #	2	Route:	US 34	Core Date:	5/15/2025	Logged By:	Chad Nelson
Station:	N/A	Latitude:	41.56106000		Longitude:	-89.03380000	
Offset:	Center of lane			Direction:	WB	Lane:	Driving Lane
Comments:	1.2 miles east of HMA/PCC joint at I-39. PCC rubble.

Lift	Thickness	Material	Condition	Pavement Cracks	Aggregate Cracks	Voids	Comments
1	1.125"	HMA Surface	Fair	None	Some	None	
2	0.625"	HMA Surface	Poor	None	Many	Many	
3	1.75"	HMA Surface	Poor	None	Some	Many	
4	0.75"	HMA Surface	Poor	None	Some	Some	
5	1.50"	HMA Surface	Fair	None	Some	Some	
6	1.25"	HMA Surface	Fair	None	None	None	
7	2.125"	HMA Binder	Fair	None	Some	Some	
8	1.50"	HMA Binder	Fair	None	None	None	
9	1.625"	HMA Binder	Poor	None	Many	Some

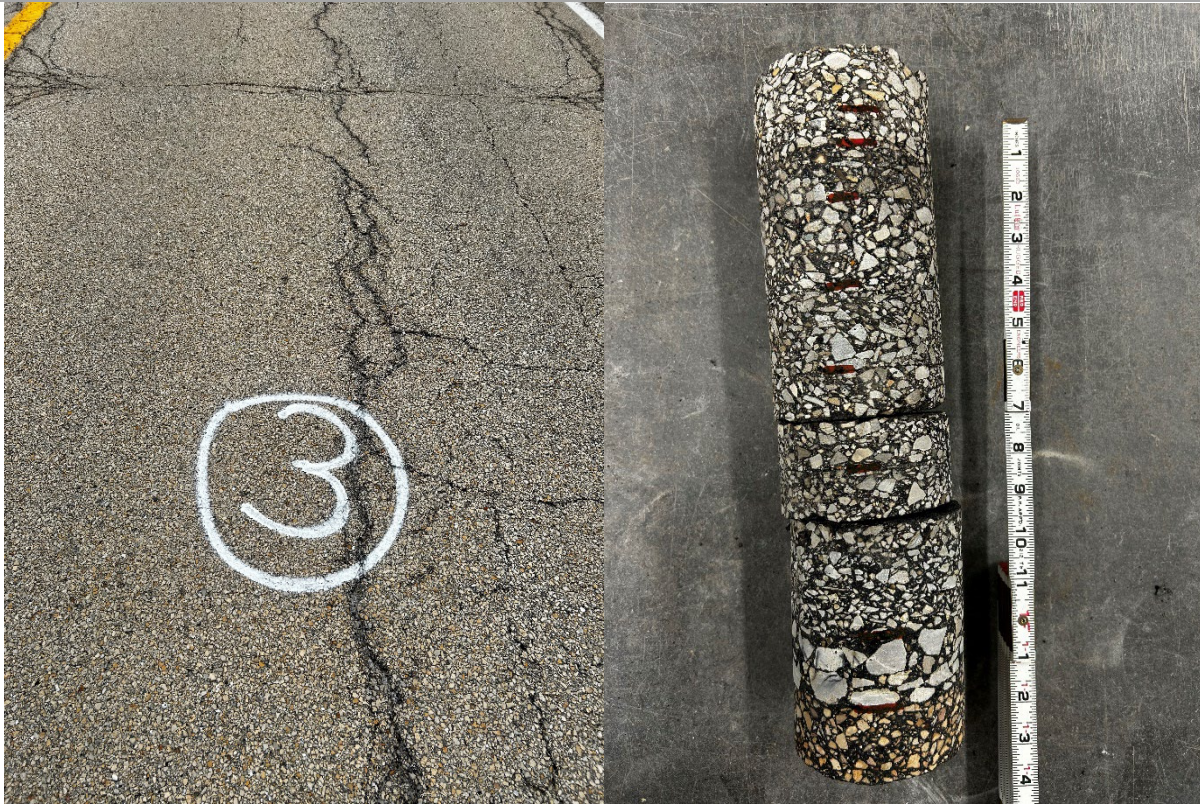
Core #	3	Route:	US 34	Core Date:	5/15/2025	Logged By:	Chad Nelson
Station:	N/A	Latitude:	41.56915000		Longitude:	-89.01795000	
Offset:	Center of lane			Direction:	EB	Lane:	Driving Lane
Comments:	2.5 miles east of HMA/PCC joint at I-39. PCC rubble.

Lift	Thickness	Material	Condition	Pavement Cracks	Aggregate Cracks	Voids	Comments
1	1.25"	HMA Surface	Fair	None	Some	Some	
2	0.75"	HMA Surface	Poor	None	Some	Many	
3	1.00"	HMA Surface	Fair	None	Some	None	
4	1.75"	HMA Binder	Fair	None	Some	None	
5	1.75"	HMA Binder	Fair	None	Some	None	
6	1.00"	HMA Surface	Fair	None	Some	Some	
7	1.00"	HMA Surface	Fair	None	Some	Some	
8	1.00"	HMA Surface	Fair	None	Some	None	
9	2.125"	HMA Surface	Fair	None	Some	None	
10	1.50"	HMA Binder	Poor	None	Some	None	
11	1.50"	HMA Binder	Fair	None	Some	None

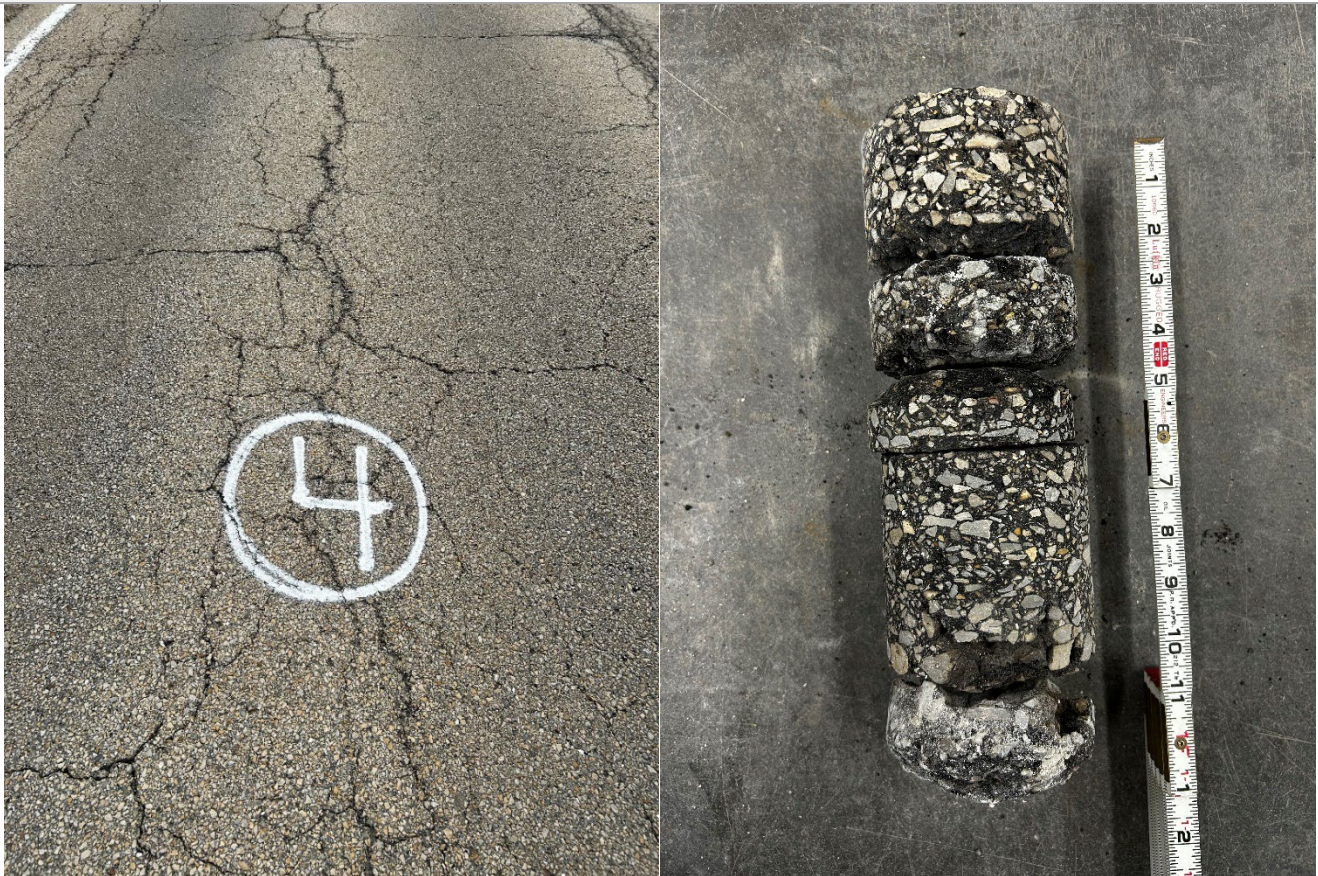
Core #	4	Route:	US 34	Core Date:	5/15/2025	Logged By:	Chad Nelson
Station:	N/A	Latitude:	41.57710000		Longitude:	-88.97238000	
Offset:	Center of lane			Direction:	WB	Lane:	Driving Lane
Comments:	5.3 miles east of HMA/PCC joint at I-39. PCC rubble.

Lift	Thickness	Material	Condition	Pavement Cracks	Aggregate Cracks	Voids	Comments
1	1.00"	HMA Surface	Fair	None	Some	Some	
2	1.25"	HMA Surface	Poor	None	Many	Many	
3	1.50"	HMA Surface	Poor	None	Many	None	
4	1.50"	HMA Surface	Poor	None	Many	None	
5	4.00"	HMA Binder	Poor	None	Some	Some	
6	2.00"	HMA Binder	Poor	None	Some	Some	
7		choose	choose	choose	choose	choose	
8		choose	choose	choose	choose	choose

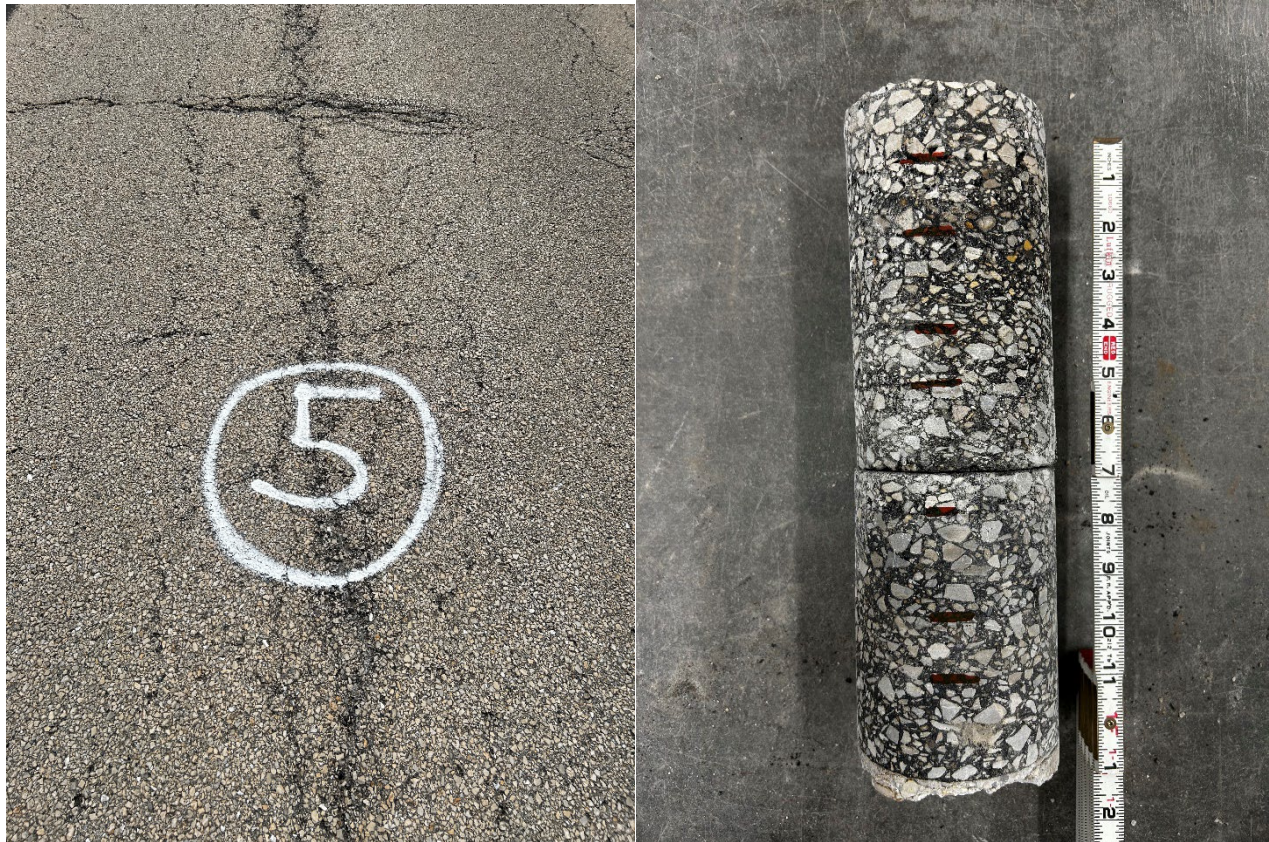
Core #	5	Route:	US 34	Core Date:	5/15/2025	Logged By:	Chad Nelson
Station:	N/A	Latitude:	41.57739000		Longitude:	-88.95030000	
Offset:	Center of lane			Direction:	EB	Lane:	Driving Lane
Comments:	6.5 miles east of HMA/PCC joint at I-39. PCC rubble.

Lift	Thickness	Material	Condition	Pavement Cracks	Aggregate Cracks	Voids	Comments
1	1.25"	HMA Surface	Poor	None	Many	Some	
2	1.25"	HMA Surface	Poor	None	Many	Some	
3	2.75"	HMA Surface	Fair	None	Some	Some	
4	0.875"	HMA Surface	Fair	None	Some	None	
5	1.50"	HMA Surface	Fair	None	None	None	
6	0.625"	HMA Surface	Fair	None	Some	None	
7	1.75"	HMA Surface	Fair	None	Some	None	
8	1.00"	HMA Surface	Fair	None	Some	Some	
9	1.75"	HMA Binder	Fair	None	Some	None
