SN 099-0009
I-55 NB over the Des Plaines River
Smith Bridge

2021 Bridge Inspection Report

Bridge Inspection By: Illinois Department of Transportation

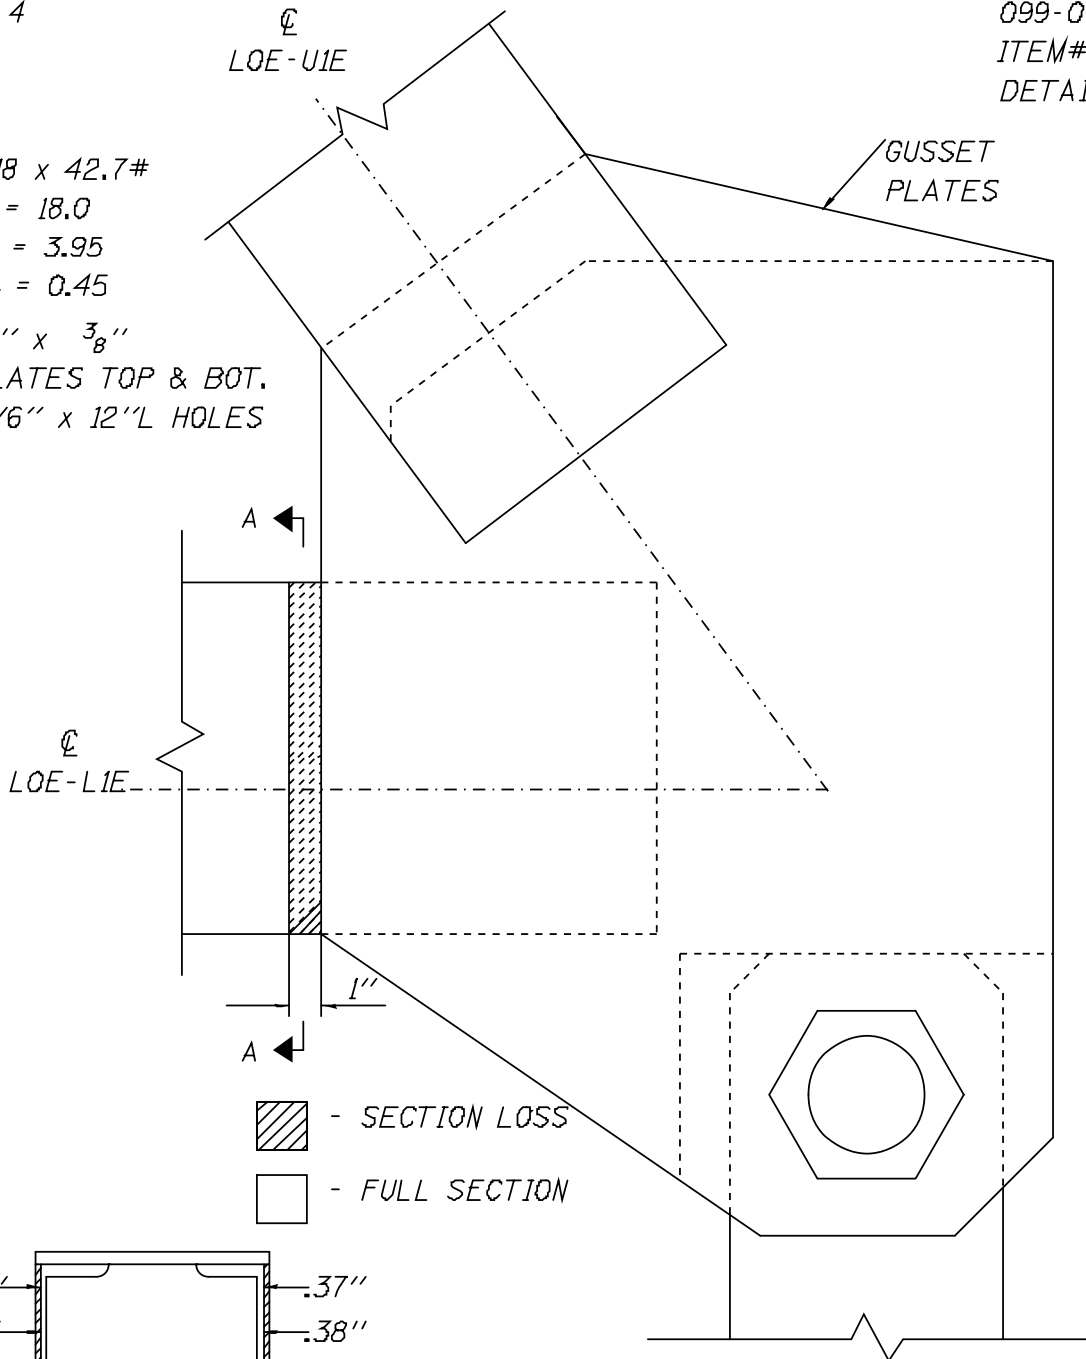
099-0009
ITEM# 24
DETAIL 1

C18 x 42.7#
d = 18.0
b_f = 3.95
t_w = 0.45
15" x 3/8"
PLATES TOP & BOT.
w/6" x 12"L HOLES

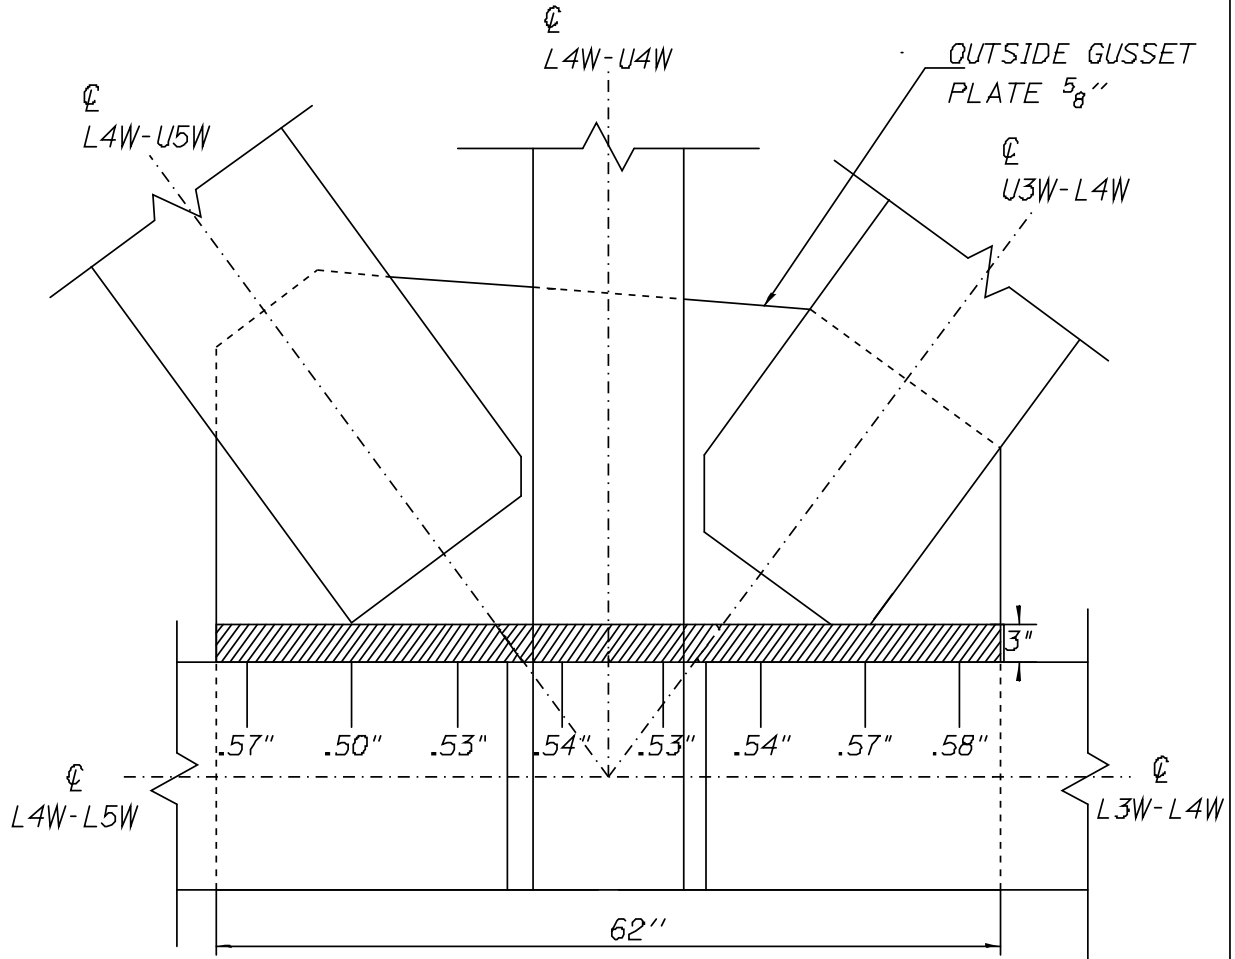
099-0009
 ITEM# 31
 DETAIL 3

SPAN 4, L4W
 GUSSET PLATE,
 OUTSIDE

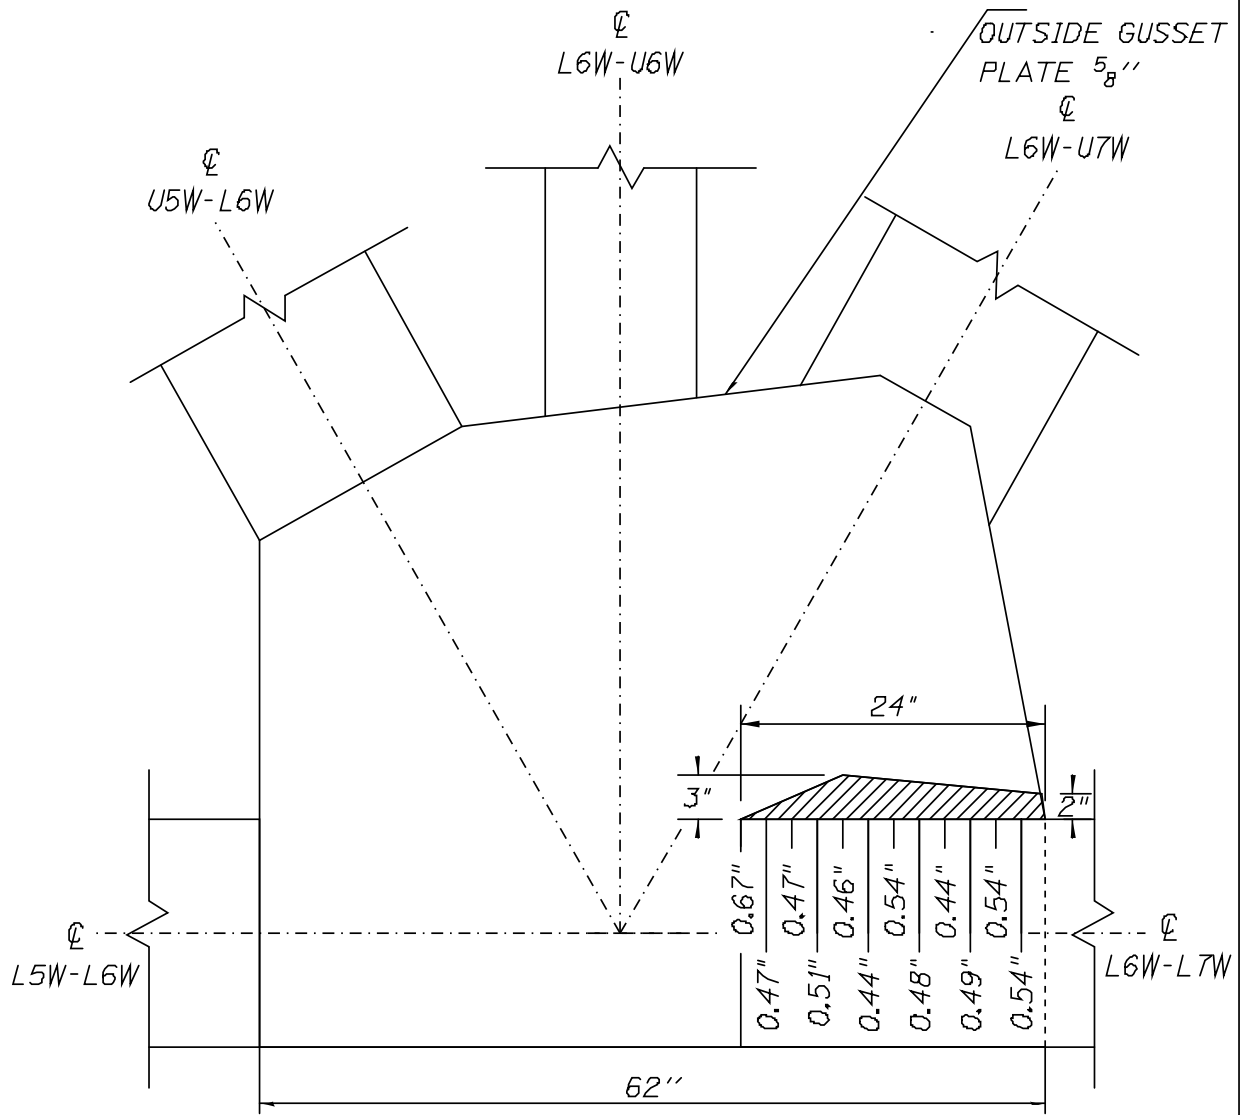
099-0009
 ITEM# 33
 DETAIL 4

SPAN 4, L6W
 GUSSET PLATE
 OUTSIDE

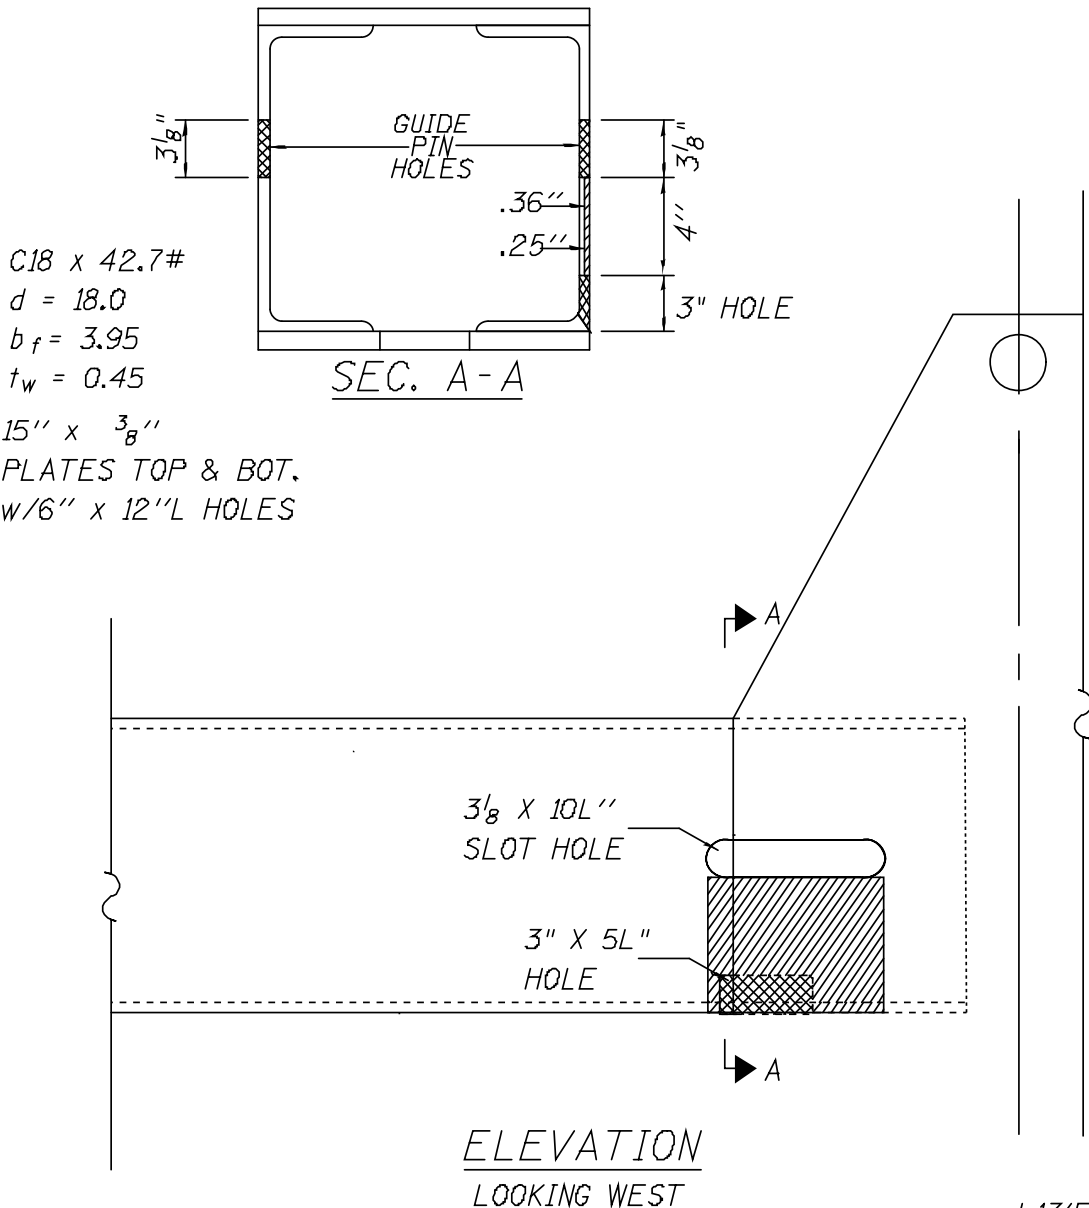
099-0009
 ITEM# 60
 DETAIL 8

106	5	Stringer 1	@ Floorbeam 13' Panel 13'	72 LE, 73LN	49% SL in Web, 27% Web Bearing Loss (See Detail 10)	N/A Zero Force Member	2017	X
60	5	L13'E-L12'E	@ L13'E	74 LNW	7% SL (See Detail 8)	N/A Zero Force Member	2005	
62	5	L13'W-L12'W	@ L13'W	75 LNE	3% SL (See Detail 9)	N/A Zero Force Member	2013	
63	5	Stringer 1-9	@ Floorbeam 13', Panel 13'	76 LNW	0% SL Web, 2" Holes Drilled into Web (Abandoned, Reinforced)	N/A	2011	
120	5	Joint	@ P.P. 13'	77 LE	5' Failed East end	Repair	2019	
59	5	Stringer 1	@ Floorbeam 13', Panel 13'	<u>122</u> LE	10" X 1/2" Offset bottom flange	N/A	2001

SPAN 5
 L13'E-L12'E
 @L13'E

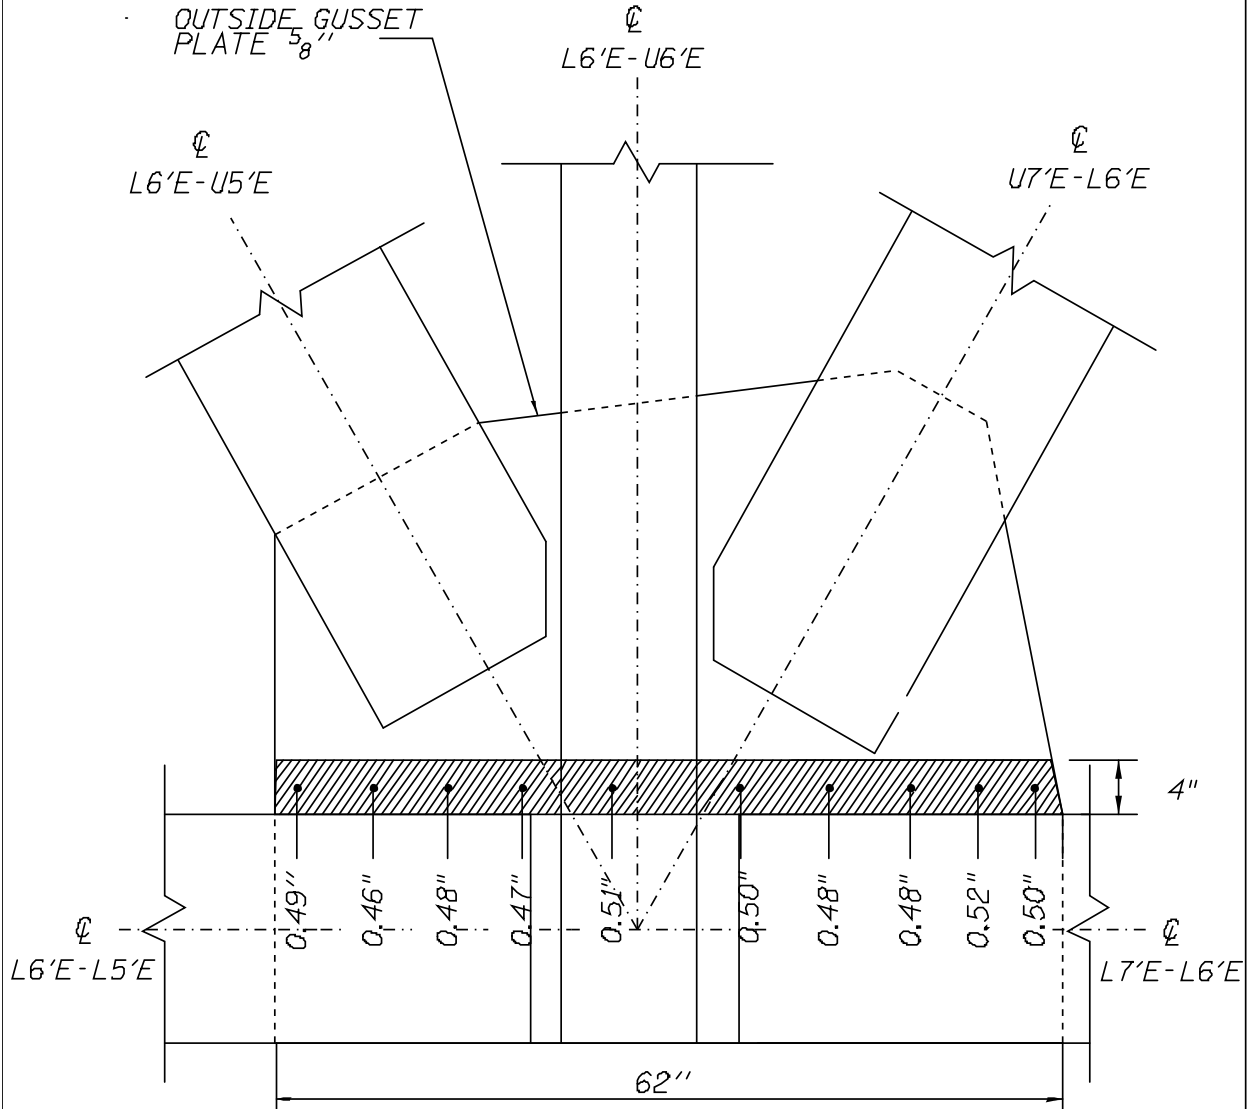
099-0009
 ITEM# 72
 DETAIL 12

69	6	U7'E-U6'E	U7'E	83 LN	<3 % SL 2 - 1" Misdrilled holes in top angle (1 Per Section)	N/A	2009	
70	6	U7'W-U6'W	@ U7'W	84 LE	2 - Partial crack tack weld (tension member)	N/A	2001	
110	6	L7'W-L6'W	@ L6'W	85 LS	0% SL 6" X 12"L area of loss with up to 3" hole in lower chord (Between access holes)	N/A	2017	
71	6	U7'E-L6'E	@ L6'E	86 LE	6% SL, 6" area of loss W/ 2" X 1"L hole in outside channel	N/A	2009	
121	6	Diaphragm	@ Floorbeam 6', Panel 7 Between Stringer 6 & 7	87 LE	1" X 5" Hole in web	N/A	2019	
72	6	Gusset Plate	L6'E (Outside)	88 LN	22% SL (See Detail 12)	N/A 22% SL -IRF = 1.58	2015

SPAN 6
 GUSSET PLATE,
 @L6'E, OUTSIDE

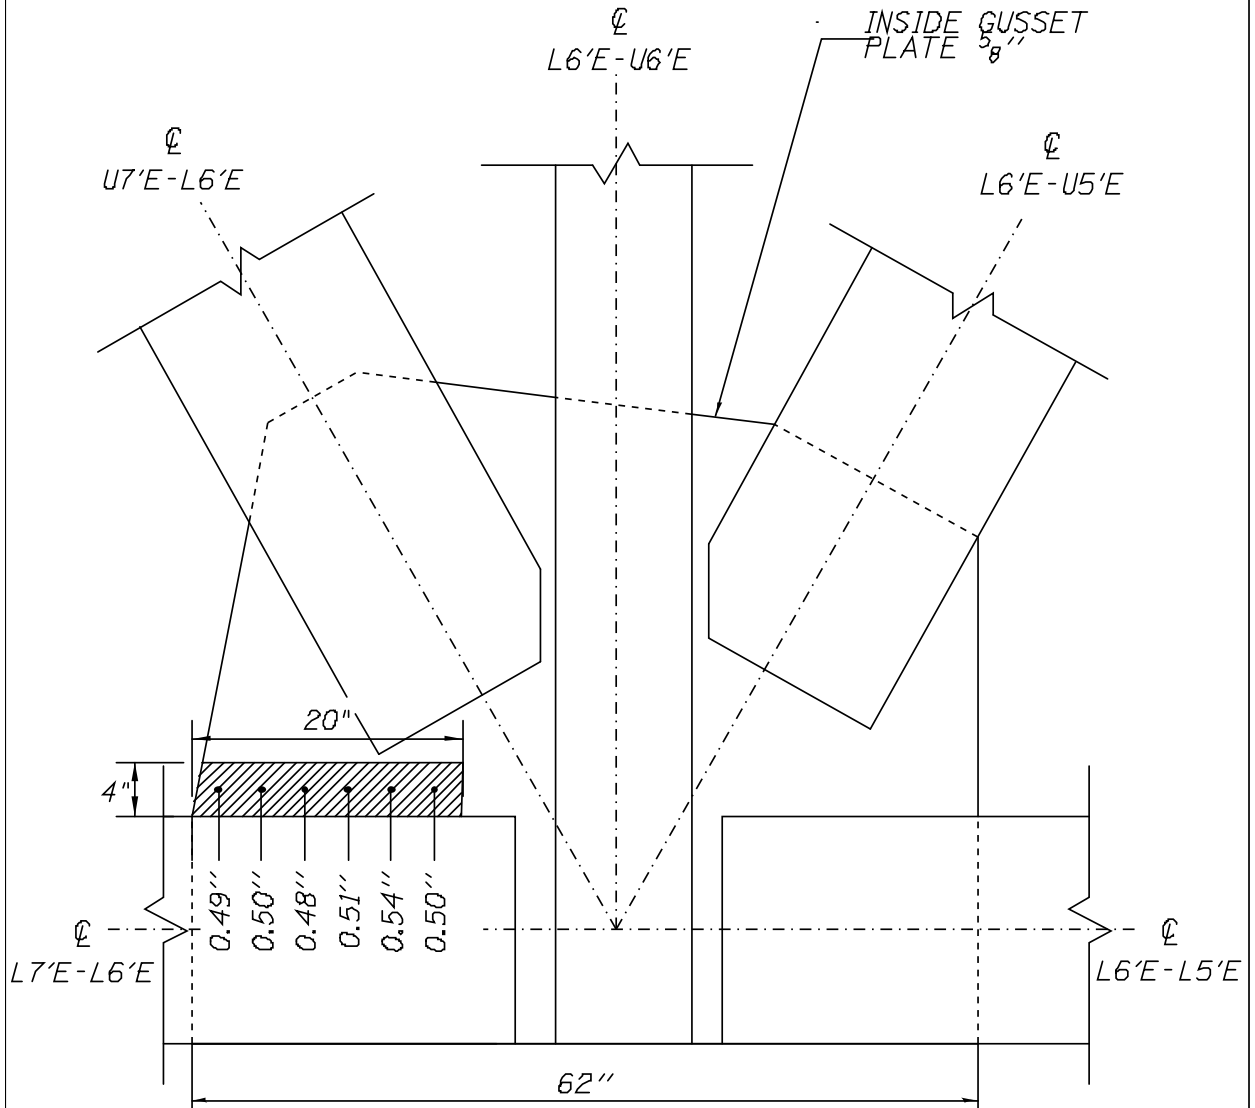
099-0009
 ITEM# 73
 DETAIL 13

ITEM#	Span(s)	Member(s)	Location(s)	Photo(s)	Deficiency(ies)	Corrective Action	Year	Load Cap. Re-Eval.
73	6	Gusset Plate	L6'E (Inside)	88 LN	6% SL (See Detail 13)	N/A 6% SL -IRF = 1.58	2009	
74	6	Stringer 8	Full Length, Panel 6'	89 LE	19% SL in Bottom Flange, 14% SL in Top Flange 6% SL in web (See Detail 14)	N/A 19% SL in Bottom Flange, 14% SL in Top Flange 6% SL in Web IRF = 1.69	2015	
111	6	L6'W-L5'W	@ L6'W	90 LN	35% SL 6" Hole in diaphragm, 0% SL, 3" hole in top cover plate	N/A	2017	
75	6	L6'E-L5'E	3' from L6'E	91 LE	0% SL, 2" Hole in Top Plate (Between Access Holes)	N/A	2013	
76	6	U5'E-L4'E	L4'E	92 LE	4% SL, 6" X 1" L area of loss in exterior channel; 0.395" Avg. Rem., 0.6" Nom.	N/A	2009	
77	6	L4'E-U4'E	5' from L4'E	93 LS	3% SL, 2- 7/8" Misdrilled holes in North plate	N/A	2013	
78	6	Stringer 1	@ Floorbeam4', Panel 4'	94 LE	7% SL, 1" hole in web (13 5/8" cope)	N/A	2015	
112	6	L4'W-U4'W	@ L4'W	95 LSE	3% SL, 3" X 1" l area with 1" hole in Web	N/A	2017

SPAN 6
 GUSSET PLATE
 @L6'E, INSIDE

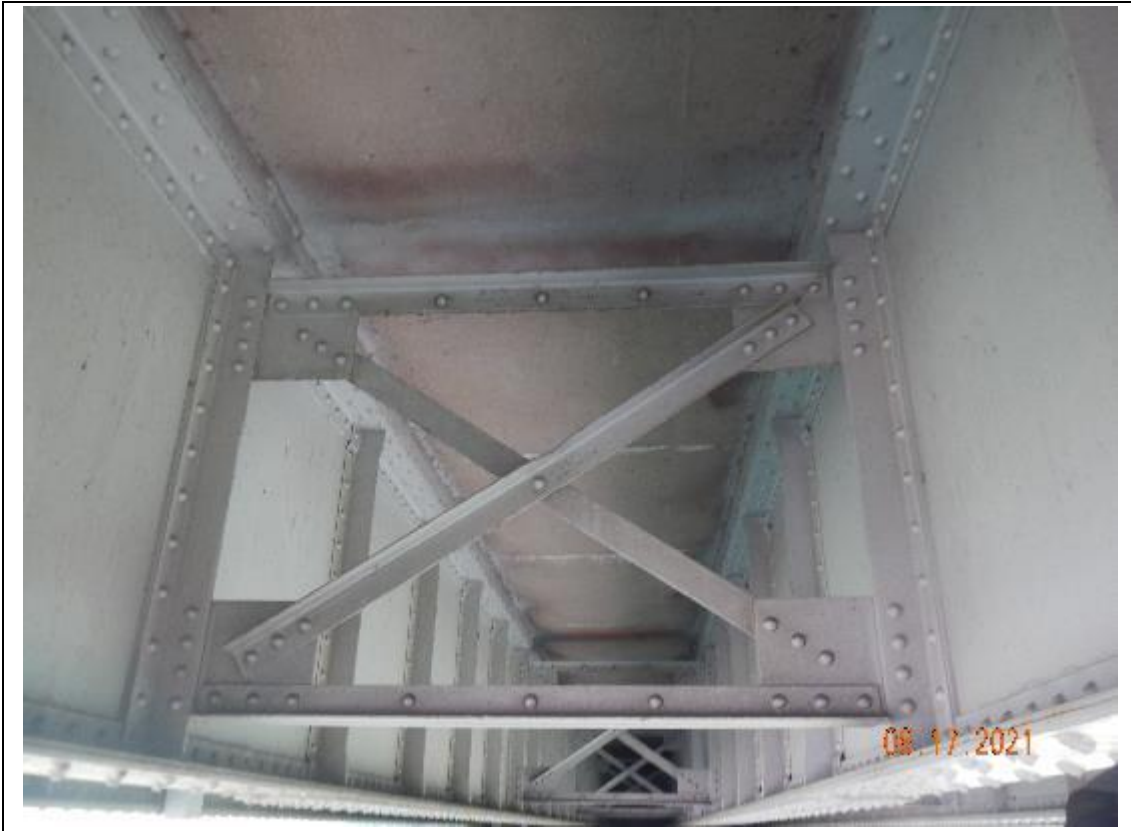
PHOTO 48

39	5	Portal Frame	Between Panel Point 12 & 13	115 LSW	¼" X 6" L Offset Centerline driving lane (Lane 2)	N/A	2001	
40	5	Lateral Bracing	L12W to Mid-Point Floorbeam 13, Full Length	48 LN	40% SL, 3/16" loss in angles, 1- Broken Rivet	N/A	2013	
42	5	L12E-L13E	@ L13E	50 LE	45% SL (See Detail 6)	Repair Zero Force Member	2013	
43	5	U12E-U13E	U13E	51 LSW	Partial crack tack weld 1 each side	N/A	2009	
118	5	Conduit	@ L13E	52 LE	Broken conduit	Repair	2019	
44	5	L13W-U13W	3' from L13W	53 LE	3% SL, 10" X 6 ½" L Area Of Loss Is Plate; 0.382" Avg. Rem., 0.5" Nom.	N/A	2009
