Orangeville Road  
Stephenson County, IL  
Sampling Report

# Orangeville Road; Stephenson Co, IL - Sampling Report Summary

# Sampling and Testing Locations Orangeville Road – Stephenson Co, IL

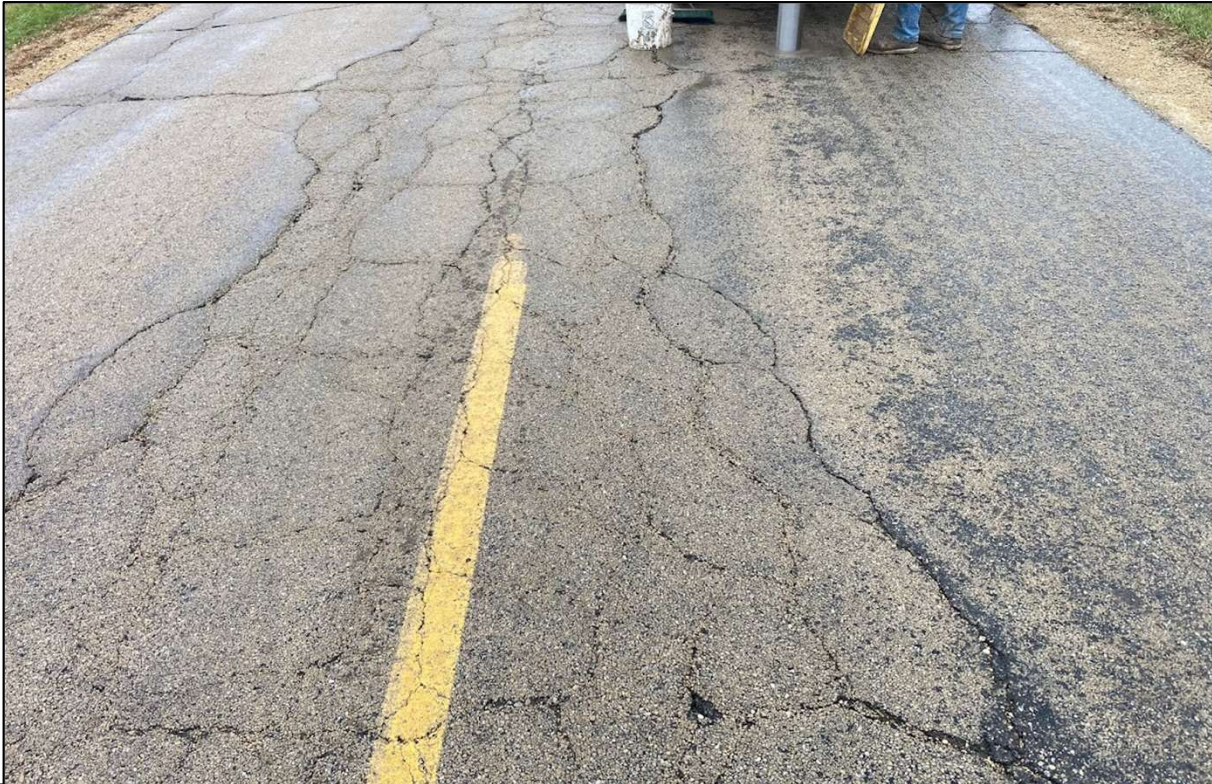
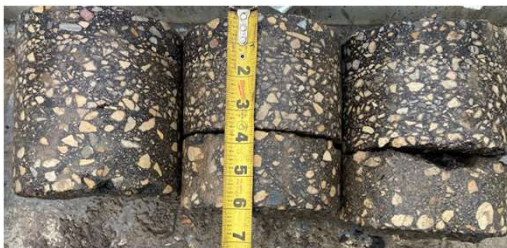
### Location 1: Westbound Lane

- Transverse cracking was observed
- Block cracking was observed
- An average of 6.0 inches of bituminous material was observed at this location
- Debonding in core #2 and 3 was observed at a depth of 3.8 inches
- A crushed aggregate base was observed directly below the bituminous material past a depth of 9.5 inches

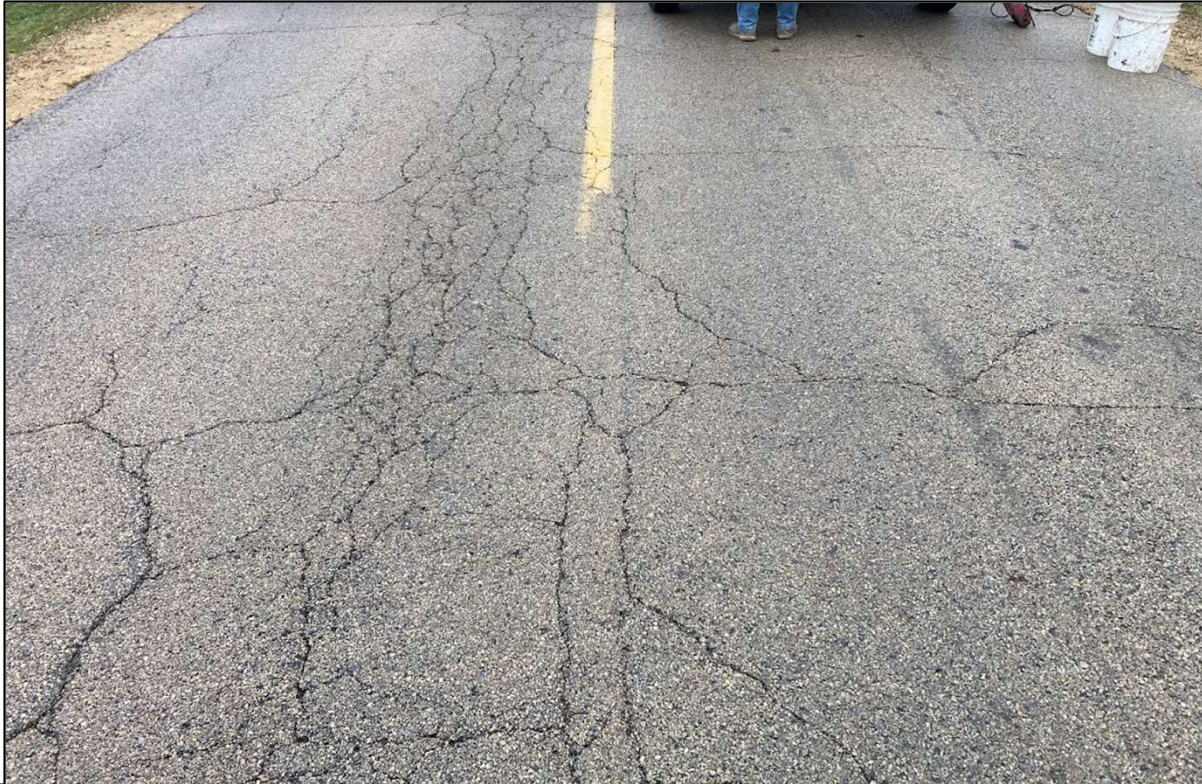
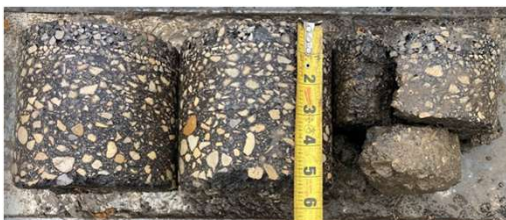
### Location 2: Westbound Lane

- Longitudinal and transverse cracking was observed
- Alligator cracking was observed
- An average of 5.5 inches of bituminous material was observed at this location
- Full depth cracking was observed in core #3
- A crushed aggregate base was observed directly below the bituminous material past a depth of 8.5 inches

- Per conversations with Stephenson County, a 4.0-inch CIR is planned for Orangeville Road. Full-depth cracking and stripping similar to that observed at locations #2, 4, 11, 12, 13, 14, and 16 cannot be addressed with a 4.0-inch CIR treatment.

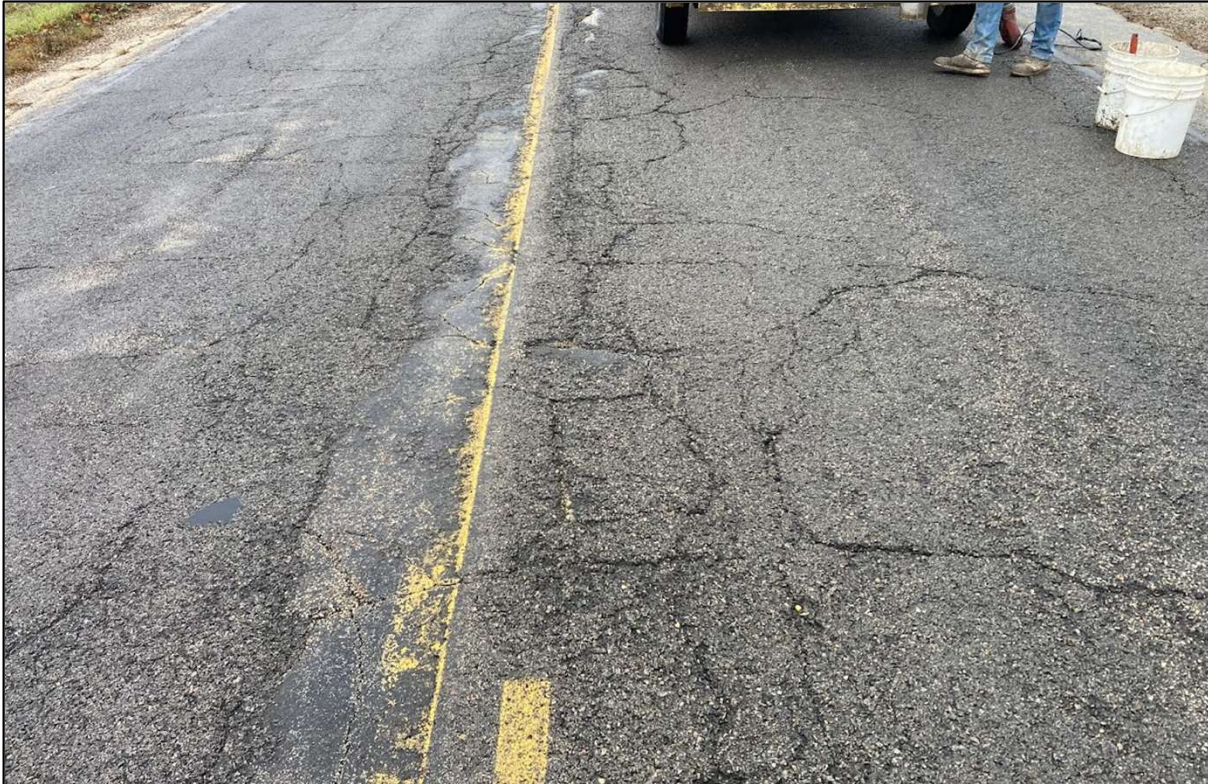
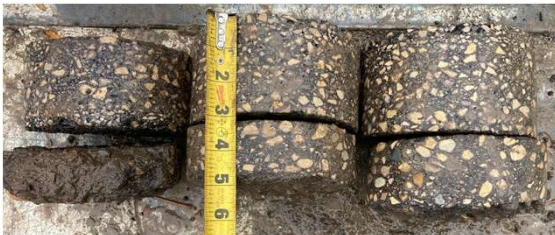
### Location 3: Westbound Lane

- Alligator cracking was observed
- An average of 5.1 inches of bituminous material was observed at this location
- Debonding was observed at depth of 3.0 inches
- A crushed aggregate base was observed directly below the bituminous material past a depth of 7.5 inches

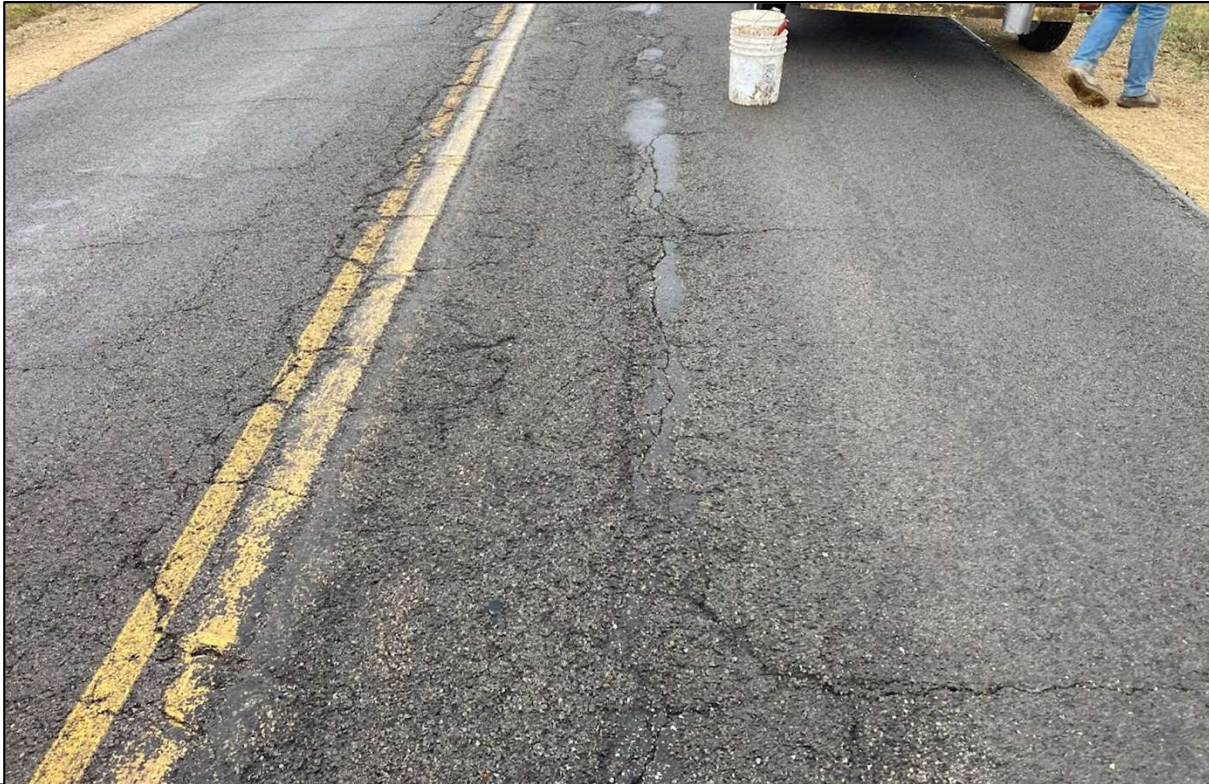
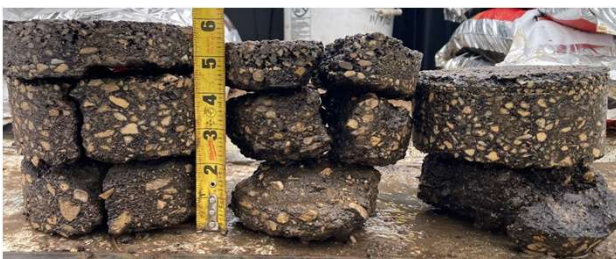
### Location 4: Westbound Lane

- Longitudinal and transverse cracking was observed
- An average of 5.1 inches of bituminous material was observed at this location
- Full depth samples unable to be extracted intact due to stripping was observed
- Full depth cracking was observed in cores #1 and 2
- A crushed aggregate base was observed below the bituminous material past a depth of 8.3 inches

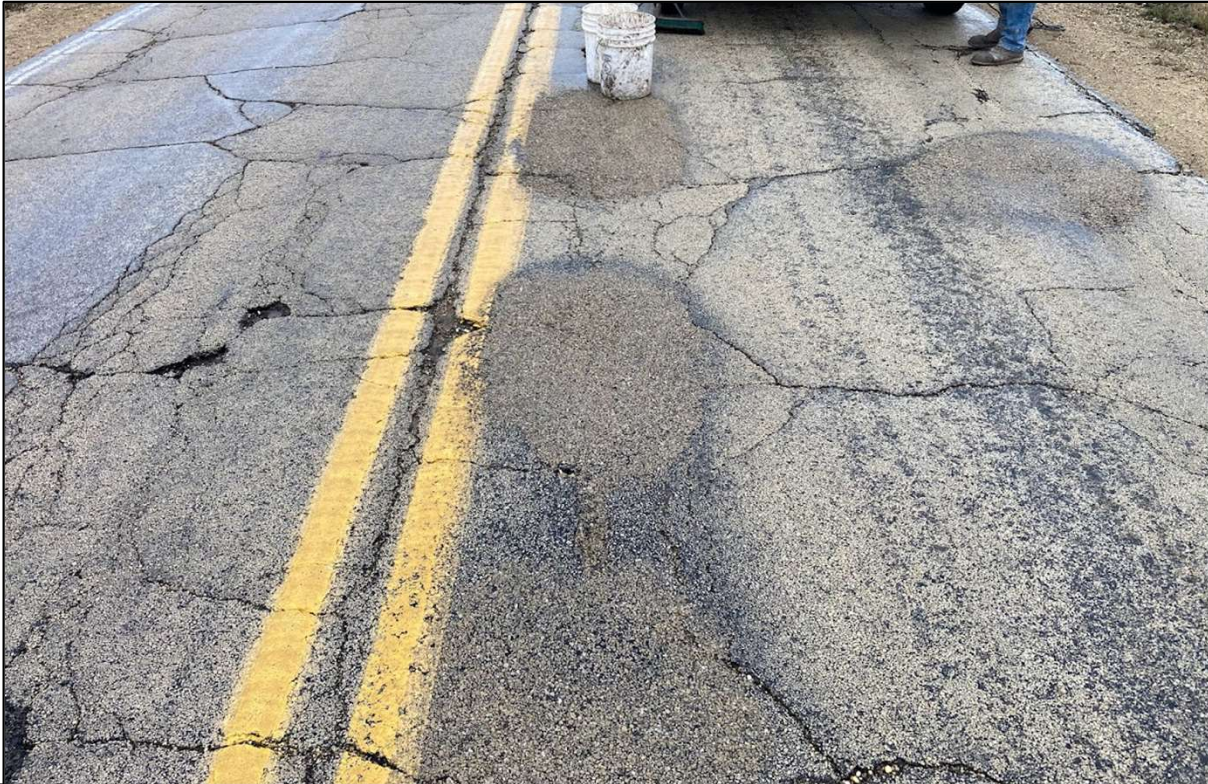
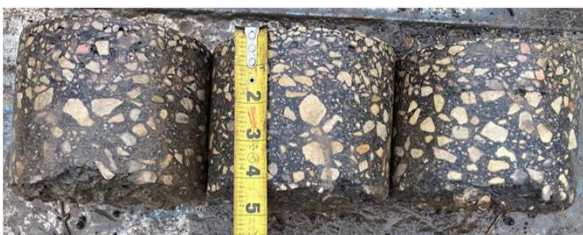
### Location 5: Northbound Lane

- Longitudinal and transverse cracking was observed
- Loss of surface material was observed
- Loss of edge material was observed
- An average of 4.5 inches of bituminous material was observed at this location
- A crushed aggregate base was observed below the bituminous material past a depth of 8.3 inches

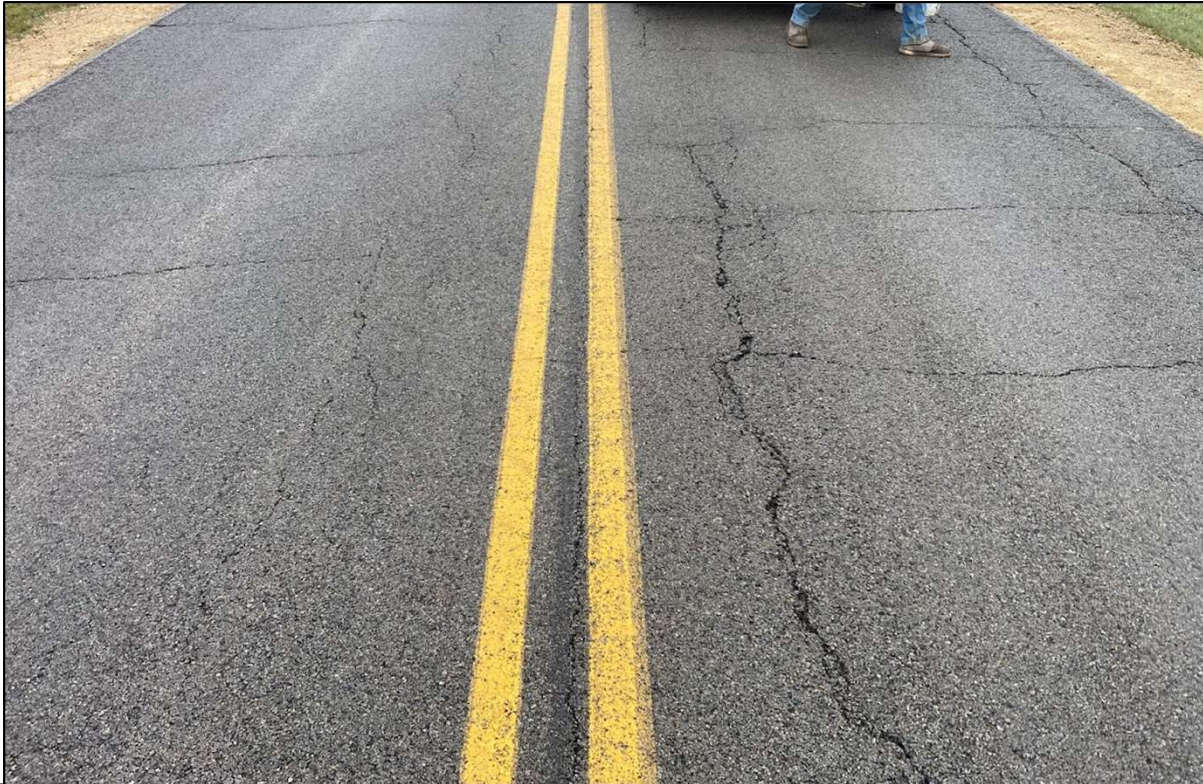
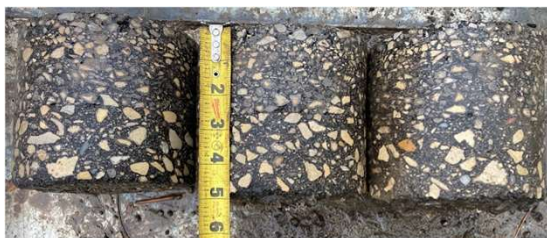
### Location 6: Northbound Lane

- Longitudinal and transverse cracking was observed
- An average of 4.9 inches bituminous material was observed at this location
- A crushed aggregate base was observed directly below the bituminous material past a depth of 8.5 inches

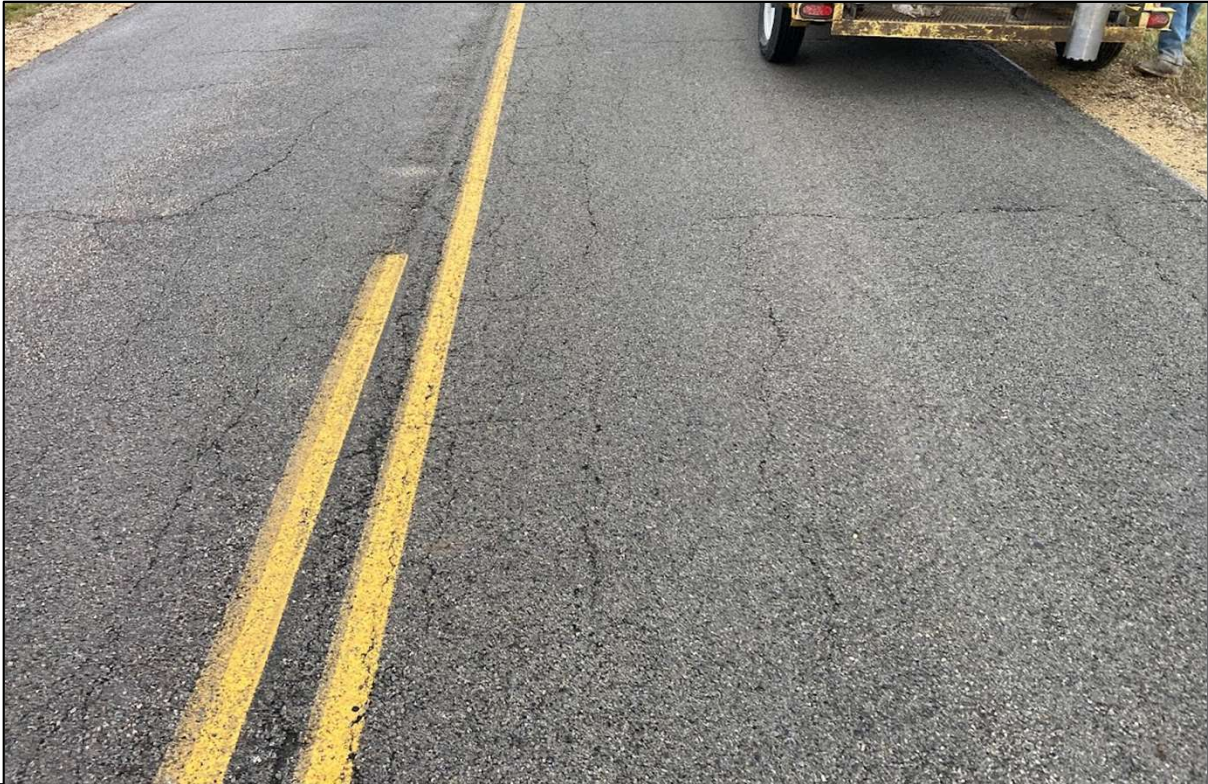
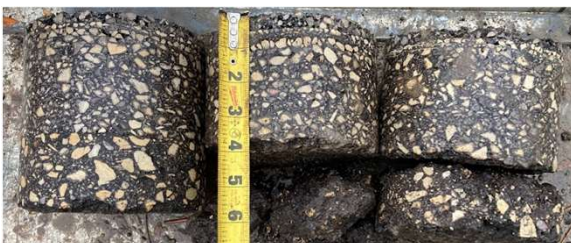
### Location 7: Eastbound Lane

- Longitudinal and transverse cracking was observed
- A total of 6.0 inches of bituminous material was observed at this location
- Bottom-up cracking was observed to a depth of 4.0 inches in cores #2 and 3
- A crushed aggregate base was observed below the bituminous material past a depth of 9.5 inches

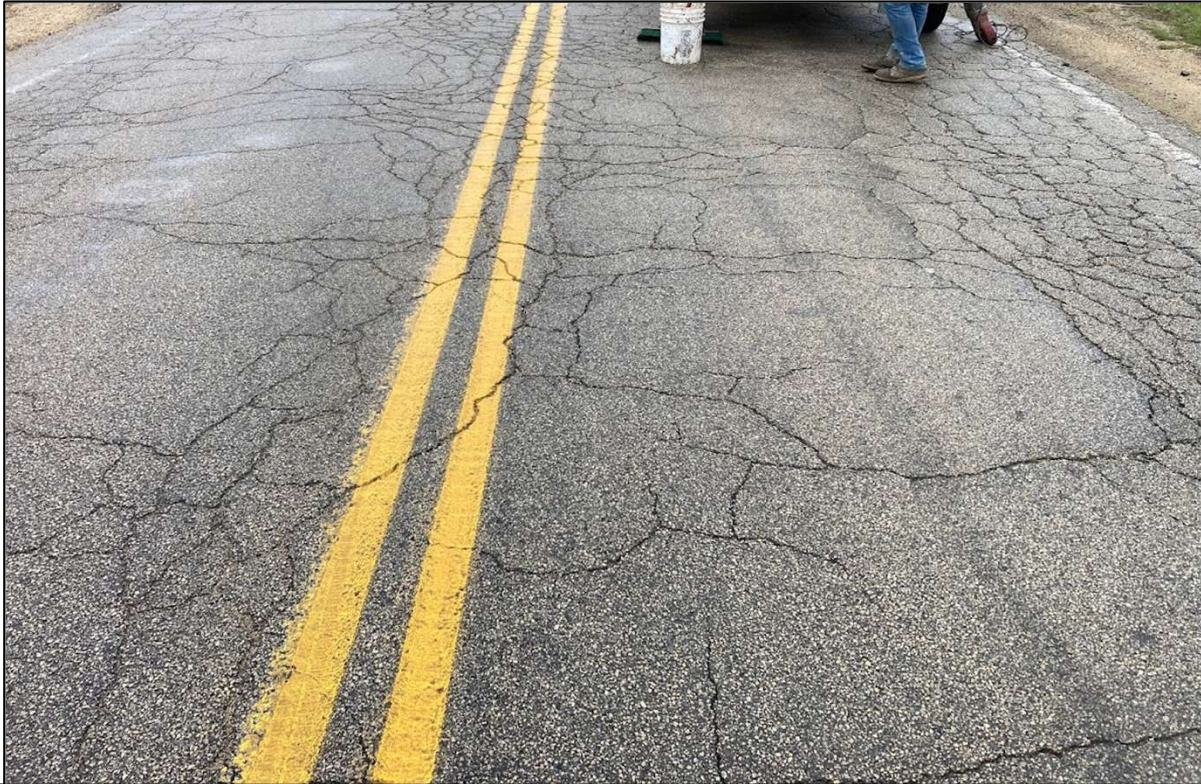
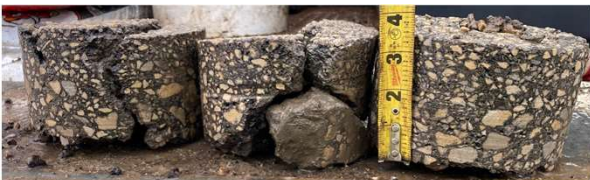
### Location 8: Eastbound Lane

- Alligator cracking was observed
- A total of 3.5 inches of bituminous material was observed at this location
- Full depth cracking was observed in core #1 and 2
- A crushed aggregate base was observed directly below the bituminous material past a depth of 7.0 inches

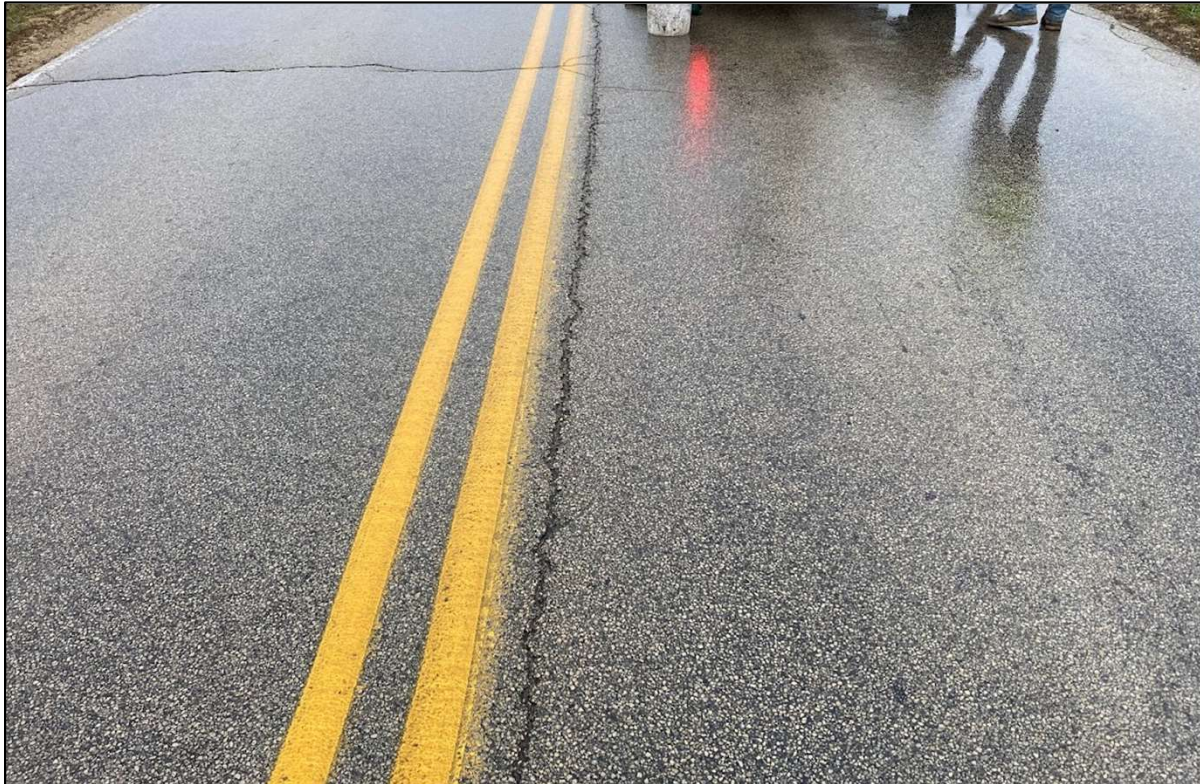
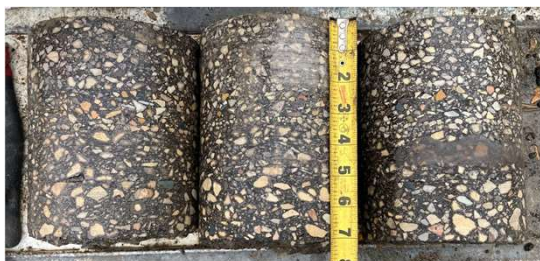
### Location 9: Eastbound Lane

- Longitudinal and transverse cracking was observed
- A total of 7.0 inches of bituminous material was observed at this location
- A crushed aggregate base was observed directly below the bituminous material past a depth of 9.8 inches

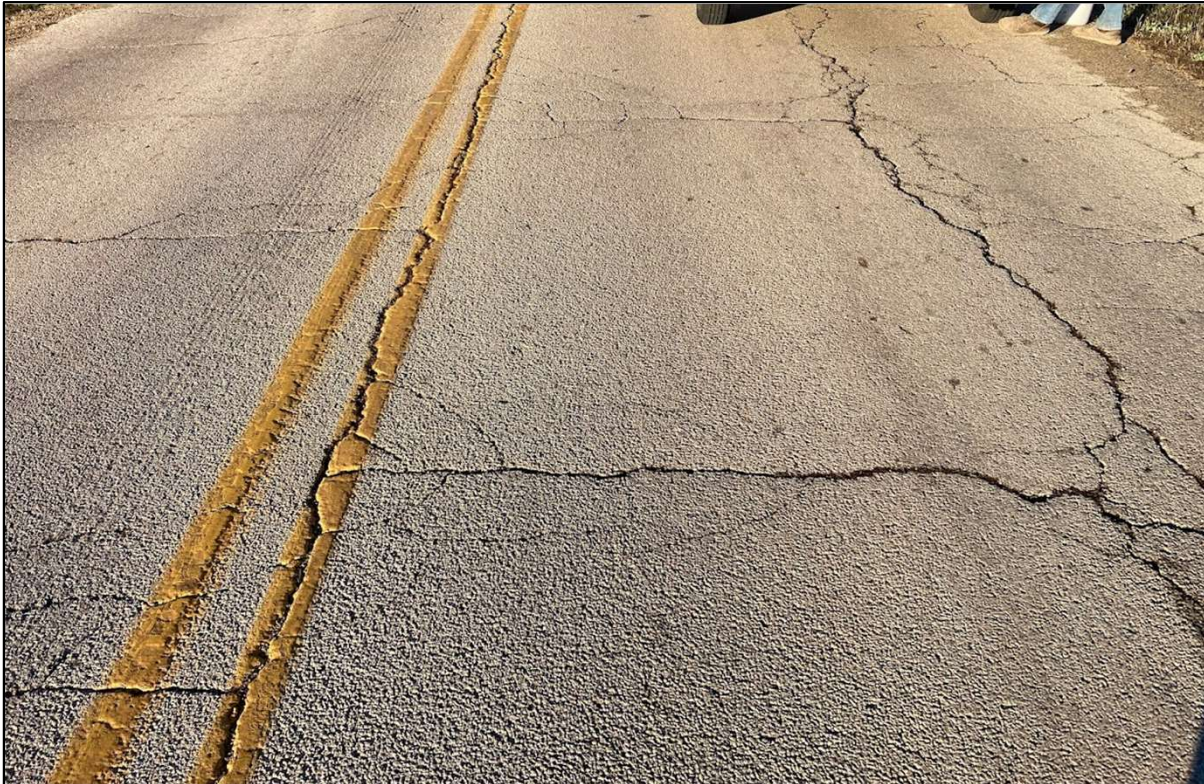
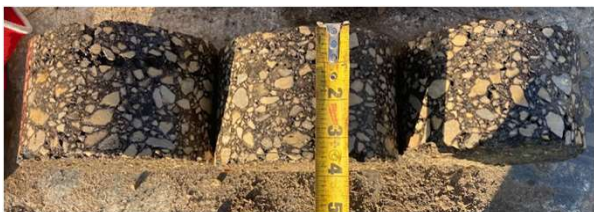
### Location 10: Eastbound Lane

- Longitudinal and transverse cracking was observed
- A total of 3.5 inches of bituminous material was observed at this location
- Top-down cracking was observed to a depth of 1.0 inches
- A crushed aggregate base was observed below the bituminous material past a depth of 7.0 inches

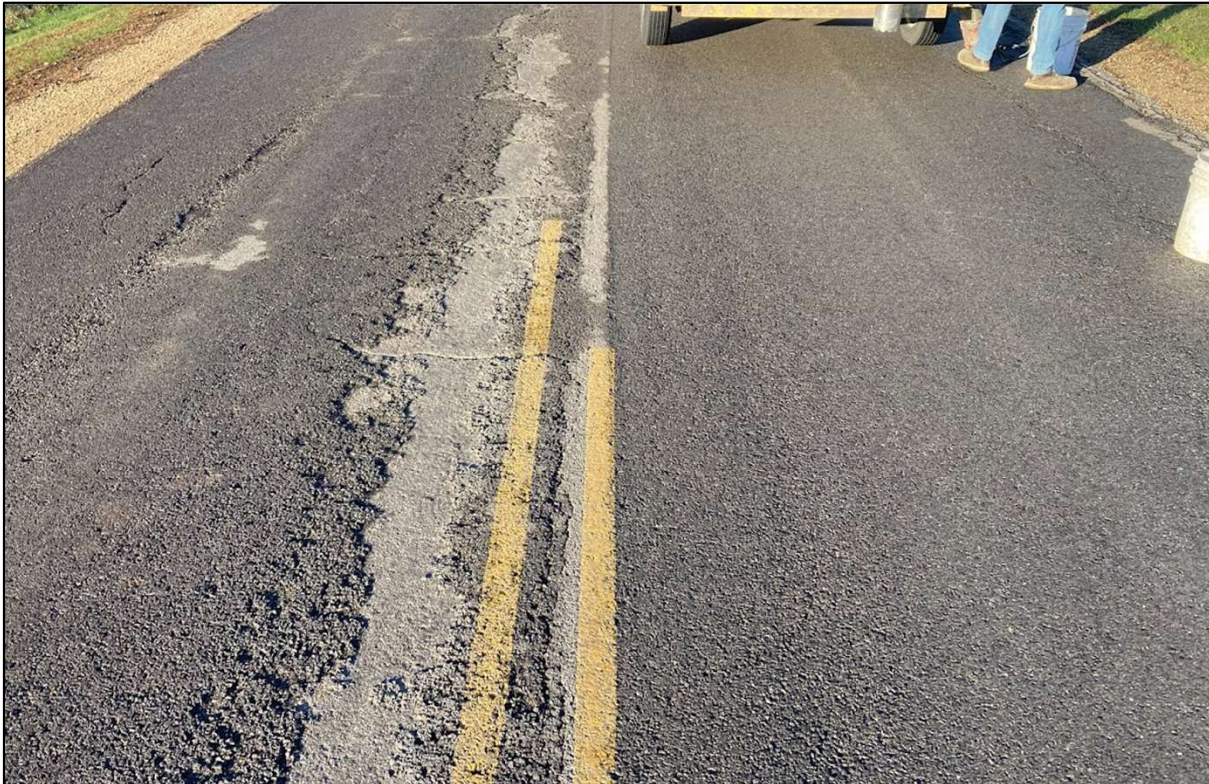
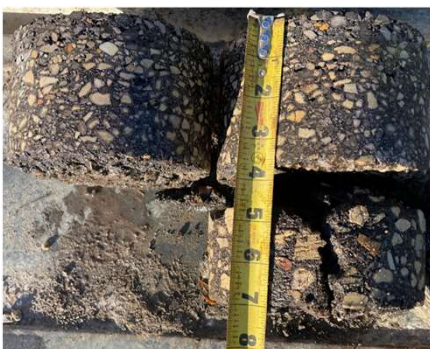
### Location 11: Eastbound Lane

- Loss of surface material was observed in the westbound lane
- A total of 6.8 inches of bituminous material was observed at this location
- Stripping and cracking was observed below 4.0 inches in the cores
- A crushed aggregate base was observed directly below the bituminous material past a depth of 10.0 inches

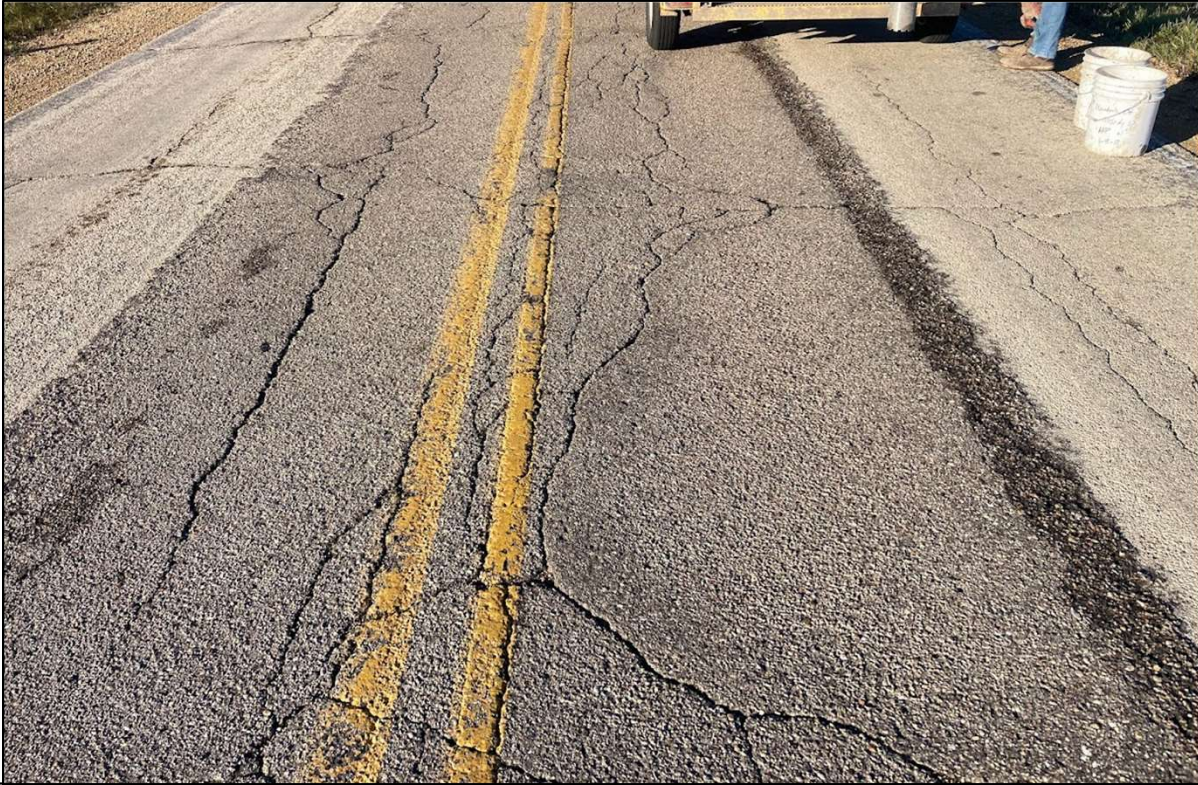
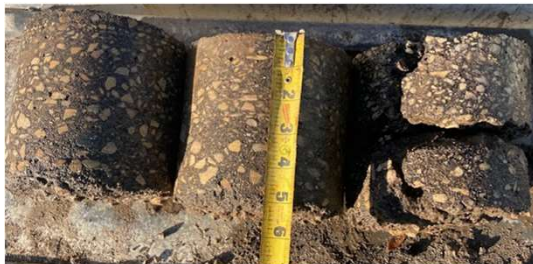
### Location 12: Eastbound Lane

- Longitudinal and transverse cracking was observed
- An average of 6.0 inches of bituminous material was observed at this location
- Full depth samples unable to be extracted intact
- Full depth cracking was observed in core #3
- A crushed aggregate was observed directly below the bituminous material past a depth of 8.5 inches

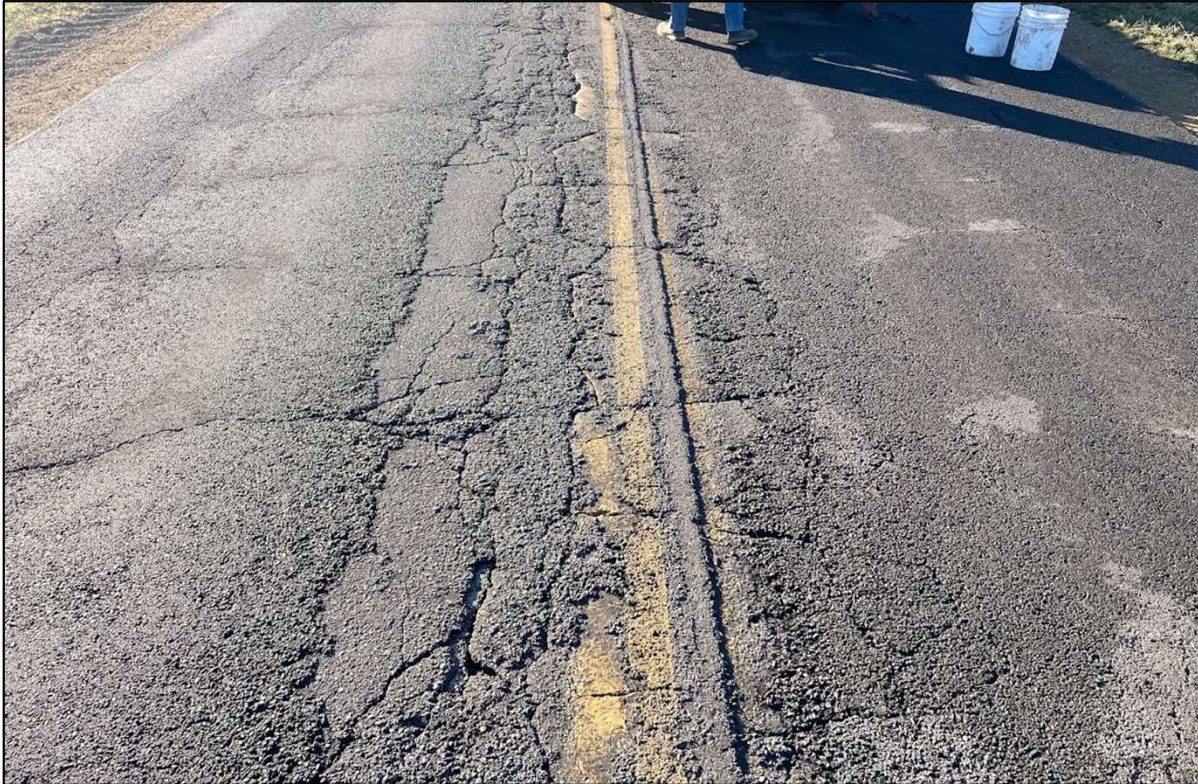
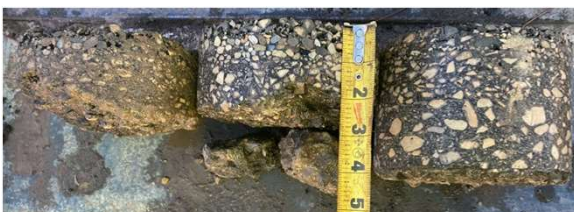
### Location 13: Southbound Lane

- Alligator cracking was observed
- An average of 4.0 inches of bituminous material was observed at this location
- Full depth samples unable to be extracted intact due to stripping past a depth of 2.0 inches in core #1 and 2
- A crushed aggregate was observed directly below the bituminous material past a depth of 8.0 inches

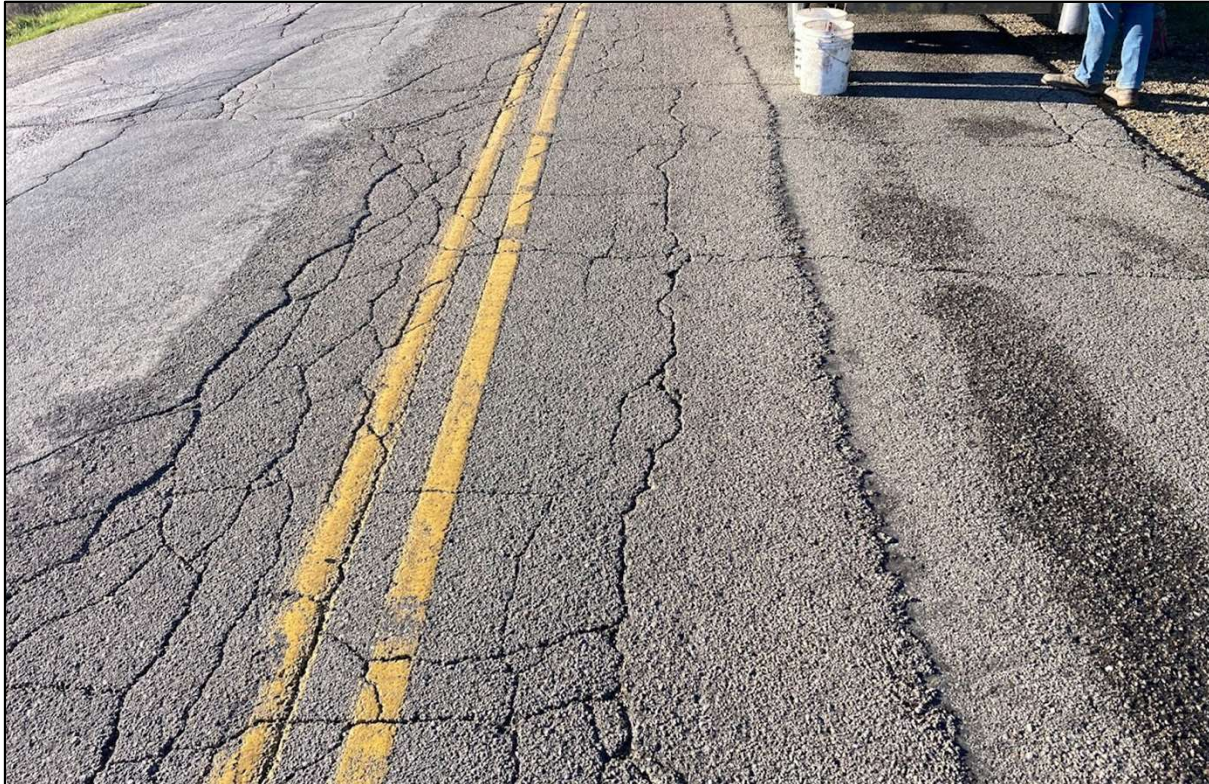
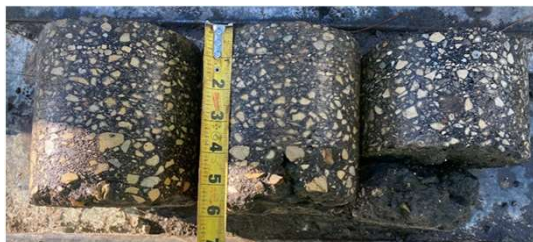
### Location 14: Southbound Lane

- Longitudinal and transverse cracking was observed
- Alligator cracking was observed
- An average of 6.0 inches of bituminous material was observed at this location
- Stripping was observed at a depth of 4.0 inches in core #3
- Bottom-up cracking was observed in core #2
- A crushed aggregate was observed directly below the bituminous material past a depth of 9.0 inches

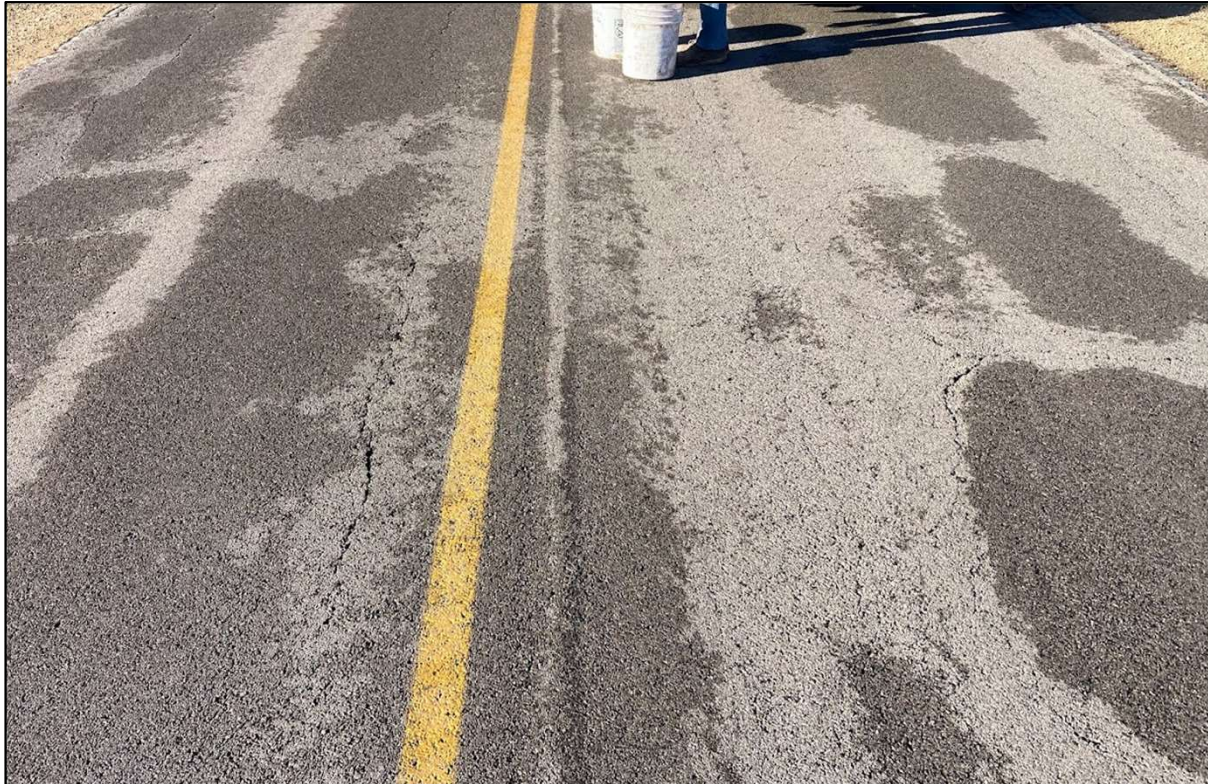
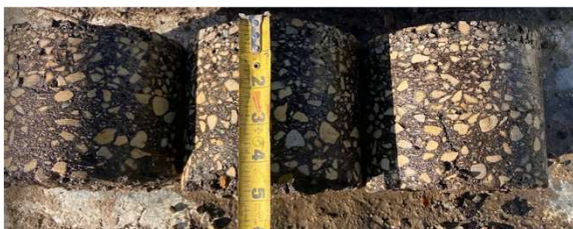
### Location 15: Eastbound Lane

- Longitudinal and transverse cracking was observed
- An average of 4.8 inches of bituminous material was observed at this location
- Bottom-up cracking was observed in core #3
- A crushed aggregate was observed directly below the bituminous material past a depth of 8.3 inches

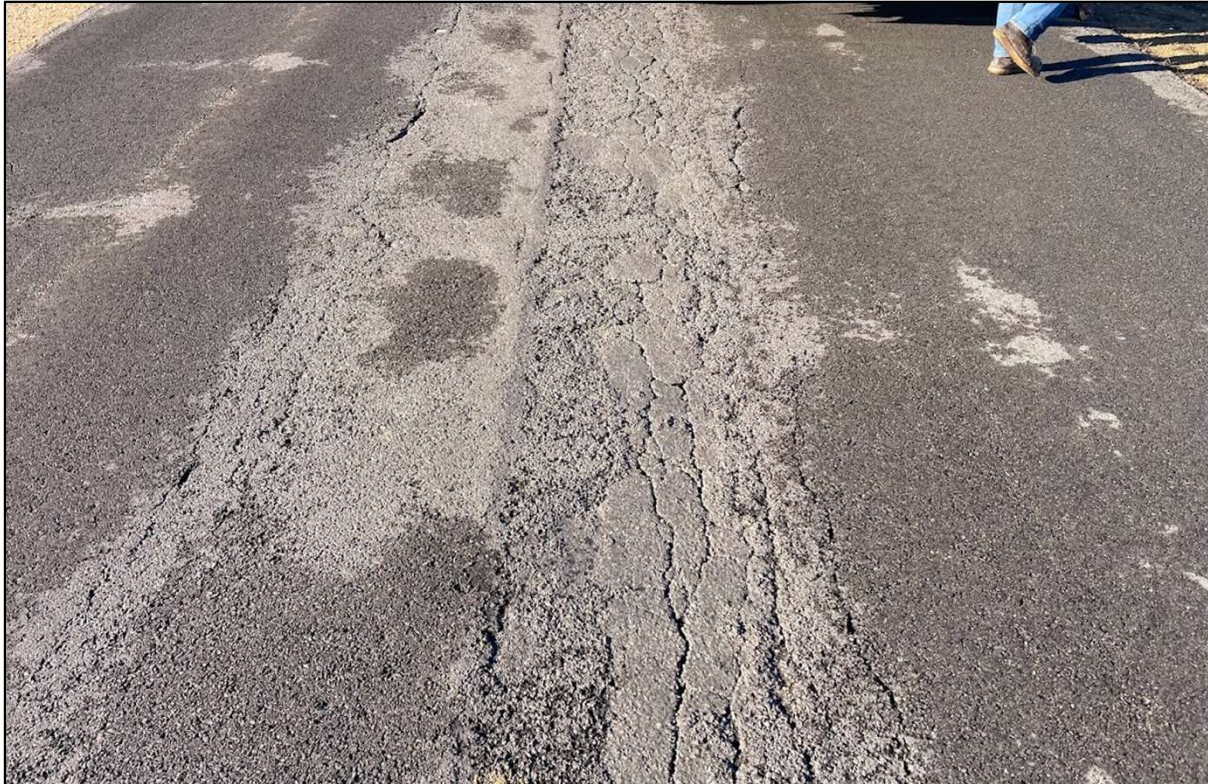
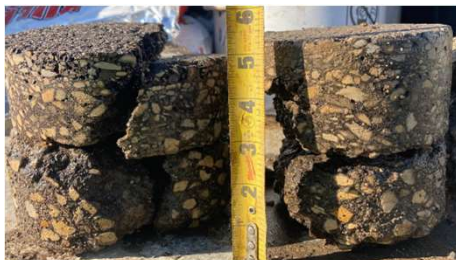
### Location 16: Eastbound Lane

- Alligator cracking was observed
- An average of 5.6 inches of bituminous material was observed at this location
- Full depth cracking was observed
- A crushed aggregate was observed directly below the bituminous material past a depth of 9.8 inches
