## BUILDING REMOVAL WITH ASBESTOS ABATEMENT (BDE)

**ACM SURVEY RESULTS - Parcel No. 8810023**  
**Single-family Residence**  
**2010 S. Main Street**  
**Dupo, Illinois**

RE: Asbestos Survey Activities  
Dupo Interchange Phase 2 Engineering  
2014 S. Main Street (White Residence)  
Dupo, Illinois  
SCI No. 2005-3284.25

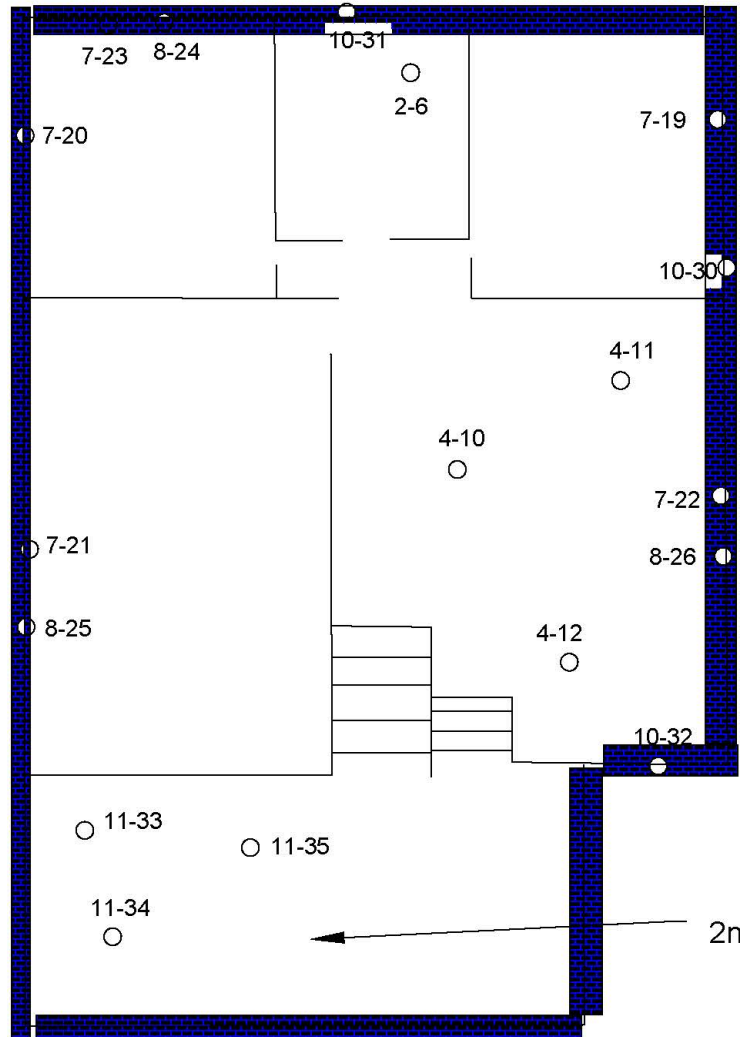
**1st and 2nd Floor Layout Map (not to scale) ↑N**

10-30 10-31 10-32	POS
Transite Exterior

11-33 11-34 11-35	<1%
Black Mastic

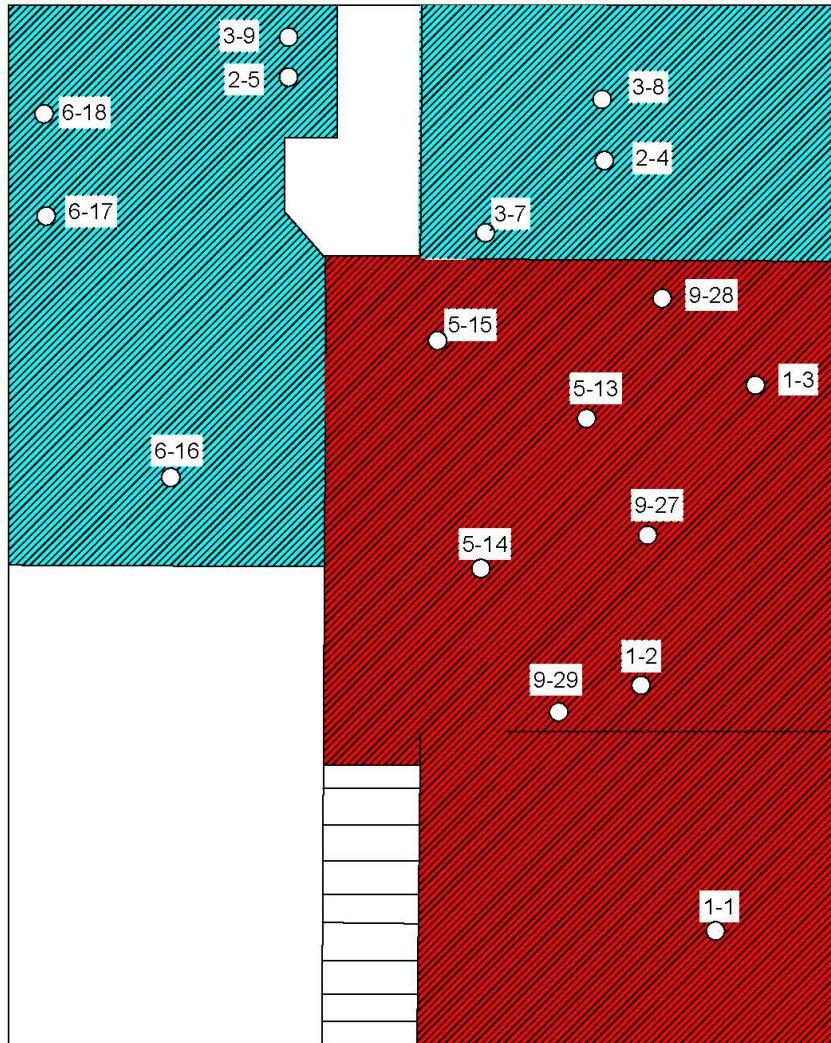
**Basement Layout Map (not to scale)**

1-1 1-2 1-3 9" x 9" Green Floor Tile and Mastic	POS	5-13 5-14 5-15 3' x 4' Ceiling Tile	ND
2-4 2-5 12" x 12" Stick on Tile Layer	ND	6-16 6-17 6-18 2' x 4' Lay In Ceiling Tile	ND
3-7 3-8 3-9 12" x 12" Beige Floor Tile and Mastic	POS	9-27 9-28 9-29 Black Wire Cover	ND

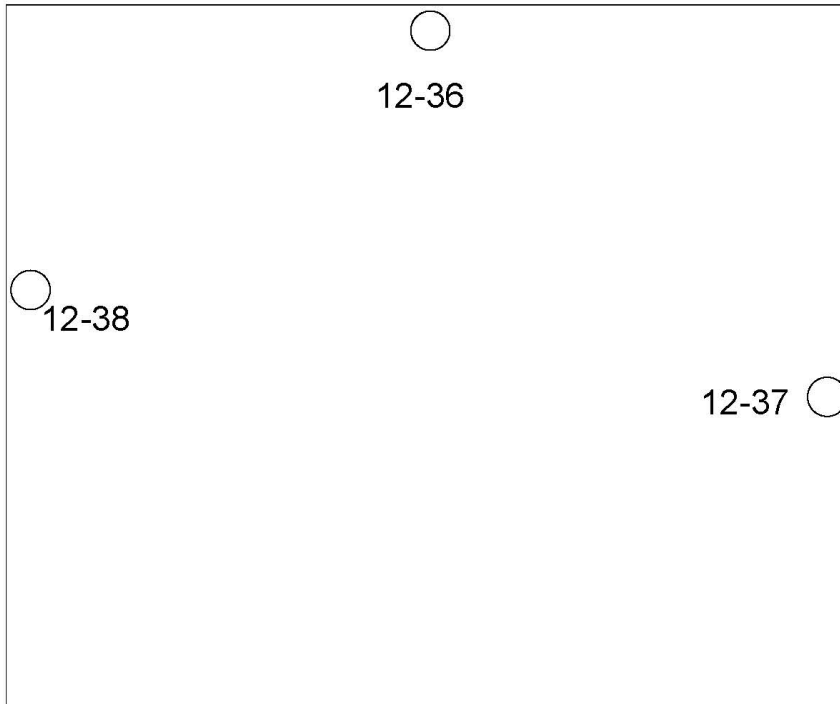
**Roof Layout Map (not to scale)**

12-36 12-37 12-38	ND
Roofing Shingles

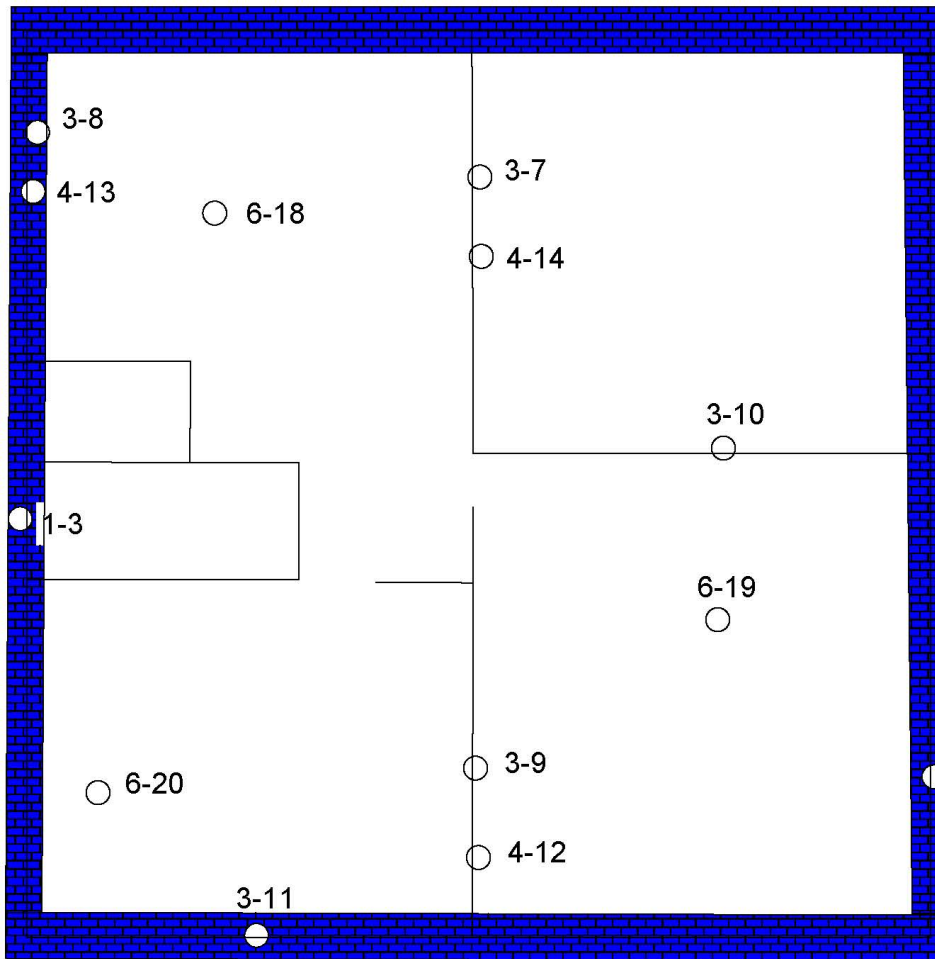
1-2 1-3	POS
Transite Siding

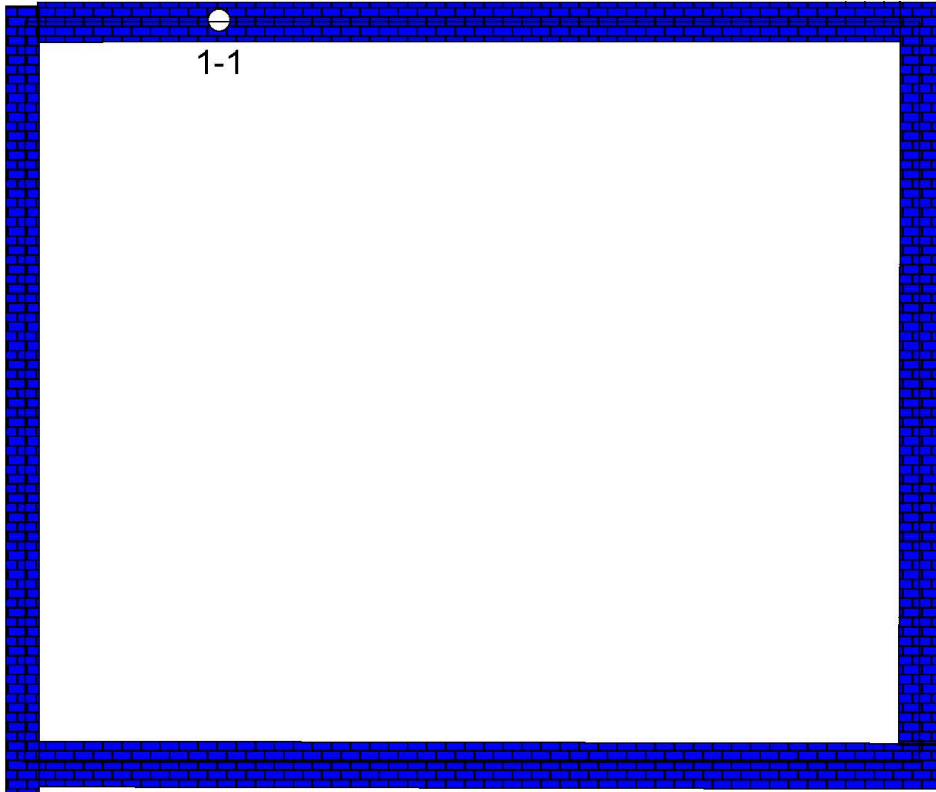
1-1	POS
Transite Siding

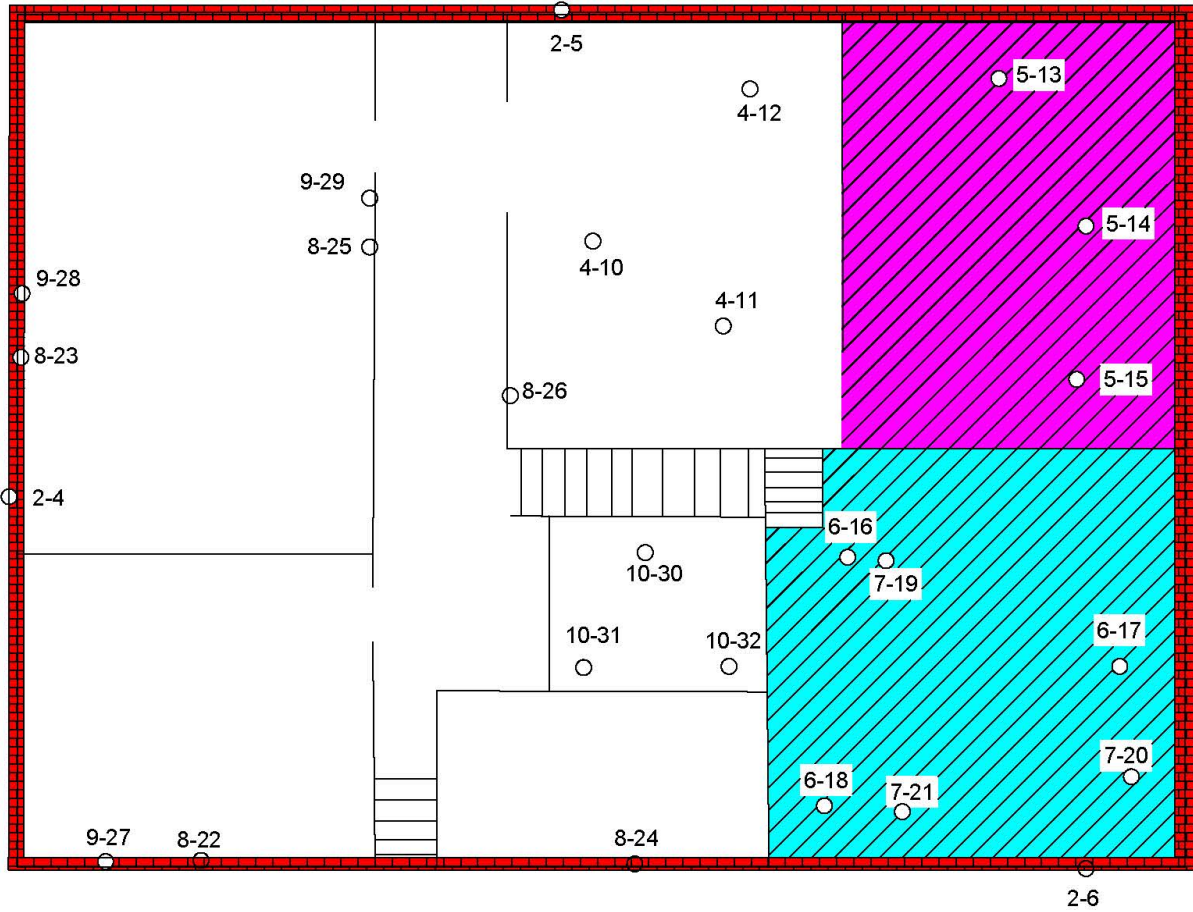
**1st Floor Layout Map (not to scale)**

Legend	
ND	Non Detect
POS	Positive
	Transite Siding
	9" x 9" Tan and Red Floor Tile
	12" x 12" Brown Floor Tile

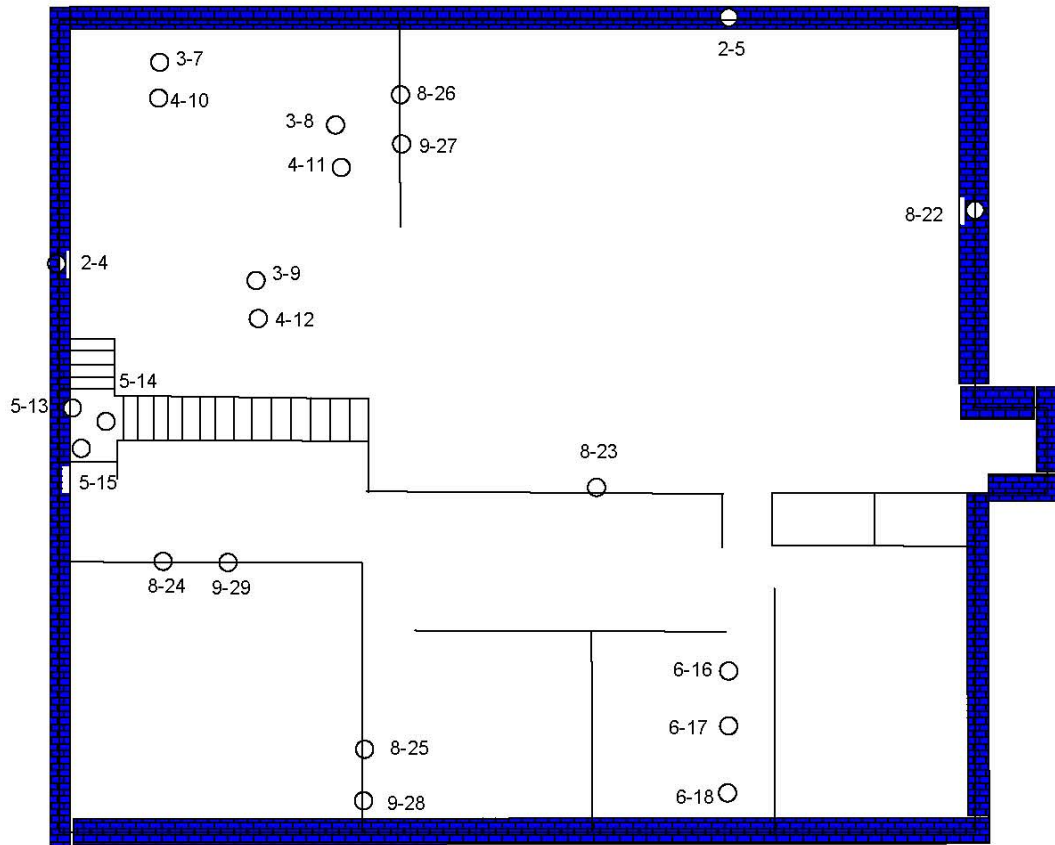
2-4 2-5	POS
Transite Siding

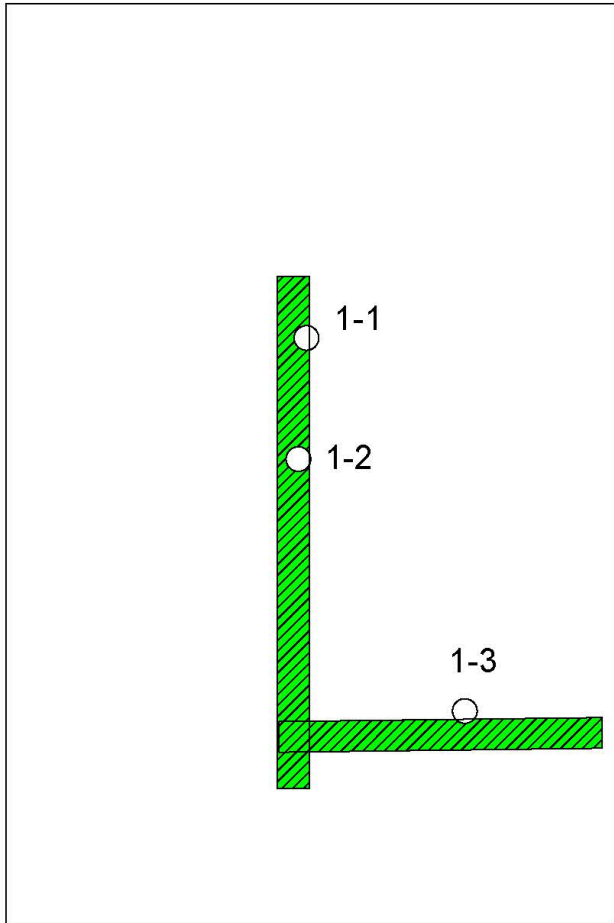
**Basement Layout Map (not to scale)**

1-1	1-2	1-3	POS
Duct Seam Cover

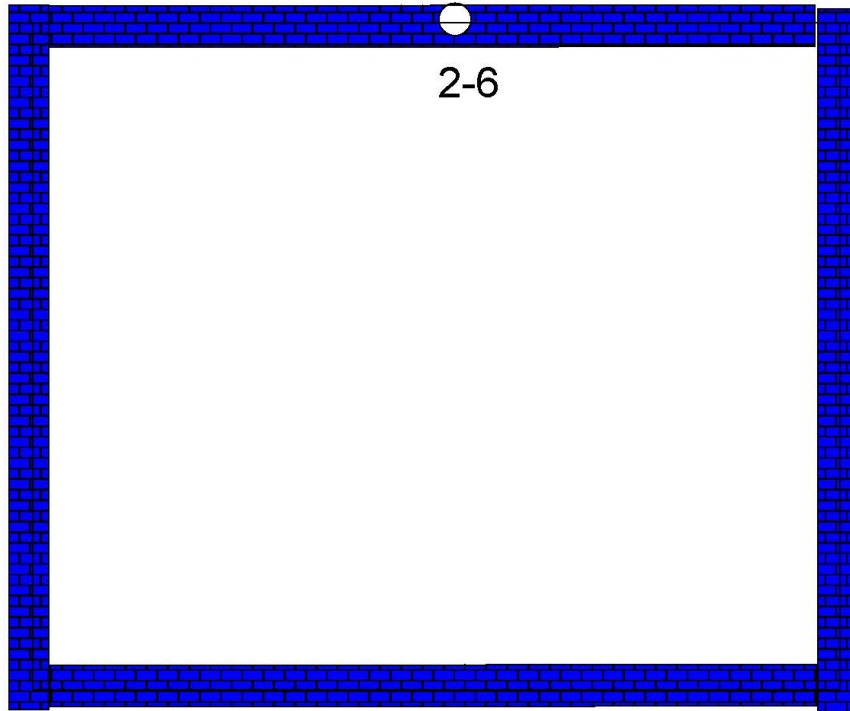
2-6	POS
Transite Siding

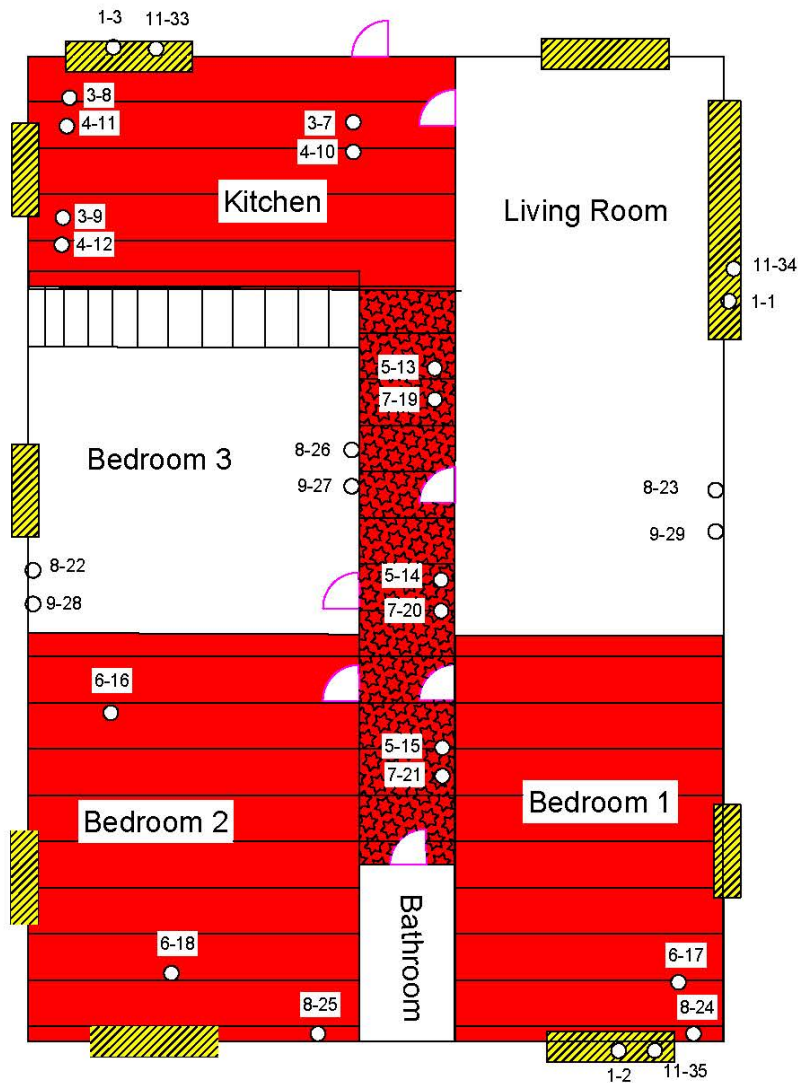
1-1 1-2 1-3	POS
Window Glazing
