Asbestos Abatement Survey

NEQ & SWQ of Ohio Street Feeder @ Chicago River

Chicago, Cook County, Illinois

August 11, 2023

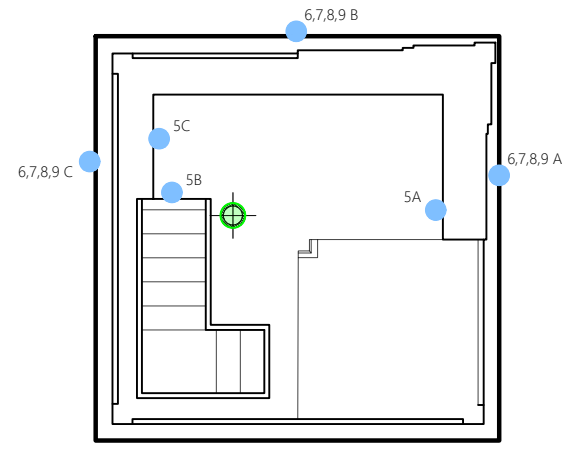
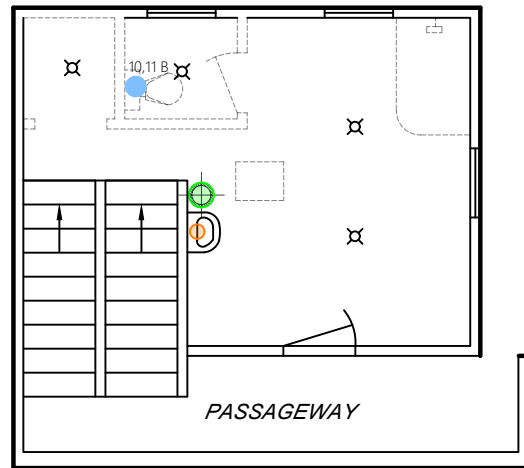
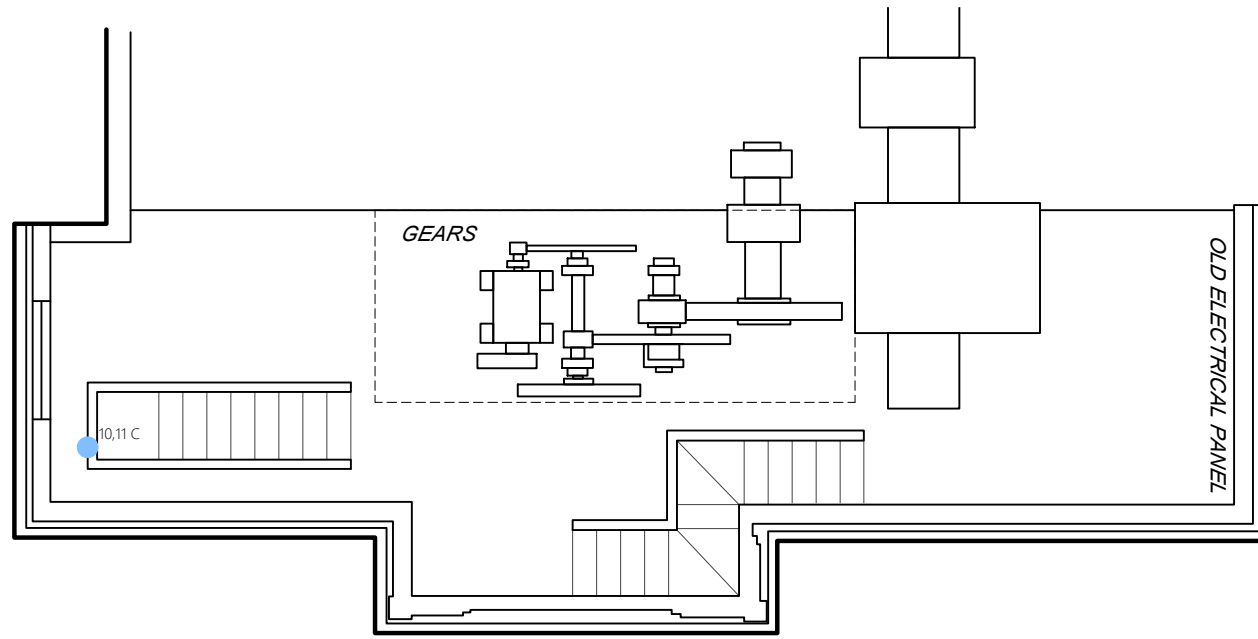
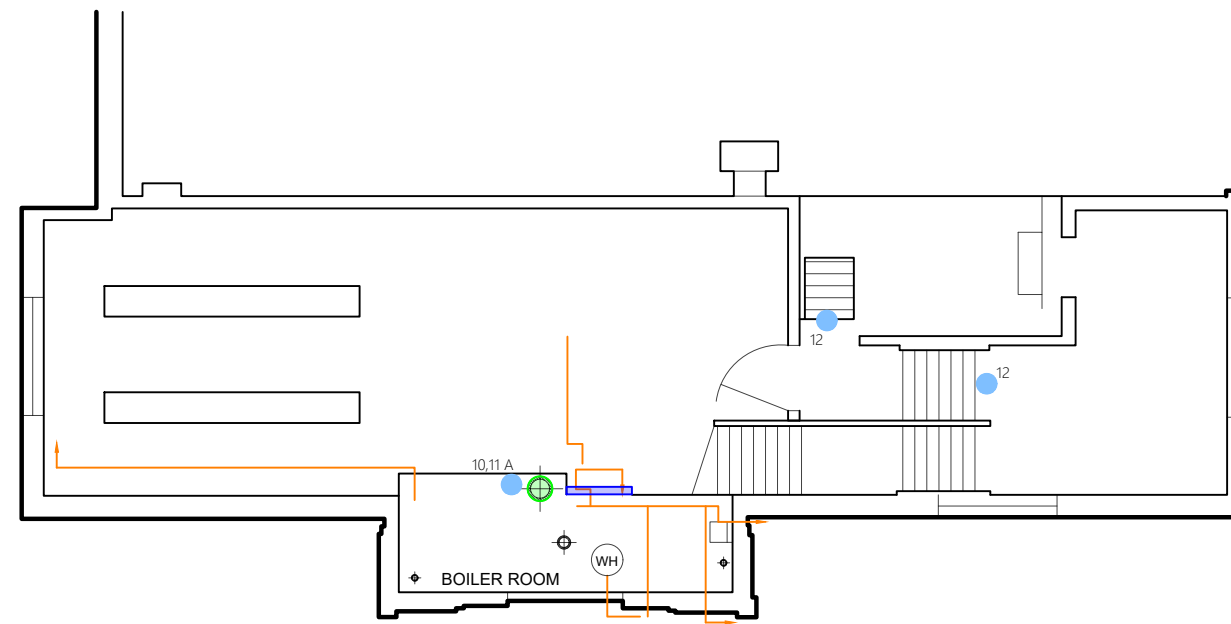
TENDER HOUSE FLOOR PLANS & ASBESTOS CONTAINING MATERIAL LOCATIONS

- LEGEND**
- ASBESTOS SAMPLE
 - WH WATER HEATER
 - HA-10: ACM AIR CELL PIPE INSULATION AND ASSOCIATED HA-11: NON-ACM FITTINGS
 - HA-12: FIRE DOOR (ASSUMED ACM)
 - HA-13: TRANSITE FLUE/VENT (ASSUMED ACM)

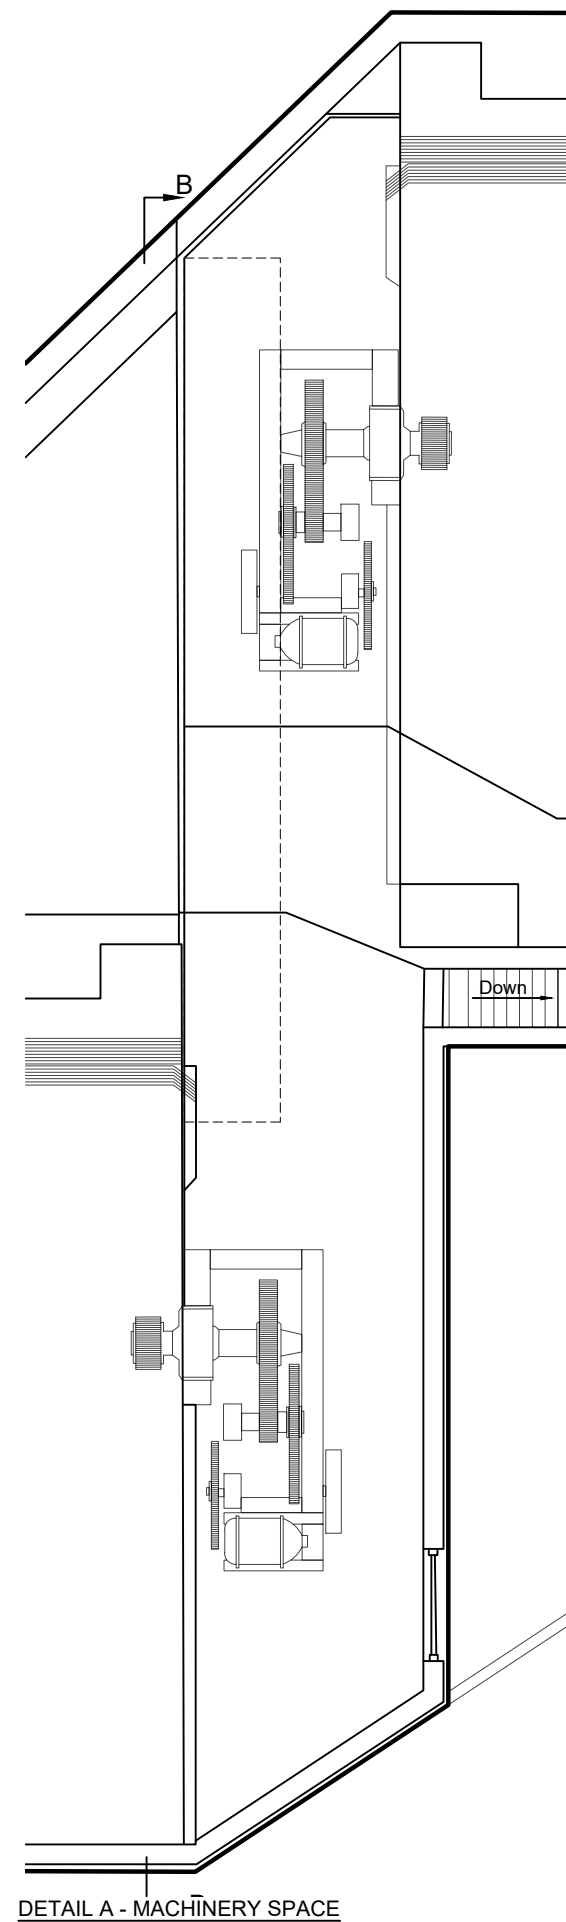
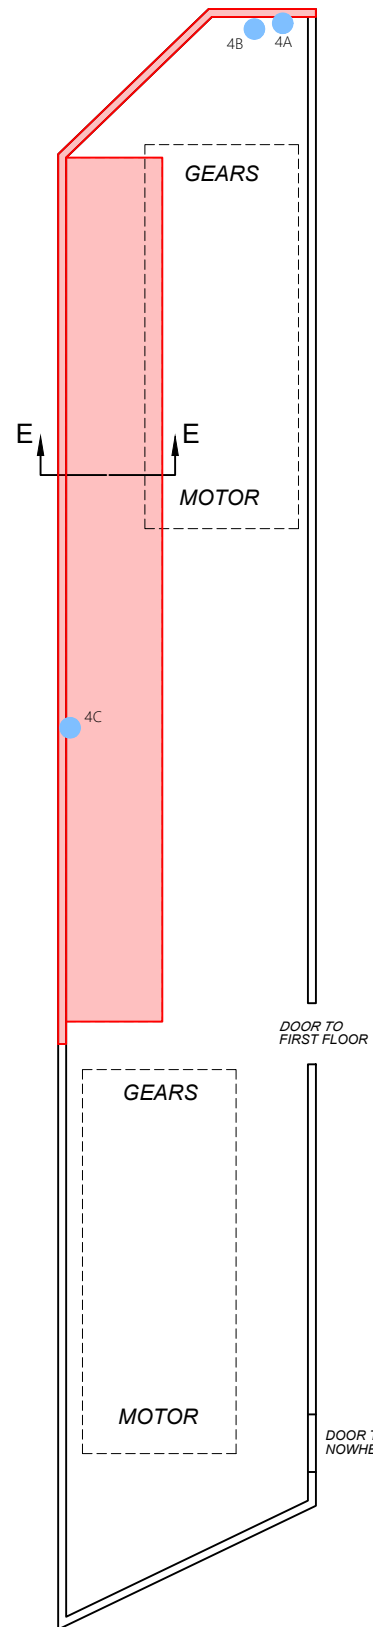
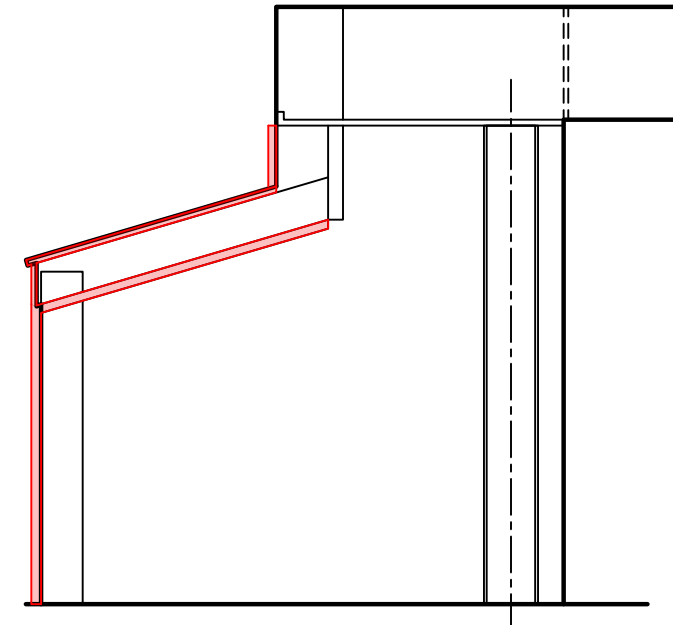
**TENDER HOUSE DETAIL
 ASBESTOS CONTAINING MATERIAL
 LOCATIONS**

- ASBESTOS SAMPLE
- HA-4: ACM TRANSITE PANELING

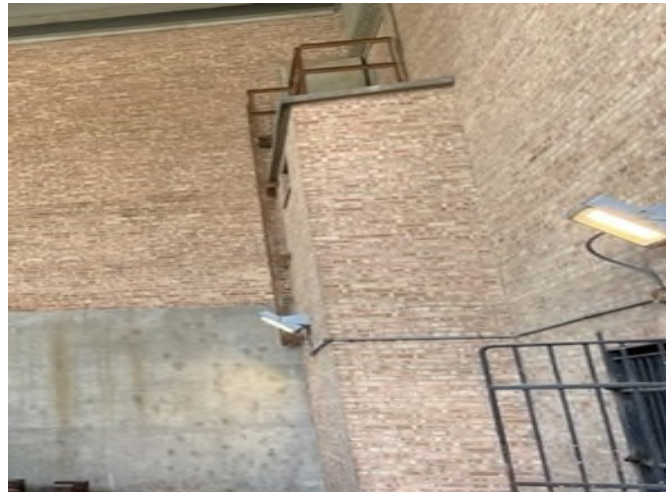
**HA-1: Red Exterior Brick
HA-2: Gray Mortar**

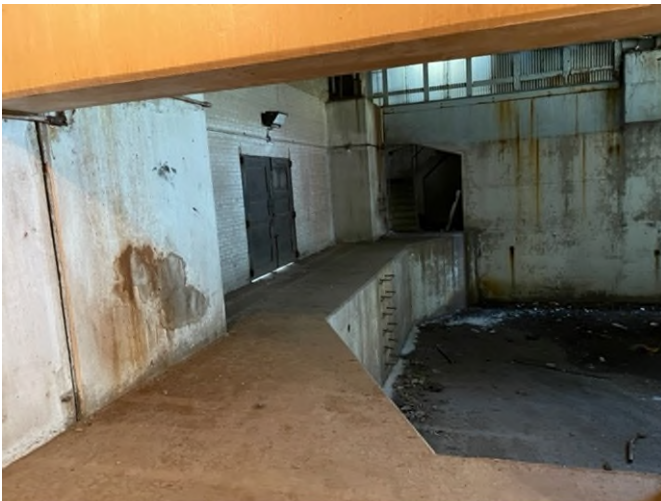
HA-3: Gray Concrete Foundation and Walls

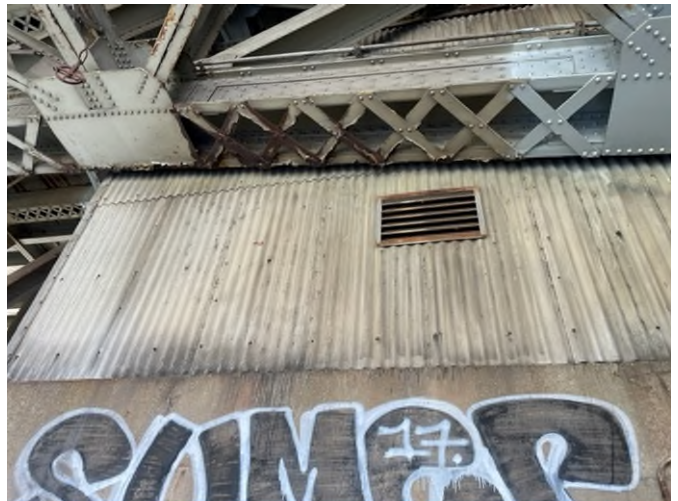
- HA-4: White Transite Panels on the east side of the southwest bridge tender house and the west side of the northeast bridge tender house.
- HA-10: White Air Cell Pipe Insulation in the bathrooms, boiler rooms and stairwells.

10	White Air Cell Pipe Insulation	Bathrooms (4LF), Boiler Rooms (130LF), Stairwells (80 LF)	10A, 10B, 10C	Good	Friable	Chrysotile 10 - 15%	214	LF	Samples were collected from the southwest bridge tender house but quantities include both houses.

HA-4: White Transite Panels

ACMs identified at the site that may be disturbed during demolition activities, must be removed by a licensed asbestos abatement contractor utilizing industry standard work procedures in accordance with all federal, state, and local regulations governing asbestos.

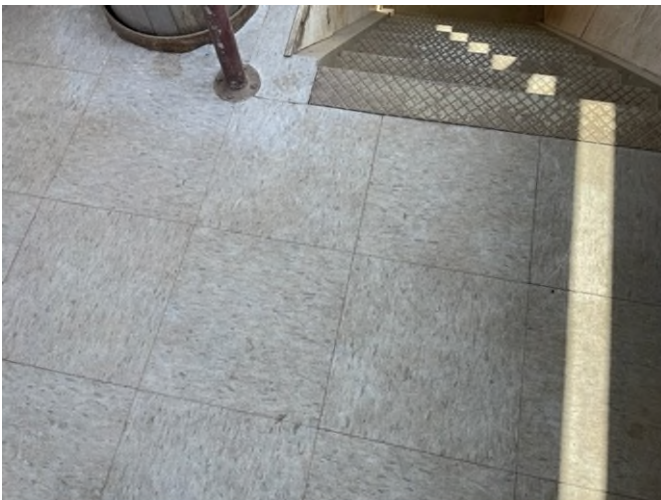
**HA-5: Gray 12 x 12 Floor Tile
HA-6: Yellow Floor Tile Mastic**

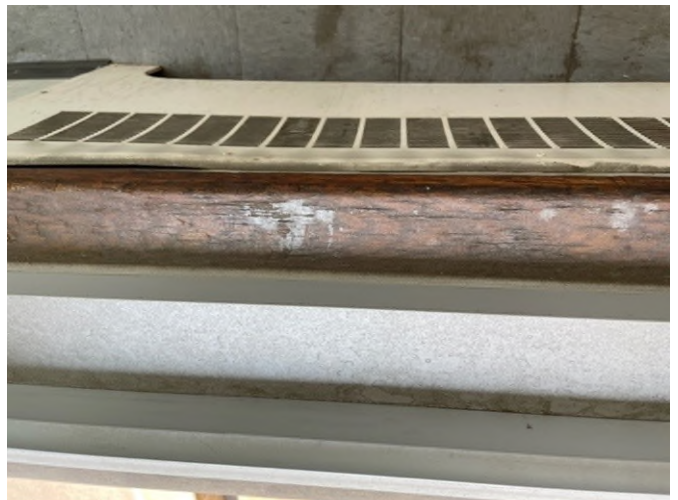
HA-7: White Window Frame Caulk

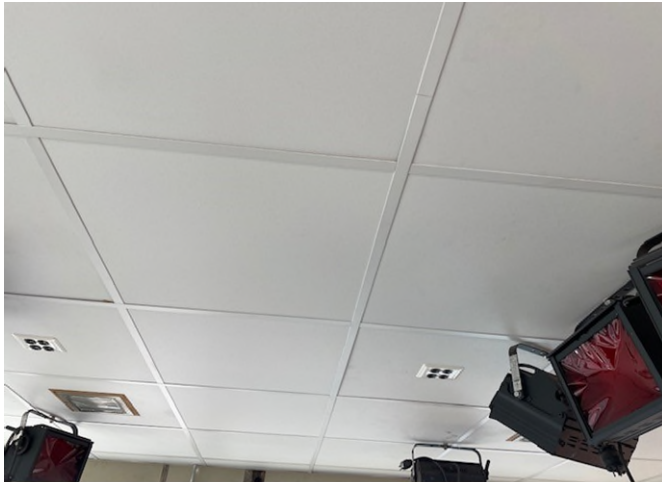
HA-8: White Gypsum Board Ceiling Panels

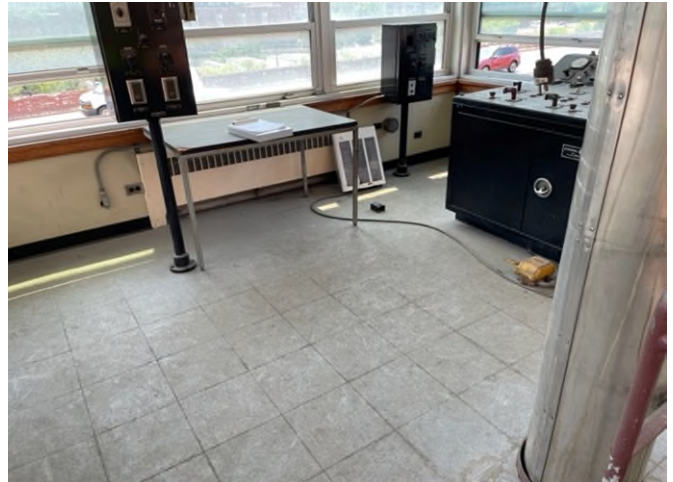
HA-9: Yellow Cove Base Mastic

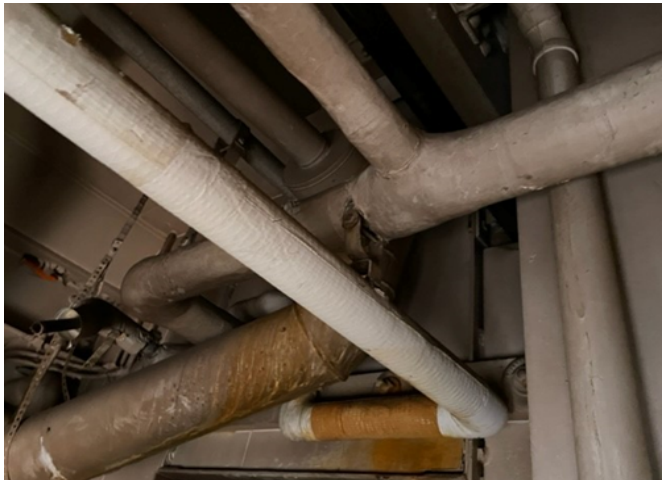
HA-10: White Air Cell Pipe Insulation

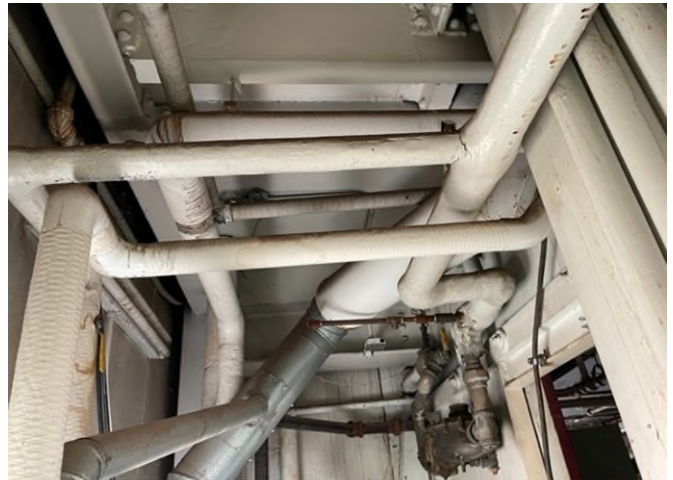
HA-11: White Hard Park Fitting

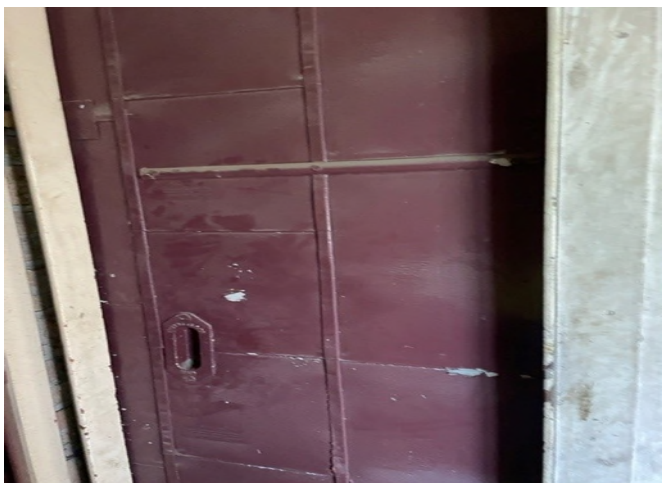
- HA-12: Dark Red Fire Doors in electrical control rooms.
- HA-13: Transite Flue/Vent in electric control rooms, bathrooms and operator rooms.

HA-12: Dark Red Fire Door

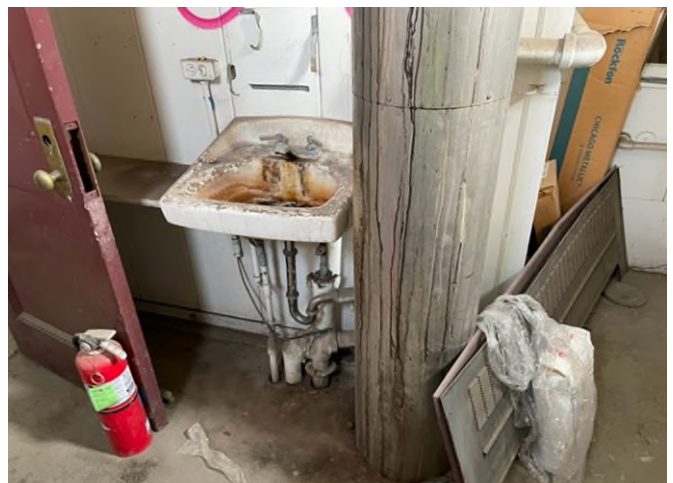
HA-13: Transite Flue/Vent (not visible inside pipe)
