ROUTE NO.	SECTION	COUNTY	SHEET NO.	SHEET	SHEET NO. 10
FAI 94	*	COOK	30	13	15 SHEETS
FED. ROAD DIST. NO. 7	ILLINOIS	FED. AID PROJECT-	Contract Number: 60E12 * 1111-700 HB-BR

PARTIAL PLANS
SUGGESTED BEAM STRAIGHTENING METHODS
Straightening force shall be maintained on all load transfer blocking during beam straightening.

BEAM STRAIGHTENING DETAILS
115th ST. OVER FAI RT. 94
COOK COUNTY
SN 016-2042

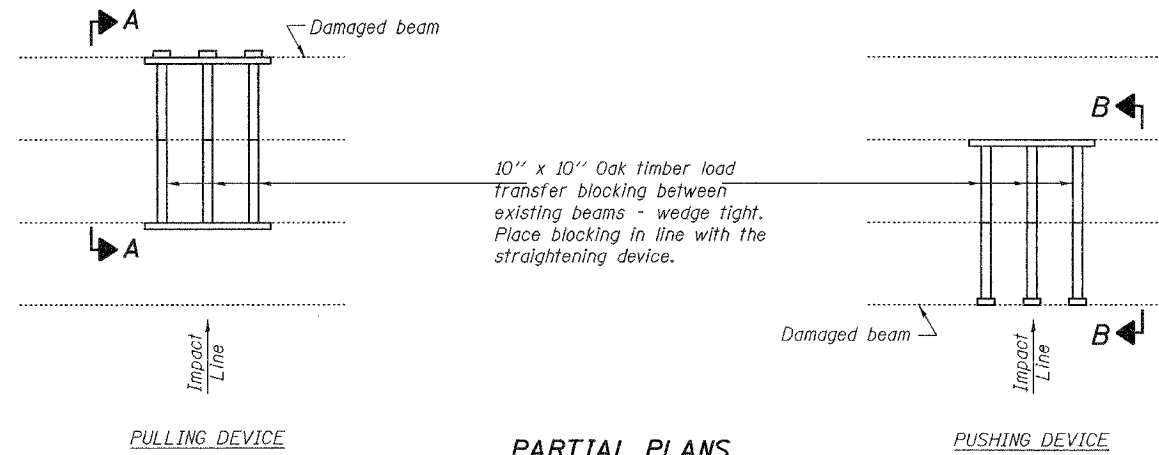
EXISTING DEFORMATION TO BE STRAIGHTENED
(Looking West)
(Approximate max. deflections)
Deflected length of beam to be straightened is approximately 20'-0''.
