**Mechanical Room Doors**

**STATE OF ILLINOIS  
DEPARTMENT OF TRANSPORTATION**

**RUBY ST OVER DES PLAINES RIVER  
SN 099-9901**

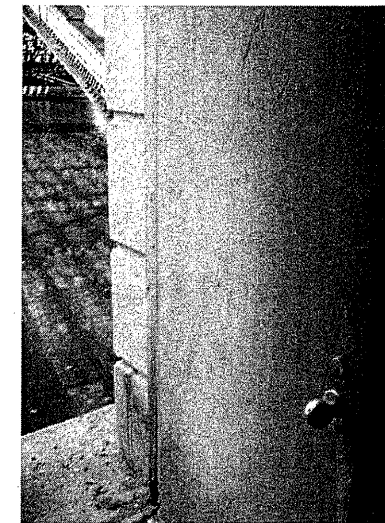
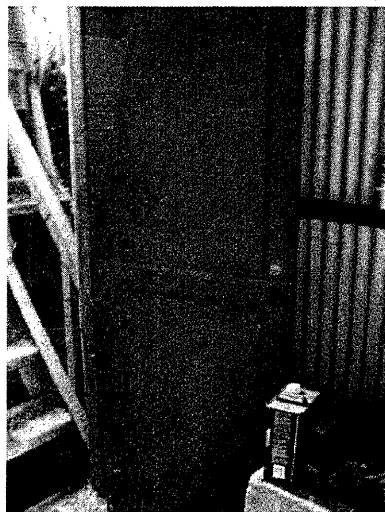
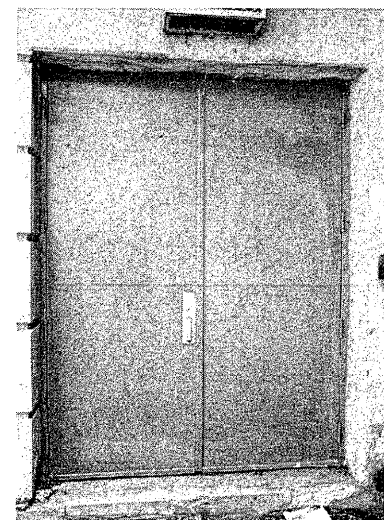
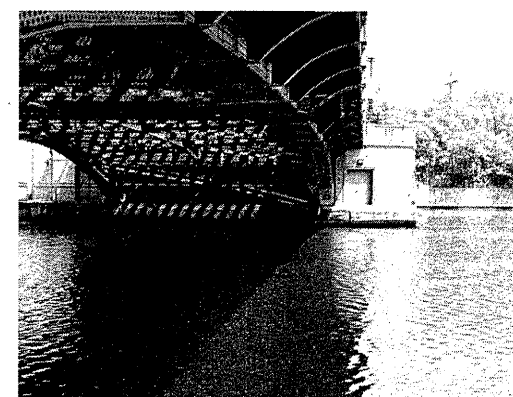
There are four sets of double doors (exterior) for the mechanical rooms on either side of the bridge that shall be painted.

There are two interior doors on each side (4 total) that shall be painted.

NOTE: The door on the northwest side; exterior; the locks shall be replaced. Cost included in the cost of "Bridge Tender House Rehabilitation".

The fiberglass wall jackets will not need painting, but the interior of all the mechanical rooms walls need to be power washed/steam cleaned per Art. 592.03 of the "Standard Specifications". All mechanical and electrical equipment shall be protected. Cost of cleaning walls included in cost of "Bridge Tender House Rehabilitation".
