STATE OF ILLINOIS
DEPARTMENT OF TRANSPORTATION

MISSOURI APPROACH BENT 7 REPAIRS
S.N. 082-6001 MLK BRIDGE OVER MISSISSIPPI RIVER

SHEET NO. S112 OF S138 SHEETS

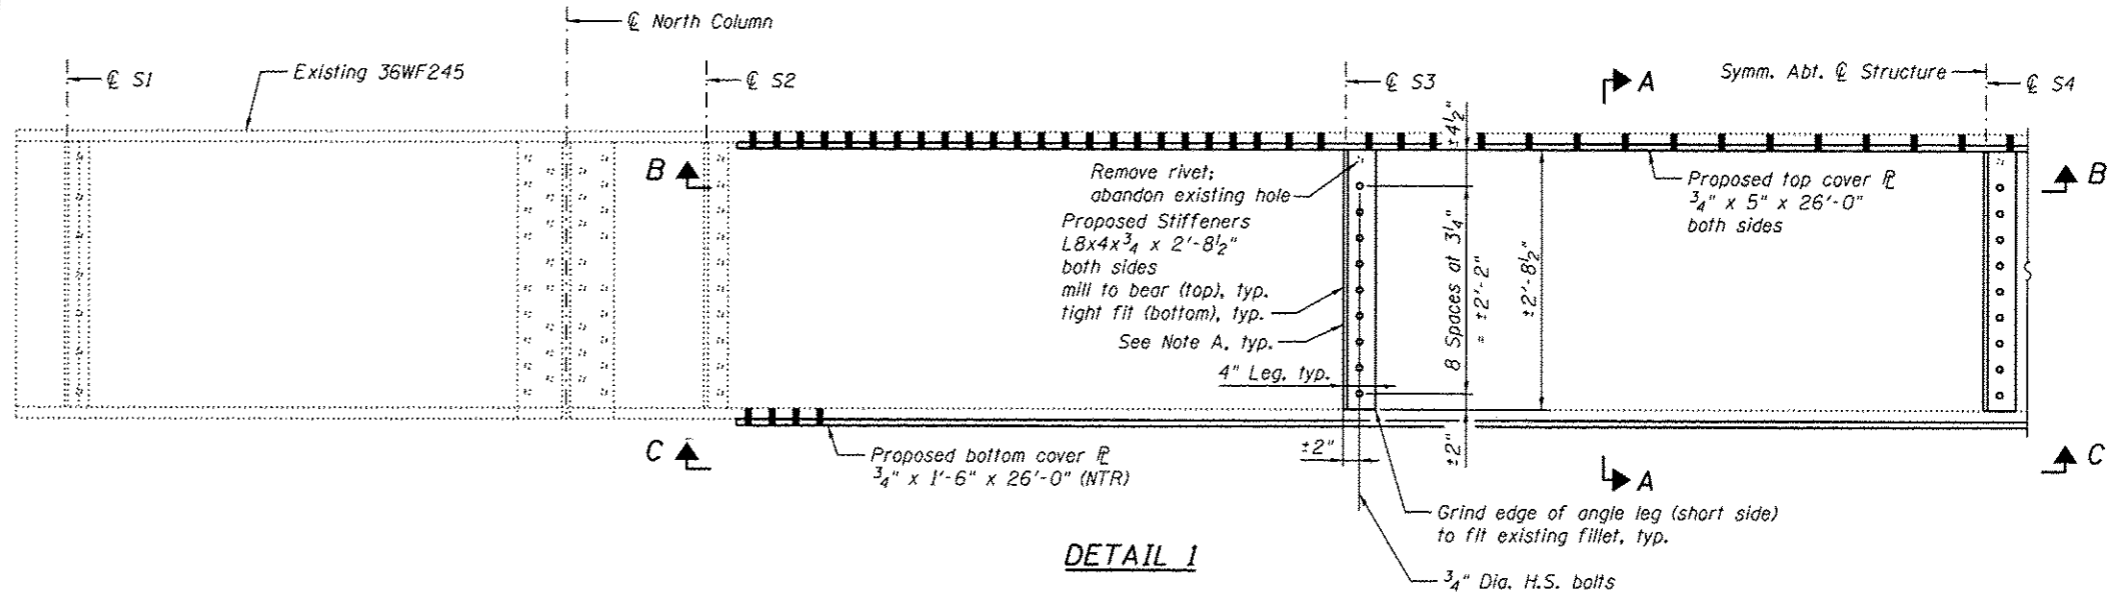
BENT 7
(Looking East)

Strengthen Bent Cap, see Detail 1, this sheet.
