STATE OF ILLINOIS
DEPARTMENT OF TRANSPORTATION

EAST ABUTMENT DETAILS
SN 072-0134

F.A.P. RTE. 317	SECTION (48B)I	COUNTY Peoria	TOTAL SHEETS 28	SHEET NO. 28B
CONTRACT NO. ---			ILLINOIS FED. AID PROJECT

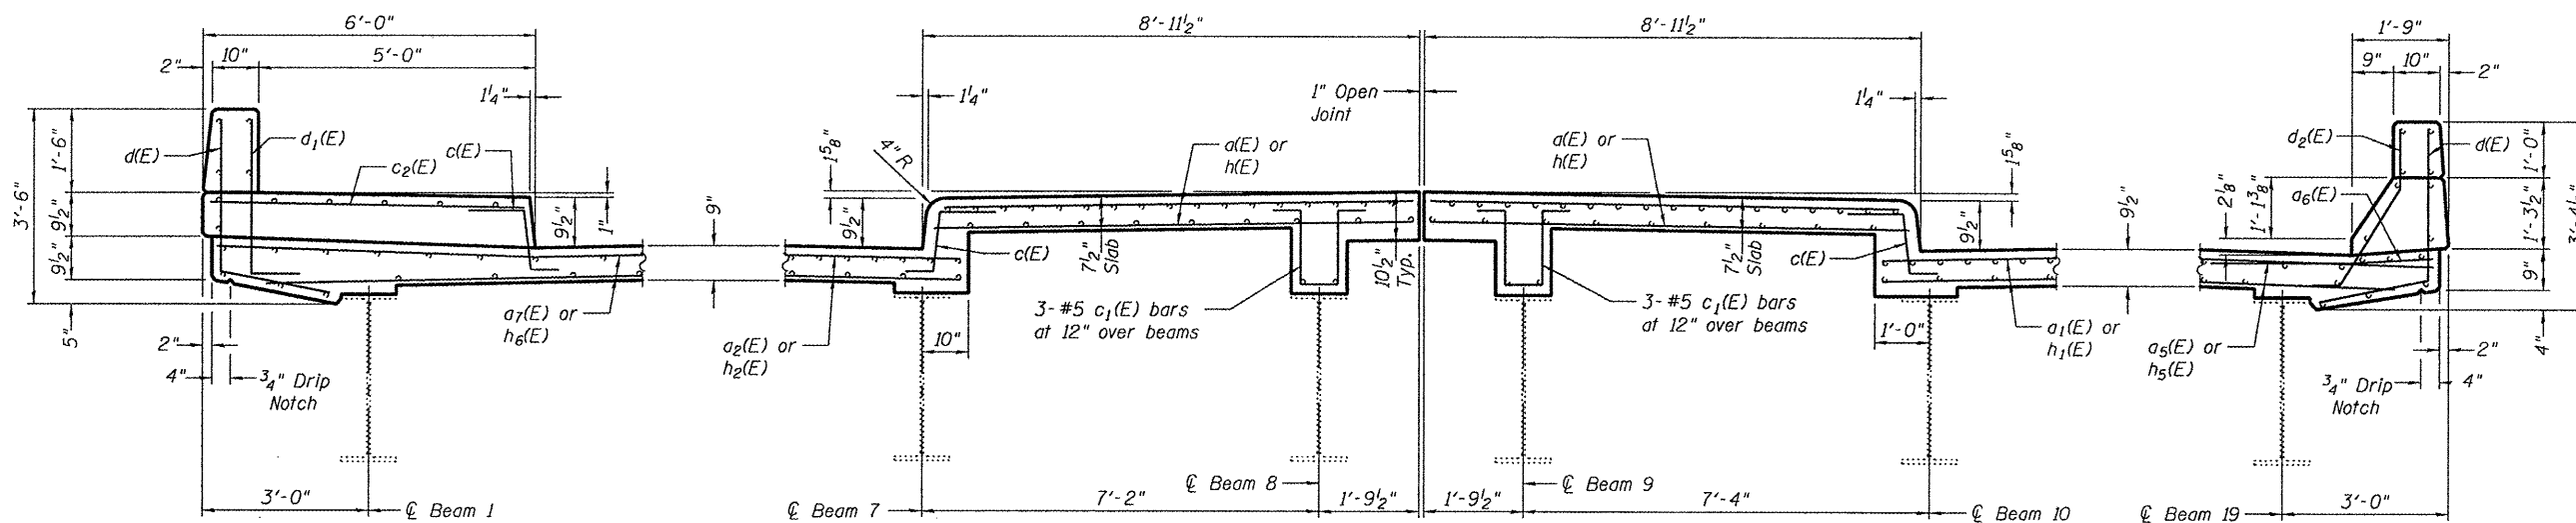
TYPICAL SIDEWALK SECTION ON NORTH SIDE

TYPICAL MEDIAN SECTION

TYPICAL PARAPET SECTION ON SOUTH SIDE

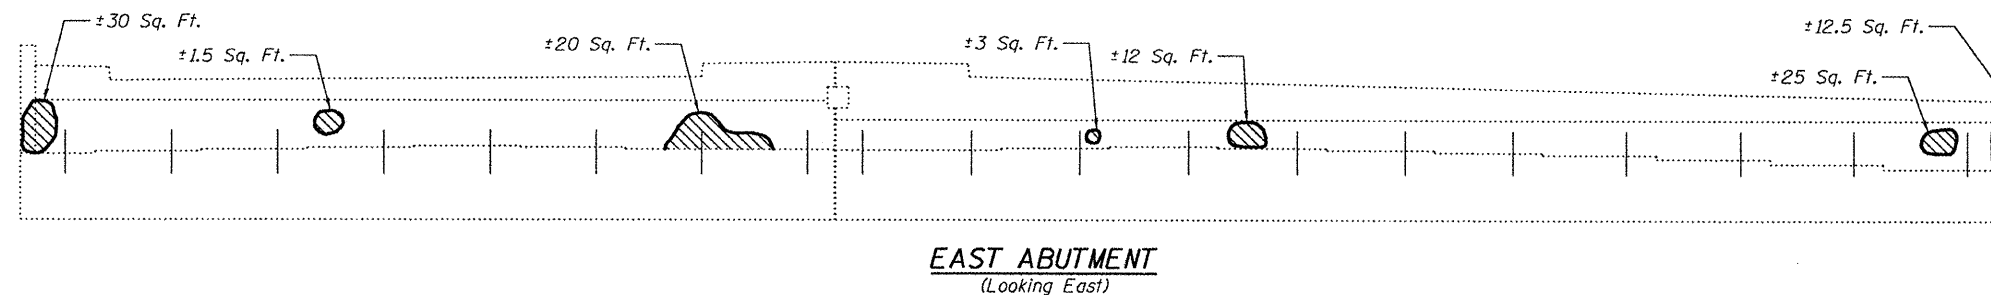
EAST ABUTMENT
(Looking East)

EAST ABUTMENT SOUTH WINGWALL
(Looking North)

Structural Repair of Concrete (Depth ≤ 5")

Structural Repair of Concrete (Depth > 5")
