STATE OF ILLINOIS
DEPARTMENT OF TRANSPORTATION

MAIN SPAN GUSSET PLATE STRENGTHENING - 5A
S.N. 082-6001 MLK BRIDGE OVER MISSISSIPPI RIVER

SHEET NO. S50A OF S138 SHEETS

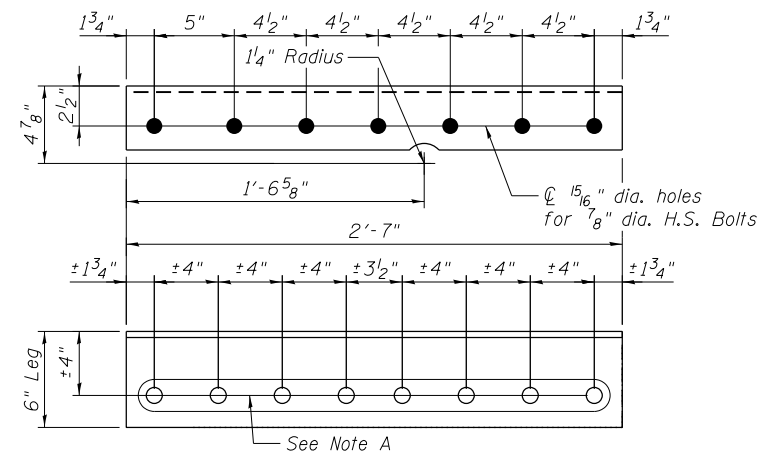
REPAIR ANGLE L8F

L6 x 4 x 3/8 x 2'-7"

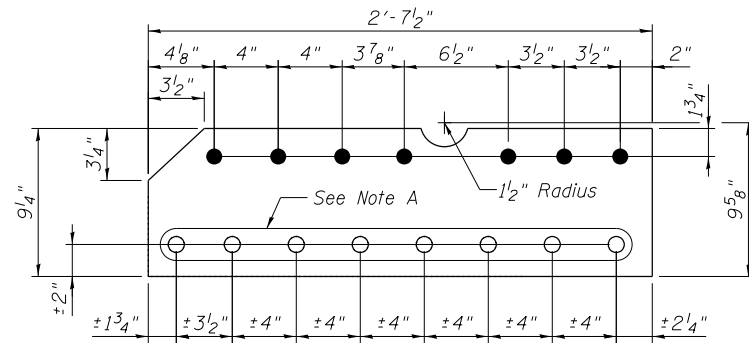
REPAIR PL L8G

PL 5/8 x 9/4 x 2'-7 1/2"

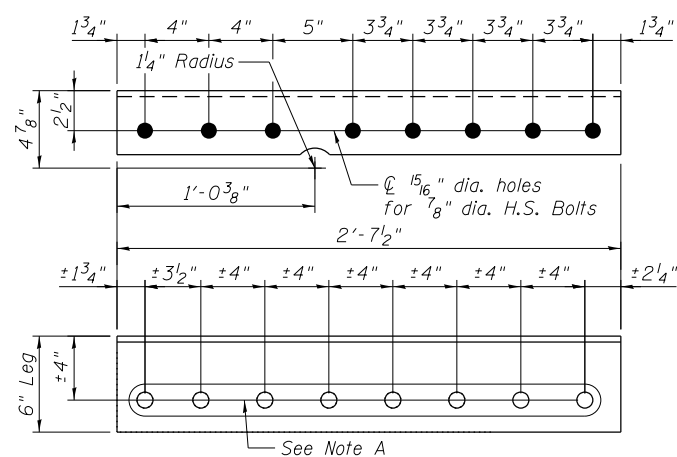
REPAIR ANGLE L8H

L6 x 4 x 3/8 x 2'-7 1/2"

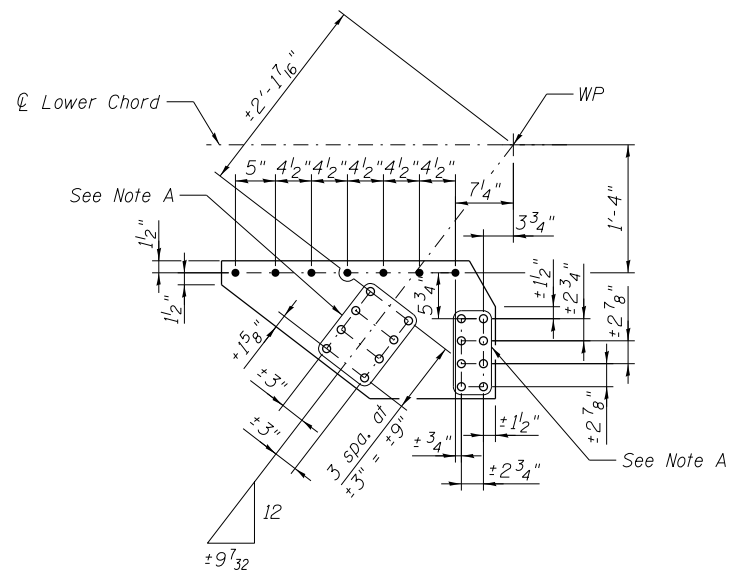
REPAIR PL L8K

PL 5/8 x 17 1/4 x 2'-10 1/4"

Note: Repair PL L8K requires 15/16" ϕ holes for 7/8" ϕ H.S. bolts.

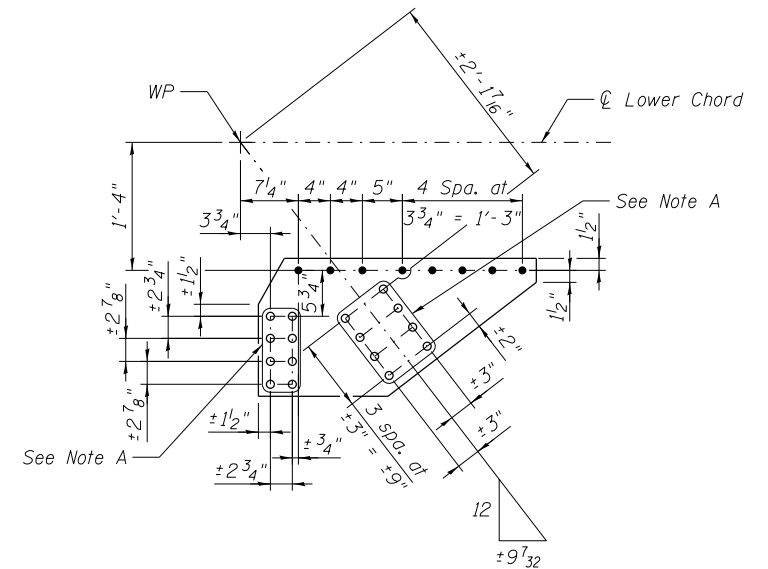
REPAIR PL L8J

PL 5/8 x 17 1/4 x 2'-10 3/4"

Note: Repair PL L8J requires 15/16" ϕ holes for 7/8" ϕ H.S. bolts.
