STATE OF ILLINOIS
DEPARTMENT OF TRANSPORTATION

CONTRACT NO. 66561

WEST ABUTMENT
IL 116 OVER KELLY CREEK
FAP ROUTE 681 - SECTION 116BR-1
FORD COUNTY
STATION 60+53.00
STRUCTURE NO. 027-0044

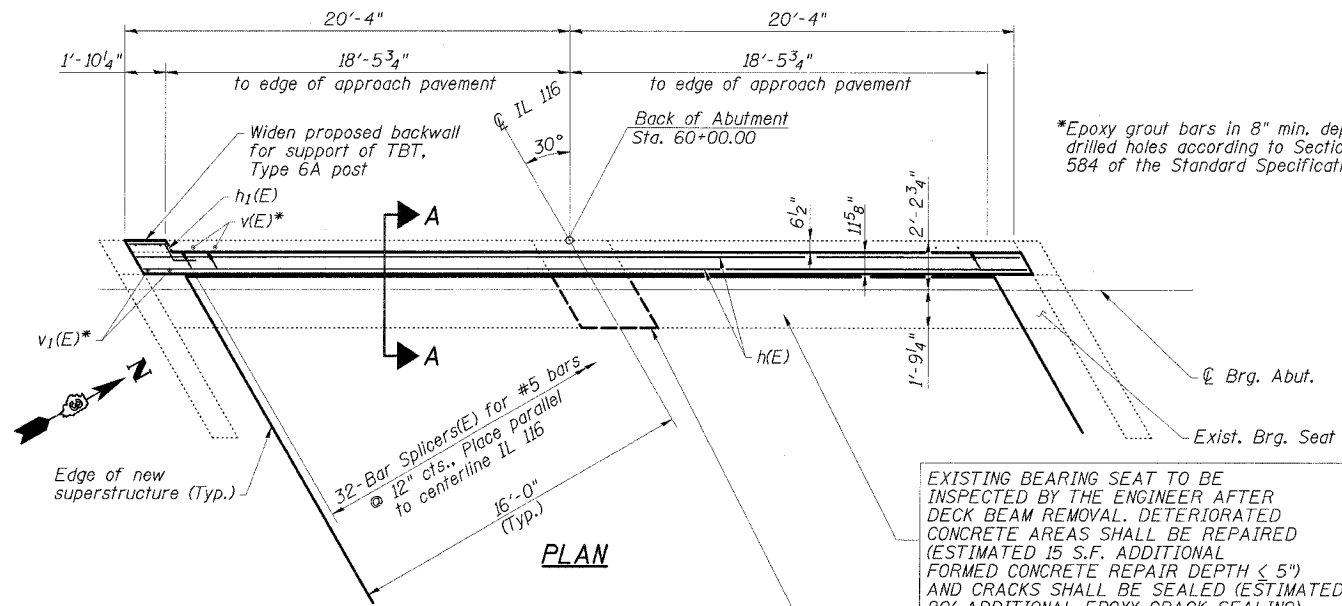
PLAN

EXISTING BEARING SEAT TO BE INSPECTED BY THE ENGINEER AFTER DECK BEAM REMOVAL. DETERIORATED CONCRETE AREAS SHALL BE REPAIRED (ESTIMATED 15 S.F. ADDITIONAL FORMED CONCRETE REPAIR DEPTH < 5") AND CRACKS SHALL BE SEALED (ESTIMATED 20' ADDITIONAL EPOXY CRACK SEALING) IF FOUND. BRIDGE SEAT SEALER SHALL BE APPLIED TO FORMED CONCRETE REPAIR AREAS.

8.7 S.F. Formed Concrete Repair to be used to slope existing level portion of abutment seat to provide uniform bearing area for proposed beams
