FILE NAME =	USER NAME = simsgm		REVISED -		AS-BUILT PATCHING PLAN S.N. 092-0001 (EB) & 092-0002 (WB)				F.A.I. RTE.	SECTION	COUNTY	TOTAL SHEET SHEETS NO.	
c:\pw_work\pwidot\simsgm\d0187665\d5909	3 Bridge Repairs.dgn		REVISED -	STATE OF ILLINOIS				74	(92-9BR)I-1	VERMILION	15 11		
	PLOT SCALE = 40.0001 / / IN.	CHECKED -	REVISED -	DEPARTMENT OF TRANSPORTATION						CONTRACT NO. 90963			
	PLOT DATE = 10/18/2010	DATE -	REVISED -		SCALE: SHEET NO OF - SHEETS STA. TO			TO STA.	FED. ROAD DIST. NO. ILLINOIS FED. AID PROJECT

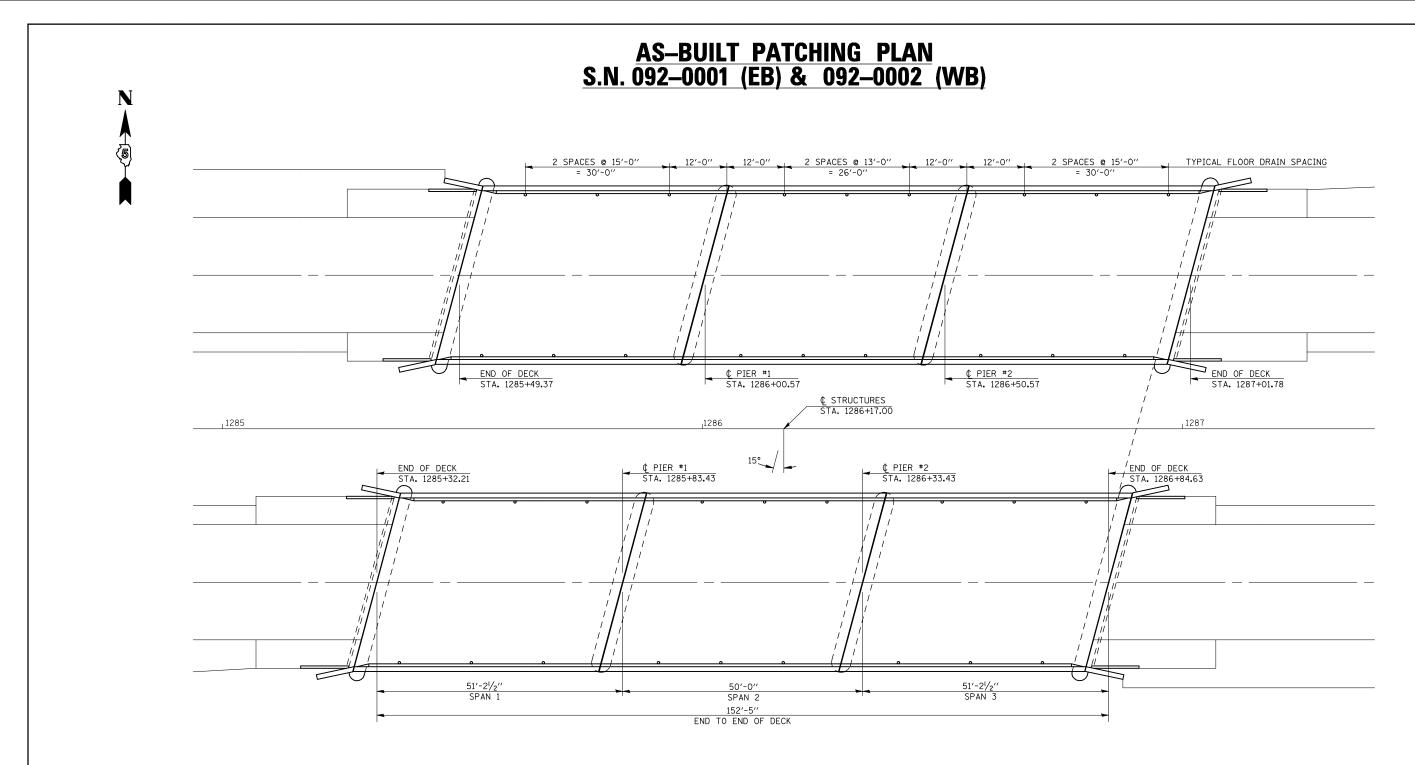
AREA OF DECK SLAB REPAIR HAS BEEN ESTIMATED. THE ACTUAL QUANTITY AND LOCATIONS SHALL BE DETERMINED BY THE ENGINEER AFTER THE EXISTING H.M.A. WEARING SURFACE AND WATERPROOFING MEMBRANE ARE REMOVED. THE ENGINEER SHALL SHOW THE ACTUAL LOCATIONS OF THE DECK REPAIRS ON THIS SHEET.
