ASBESTOS SURVEY REPORT

PTB 196-032

Asbestos Survey for Building Demolition (I-80)

613 Kiep Avenue, Joliet, Illinois

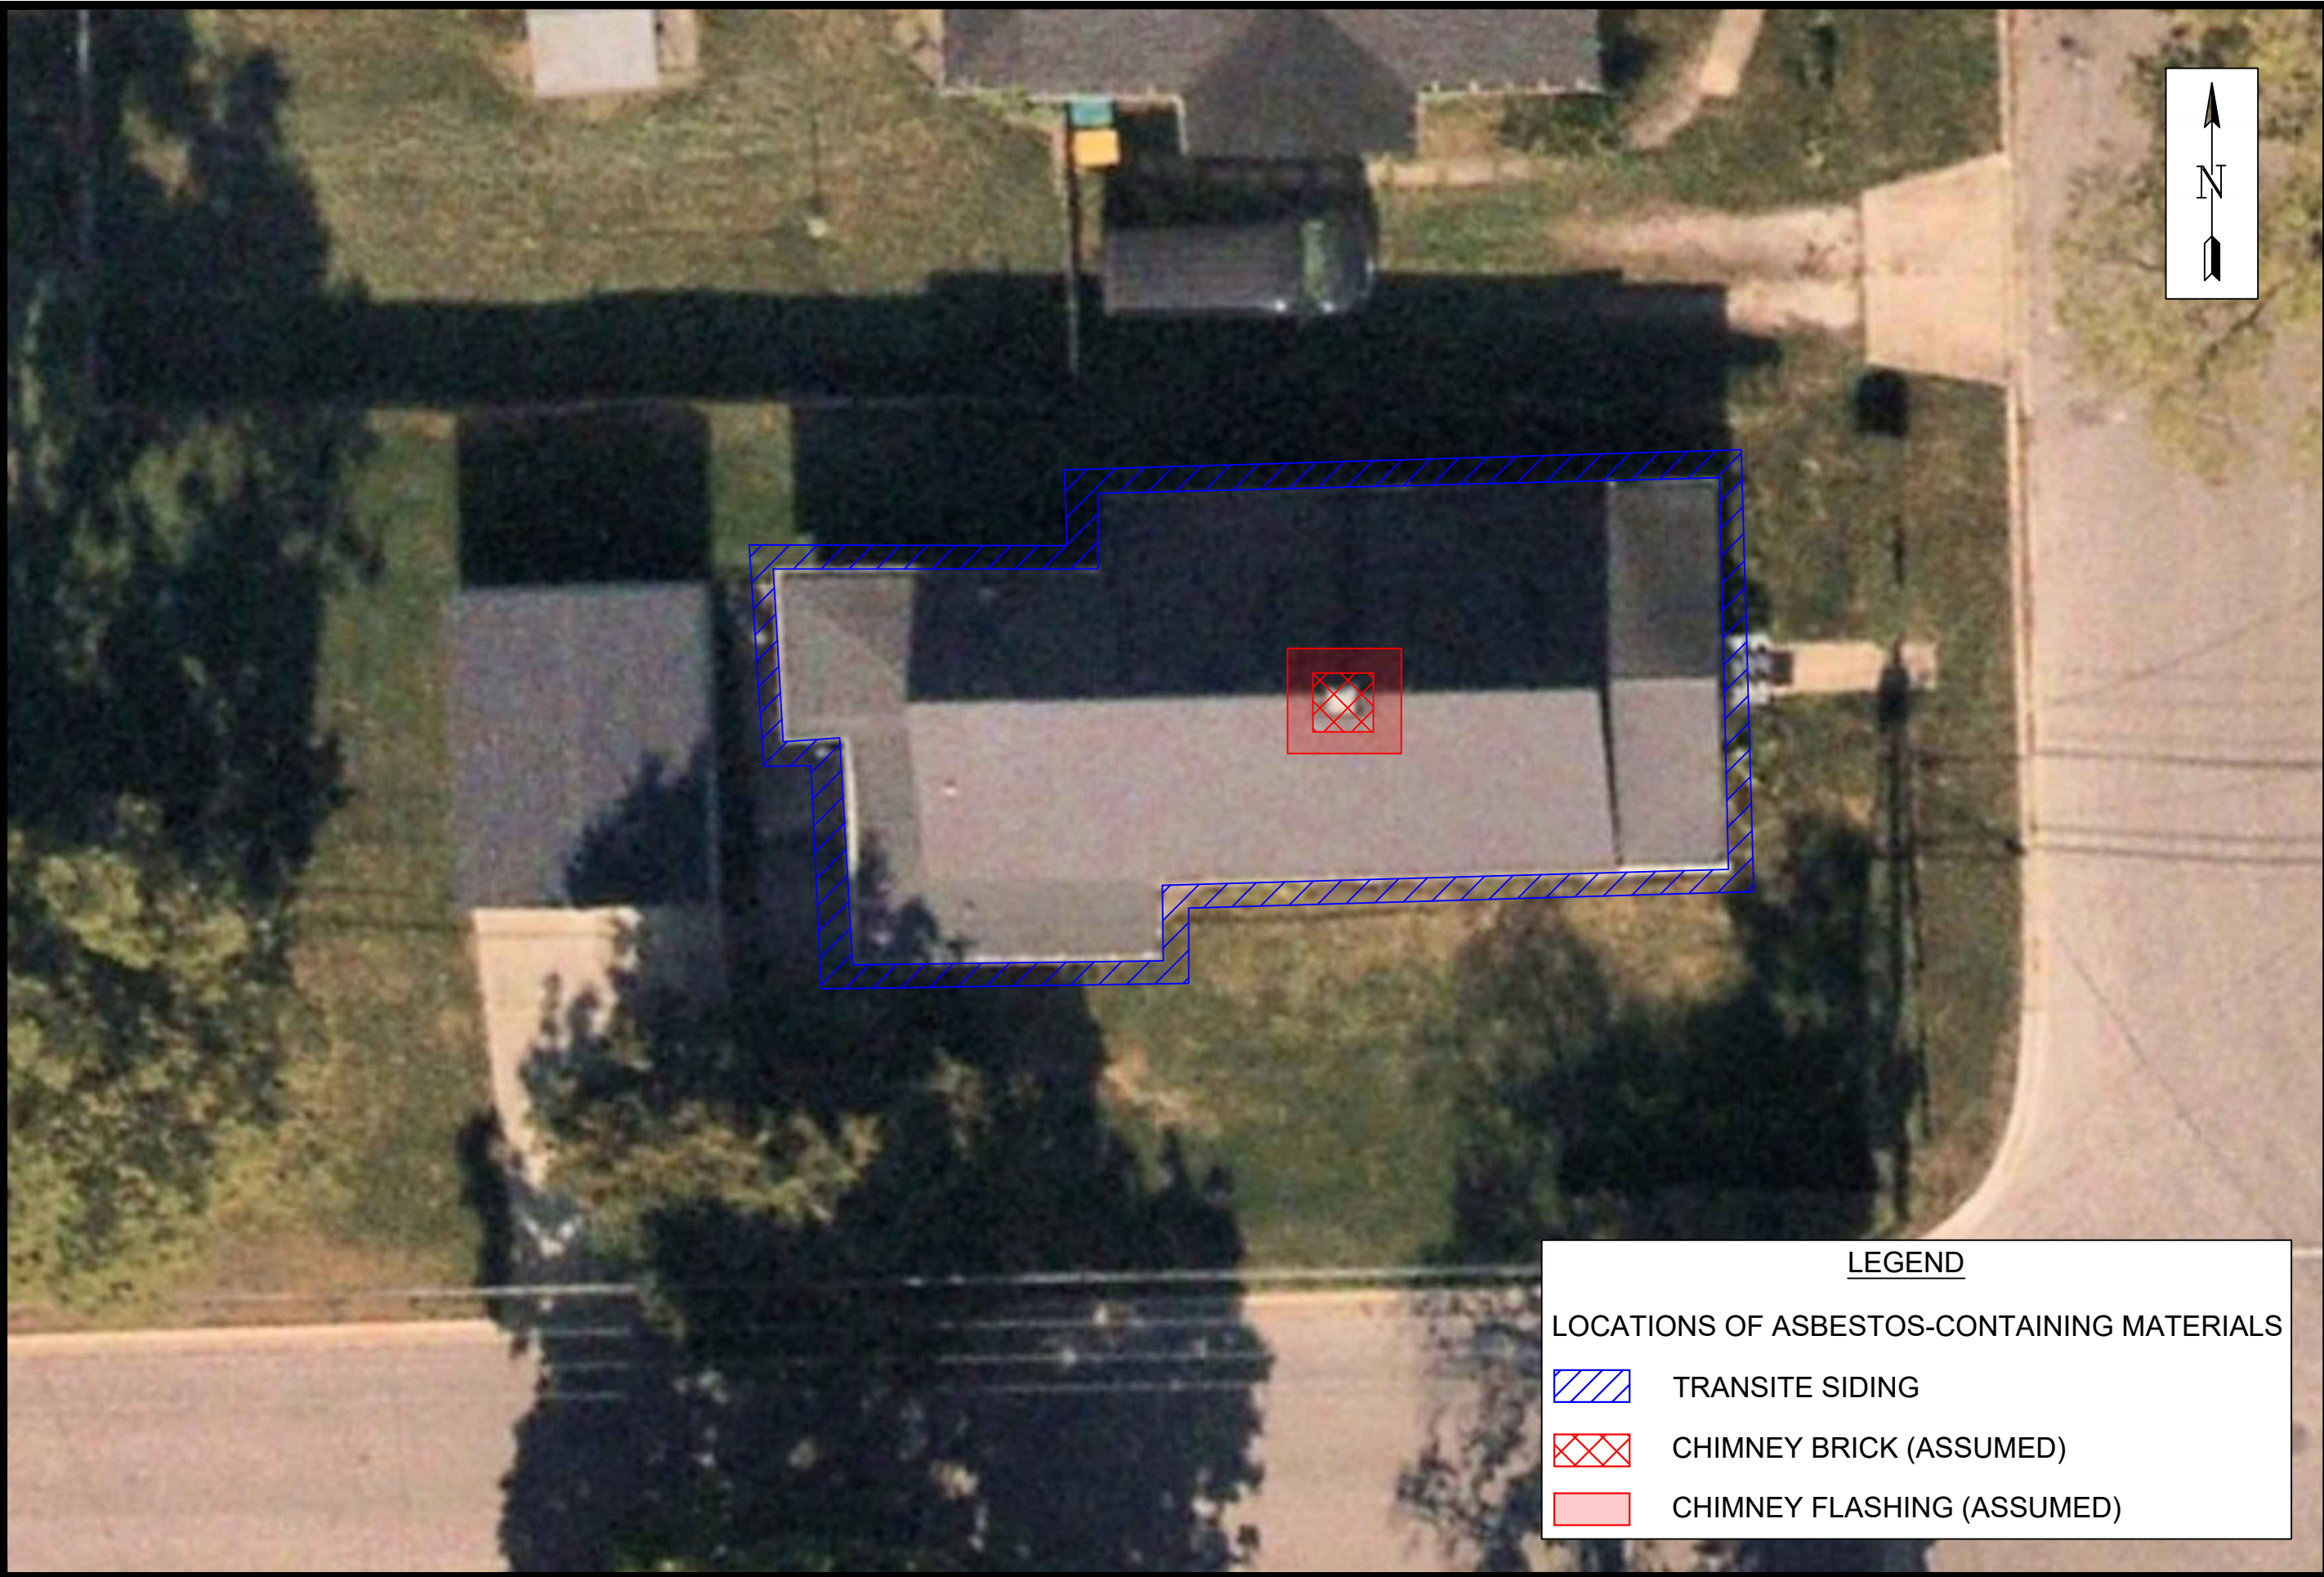
ACM-1 ACM Location Plan

TRANSITE SIDING

CHIMNEY BRICK (ASSUMED)

CHIMNEY FLASHING (ASSUMED)

All friable asbestos-containing building materials (ACBMs) identified shall be removed from any building(s) or other structures before demolition. Non-friable ACMs may be left in place, unless during demolition, the ACMs may become friable. If other suspect materials not referenced in this survey report, within or on the outside of the buildings, are identified, not listed in **Table 1**, such materials shall be assumed ACMs until the materials are inspected by a licensed asbestos inspector, sampled, and submitted for laboratory analysis. As the floor tile identified as asbestos containing is a Category I non-friable material which is not likely to become friable during demolition, it does not need to be removed prior to demolition.

GSG recommends the preparation of an asbestos abatement project design before any demolition. An asbestos abatement design plan and specifications should include information regarding the location of containments and barriers, type of sealant, and air sampling requirements and clearance during the asbestos abatement activities. The asbestos design plan and specifications shall be prepared and signed by an IDPH licensed asbestos project designer following Illinois regulations. Before starting any abatement activities, an Asbestos Abatement notification is required for all asbestos projects and must be applied for at least ten (10) working days before the start of the project. A building demolition notification is required for all demolition projects and must be applied for at least ten (10) working days before the start of the project.

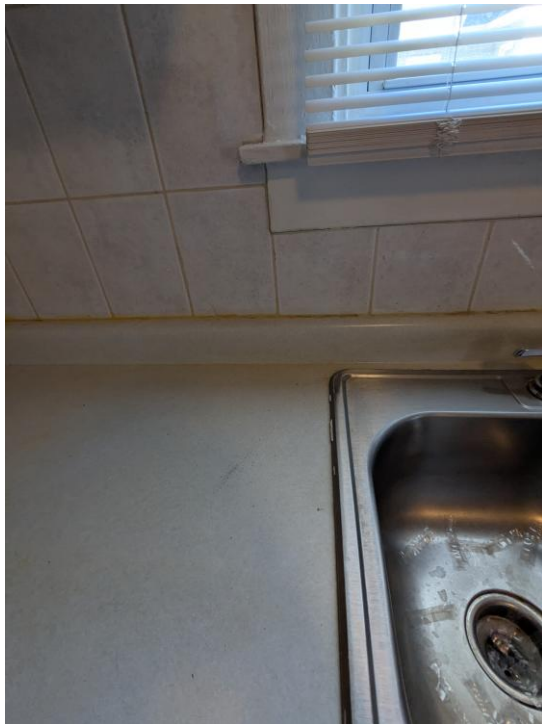
Photo Location:
Kitchen

Material Description:
Suspect ACM Sink/Counter
Caulk

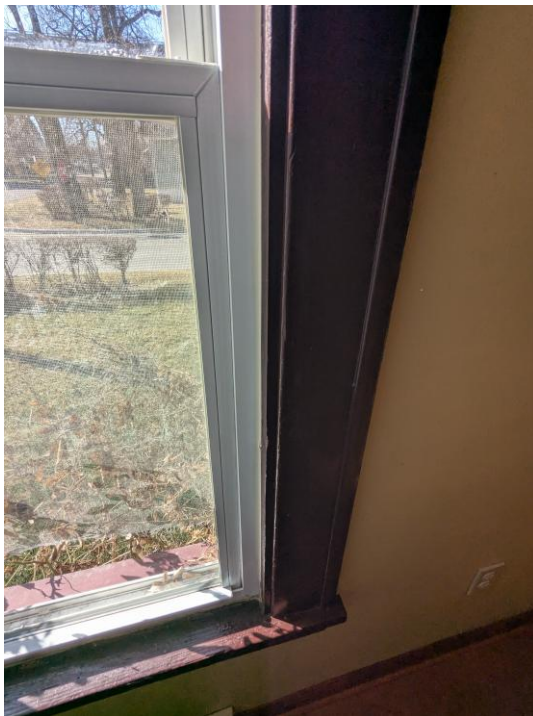
Photo Location:
Living Room

Material Description:
Suspect ACM Interior
Window Caulk

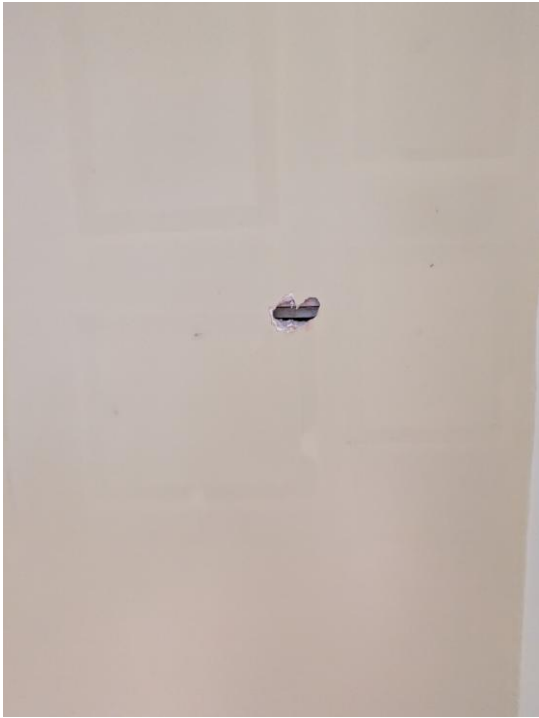
Material Description: Suspect ACM Plaster
		Photo Location: Living Room
ILLINOIS DEPARTMENT OF TRANSPORTATION I-80 OVER DES PLAINES RIVER BRIDGE IMPROVEMENTS

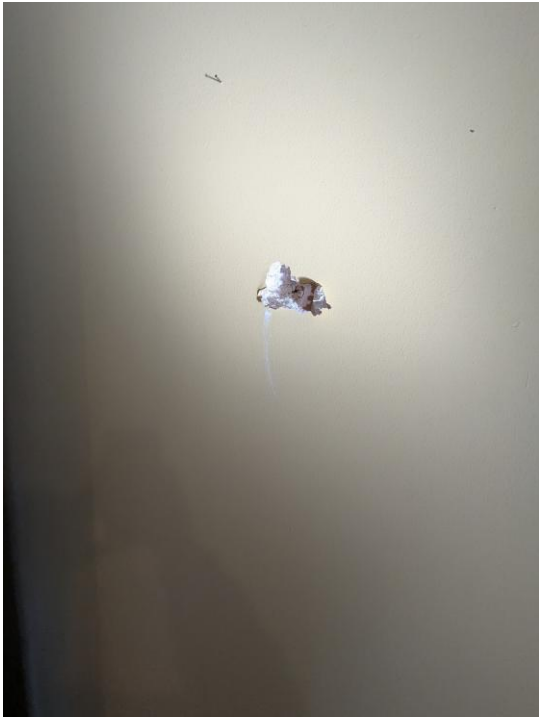
Material Description: Suspect ACM Drywall System
		Photo Location: Bedroom
ILLINOIS DEPARTMENT OF TRANSPORTATION I-80 OVER DES PLAINES RIVER BRIDGE IMPROVEMENTS

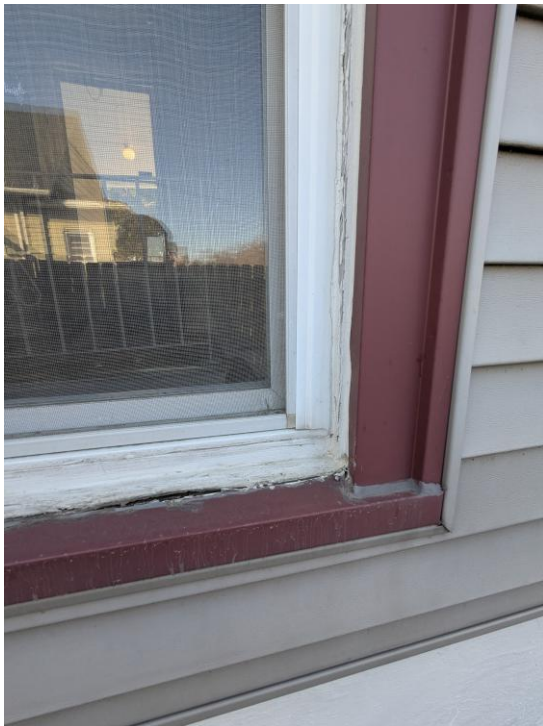
Photo Location:
Exterior

Material Description:
Suspect ACM Exterior
Window Caulk

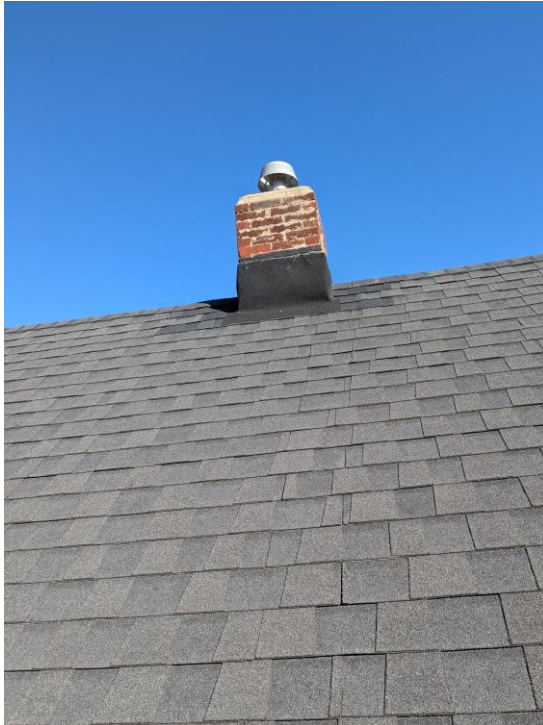
Suspect ACM that were observed but were inaccessible for sampling at the time of the survey, and therefore **assumed ACM** include the following: **chimney brick and chimney flashing**. These materials will remain assumed until sampling can occur. Please refer to **Table 1** for a list of materials that were sampled for asbestos. **Exhibit 2, ACM Locations**, shows the approximate locations of assumed ACMs present in the building.

Material Description:
Suspect ACM Roof Material
& Felt Paper

Chimney Brick & Flashing –
**Assumed Positive for
Asbestos**

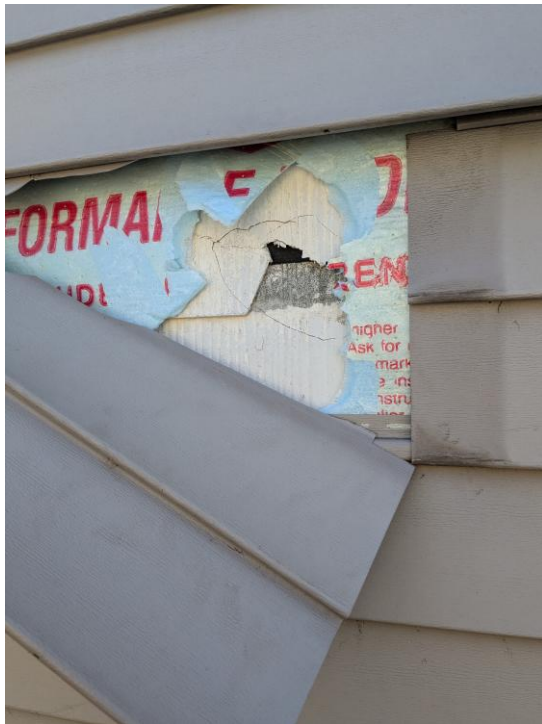
Photo Location:
Exterior

- HA-8: Transite Siding

Material Description:
Transite Siding – **Tested
Positive for Asbestos**
