ASBESTOS SURVEY REPORT

PTB 196-032
Asbestos Survey for Building Demolition (I-80)
601 Kiep Avenue, Joliet, Illinois
Region One/District One

Asbestos Survey Report
PTB 198-003
FAI-80 (I-80) over Des Plaines River Bridge
Job N. D-91-204-19
601 Kiep Avenue, Joliet, IL
Parcel No. 1P10126

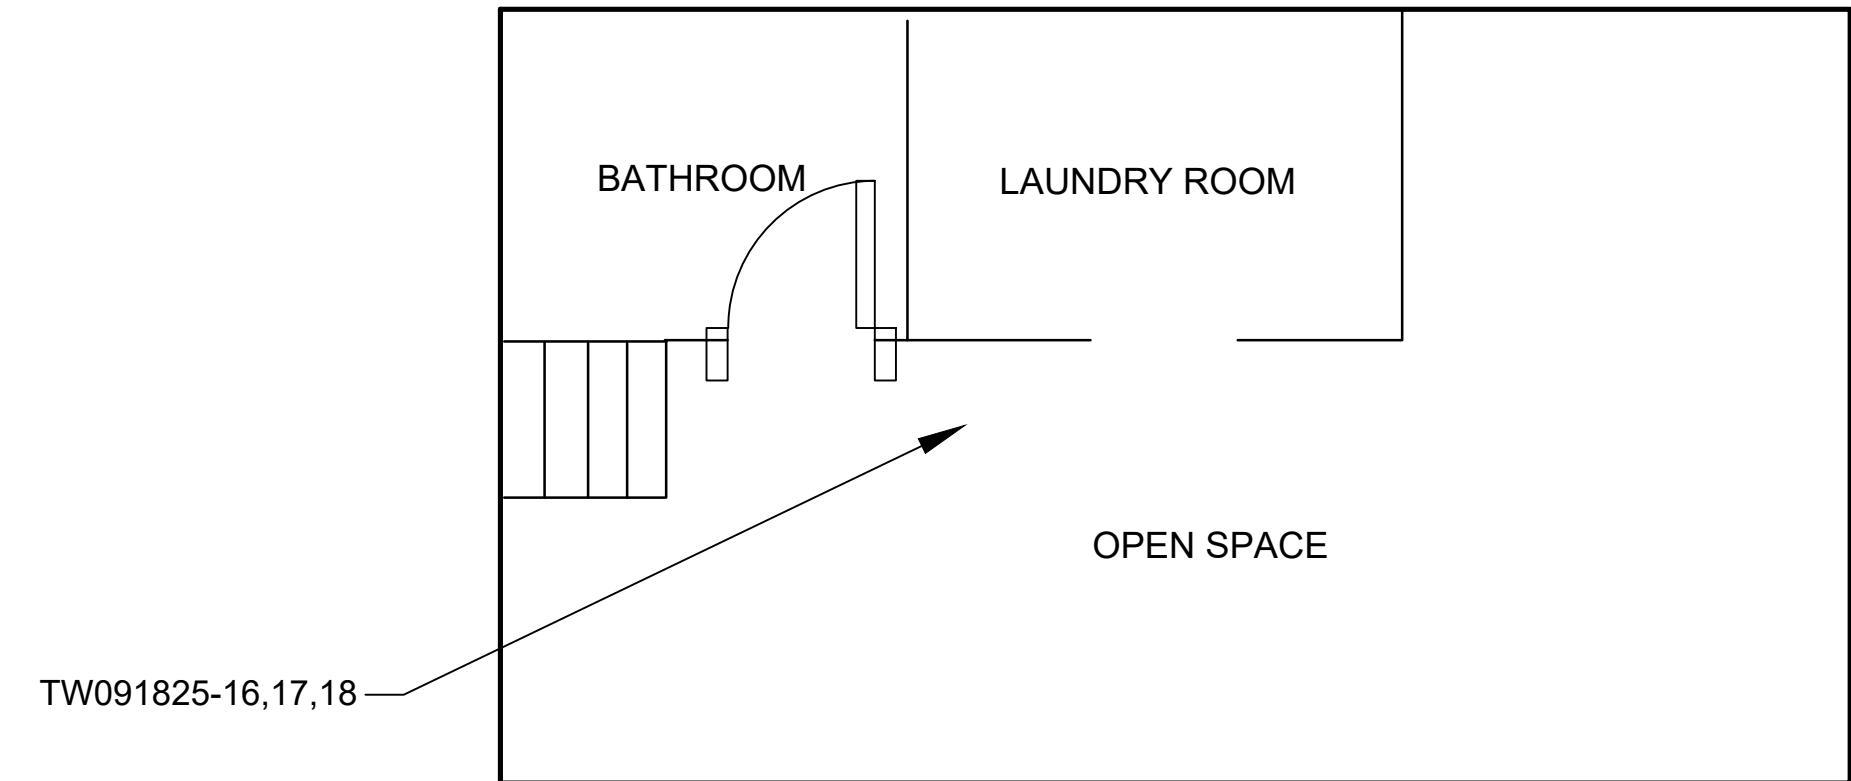
SL-1

BASEMENT
SCALE = N.T.S.

SUSPECT ASBESTOS-CONTAINING MATERIALS SAMPLE LOCATION PLAN

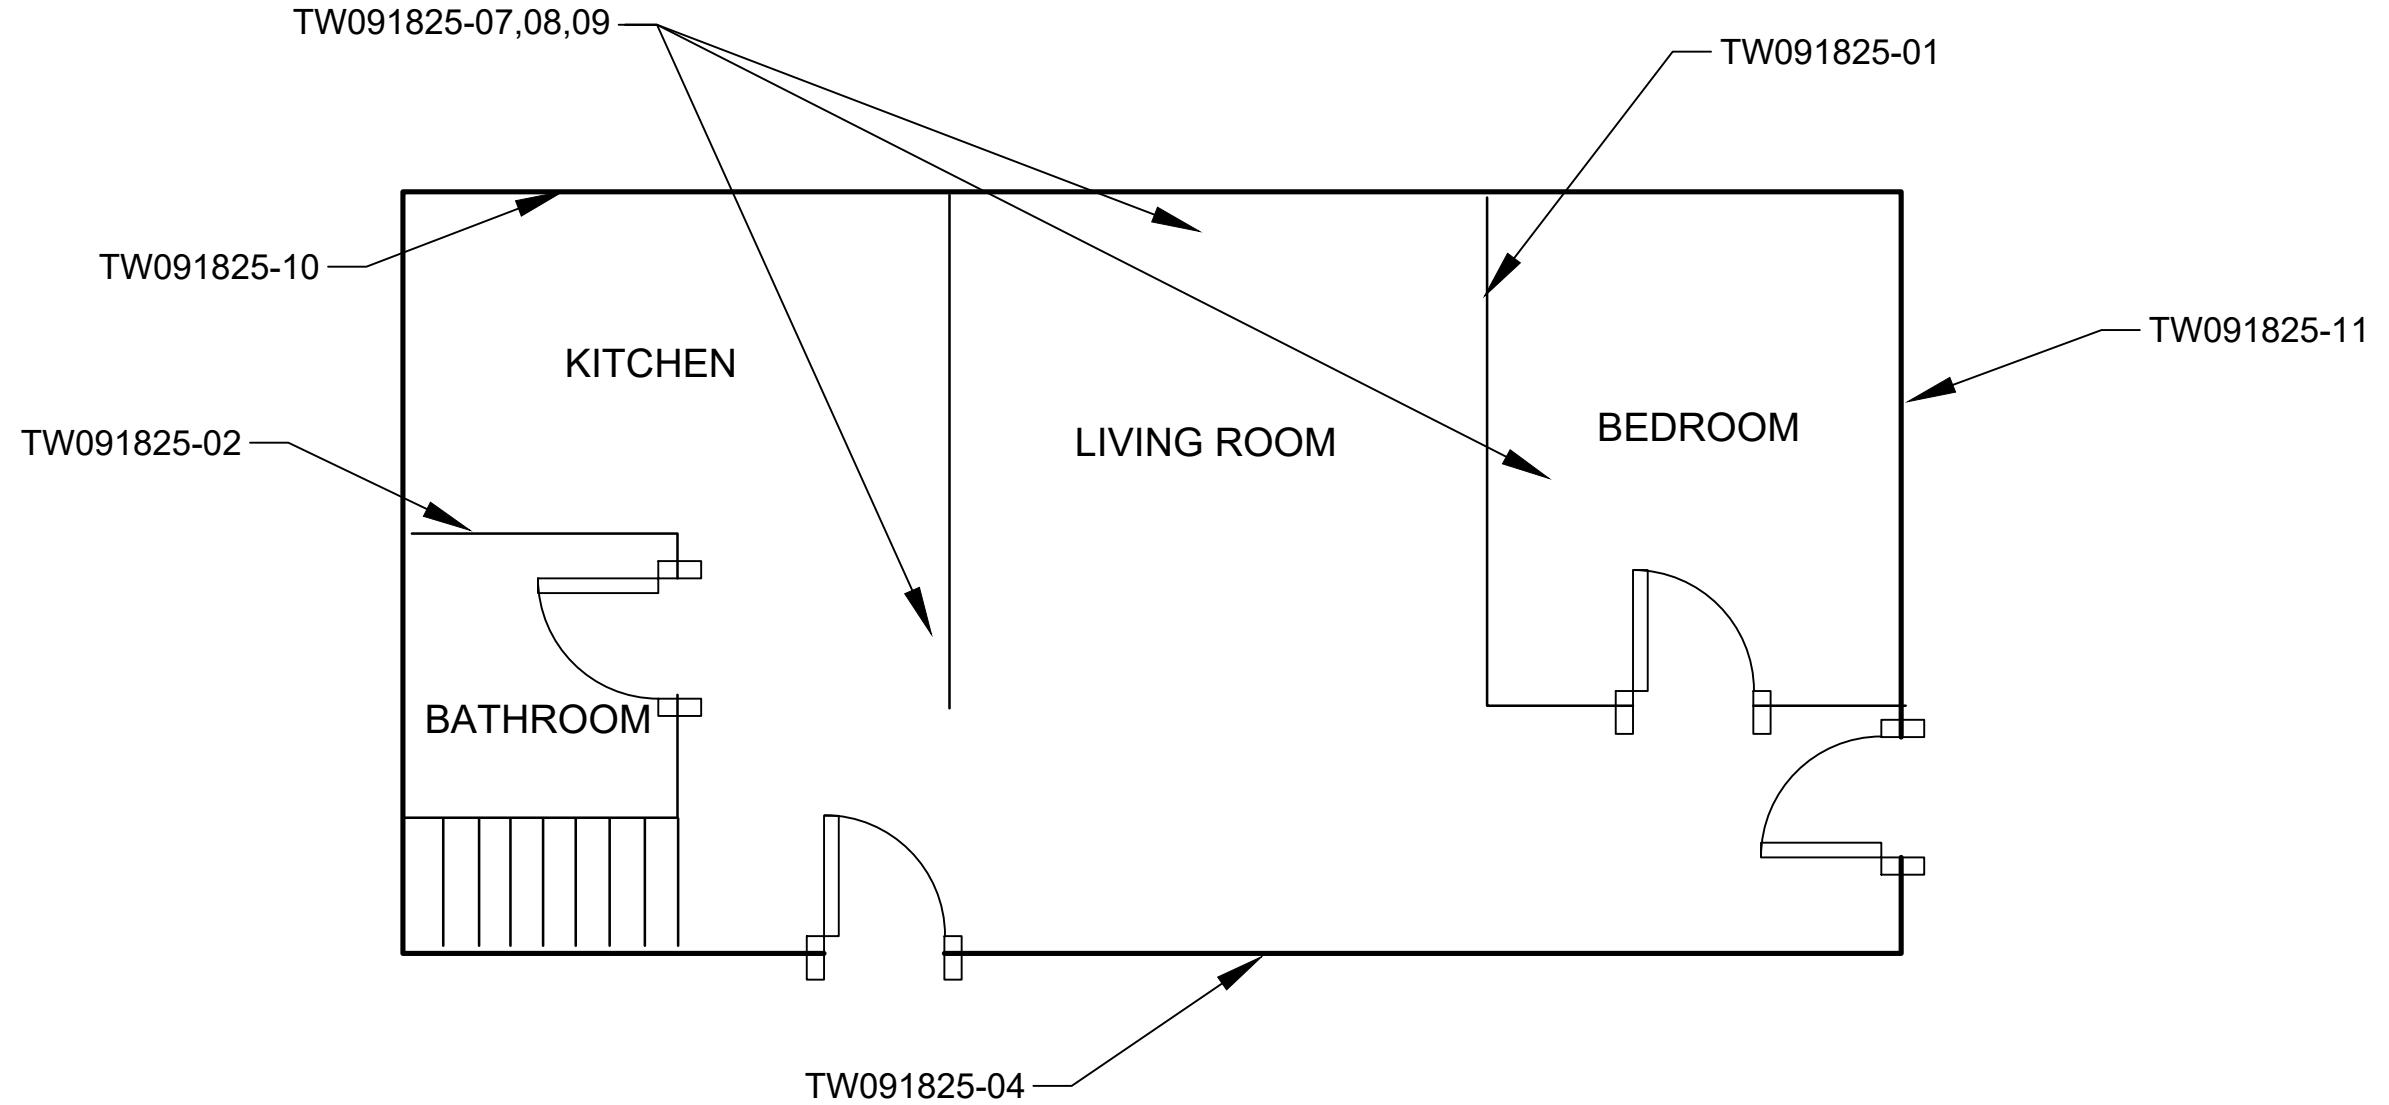
SL-2

FIRST FLOOR
SCALE = N.T.S.

SUSPECT ASBESTOS-CONTAINING MATERIALS SAMPLE LOCATION PLAN

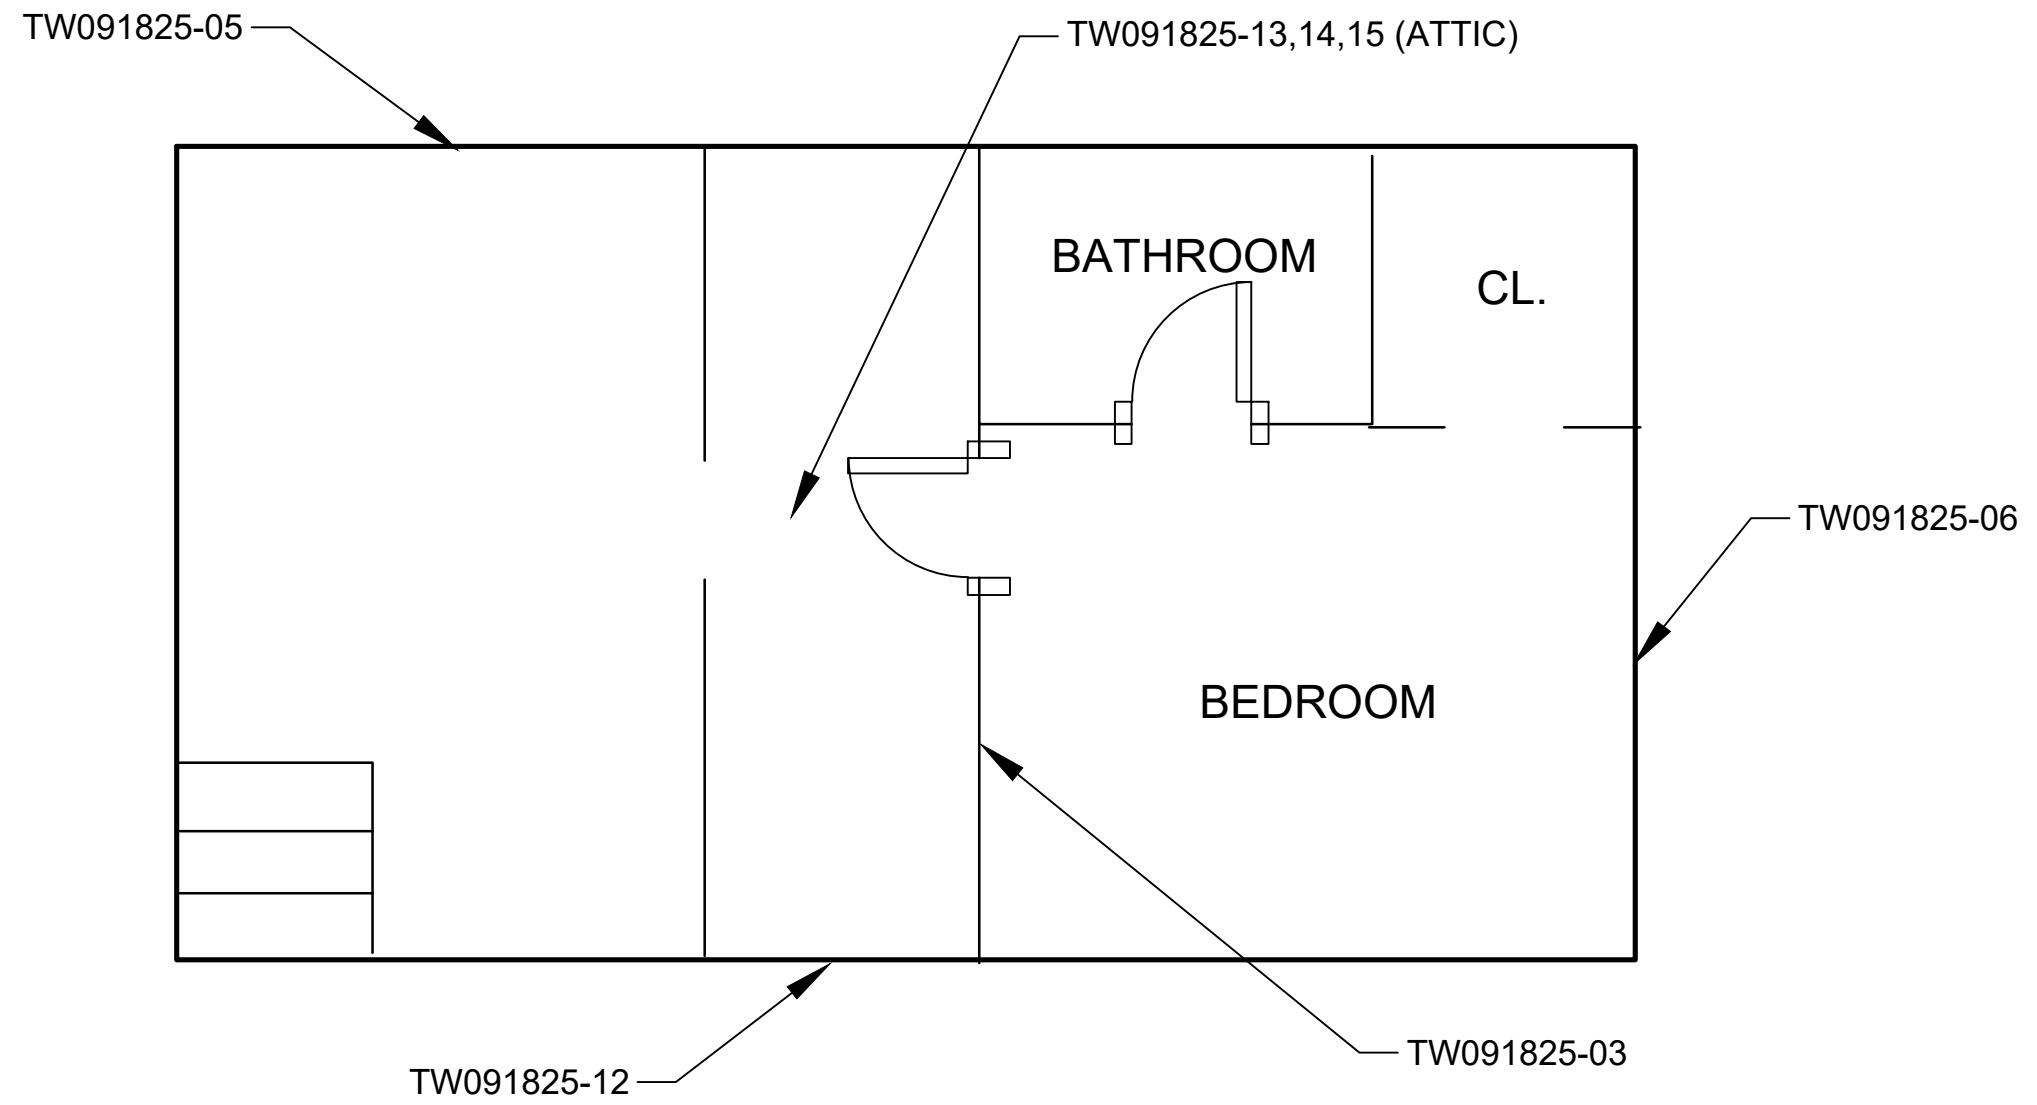
SL-3

SECOND FLOOR
SCALE = N.T.S.

SUSPECT ASBESTOS-CONTAINING MATERIALS SAMPLE LOCATION PLAN

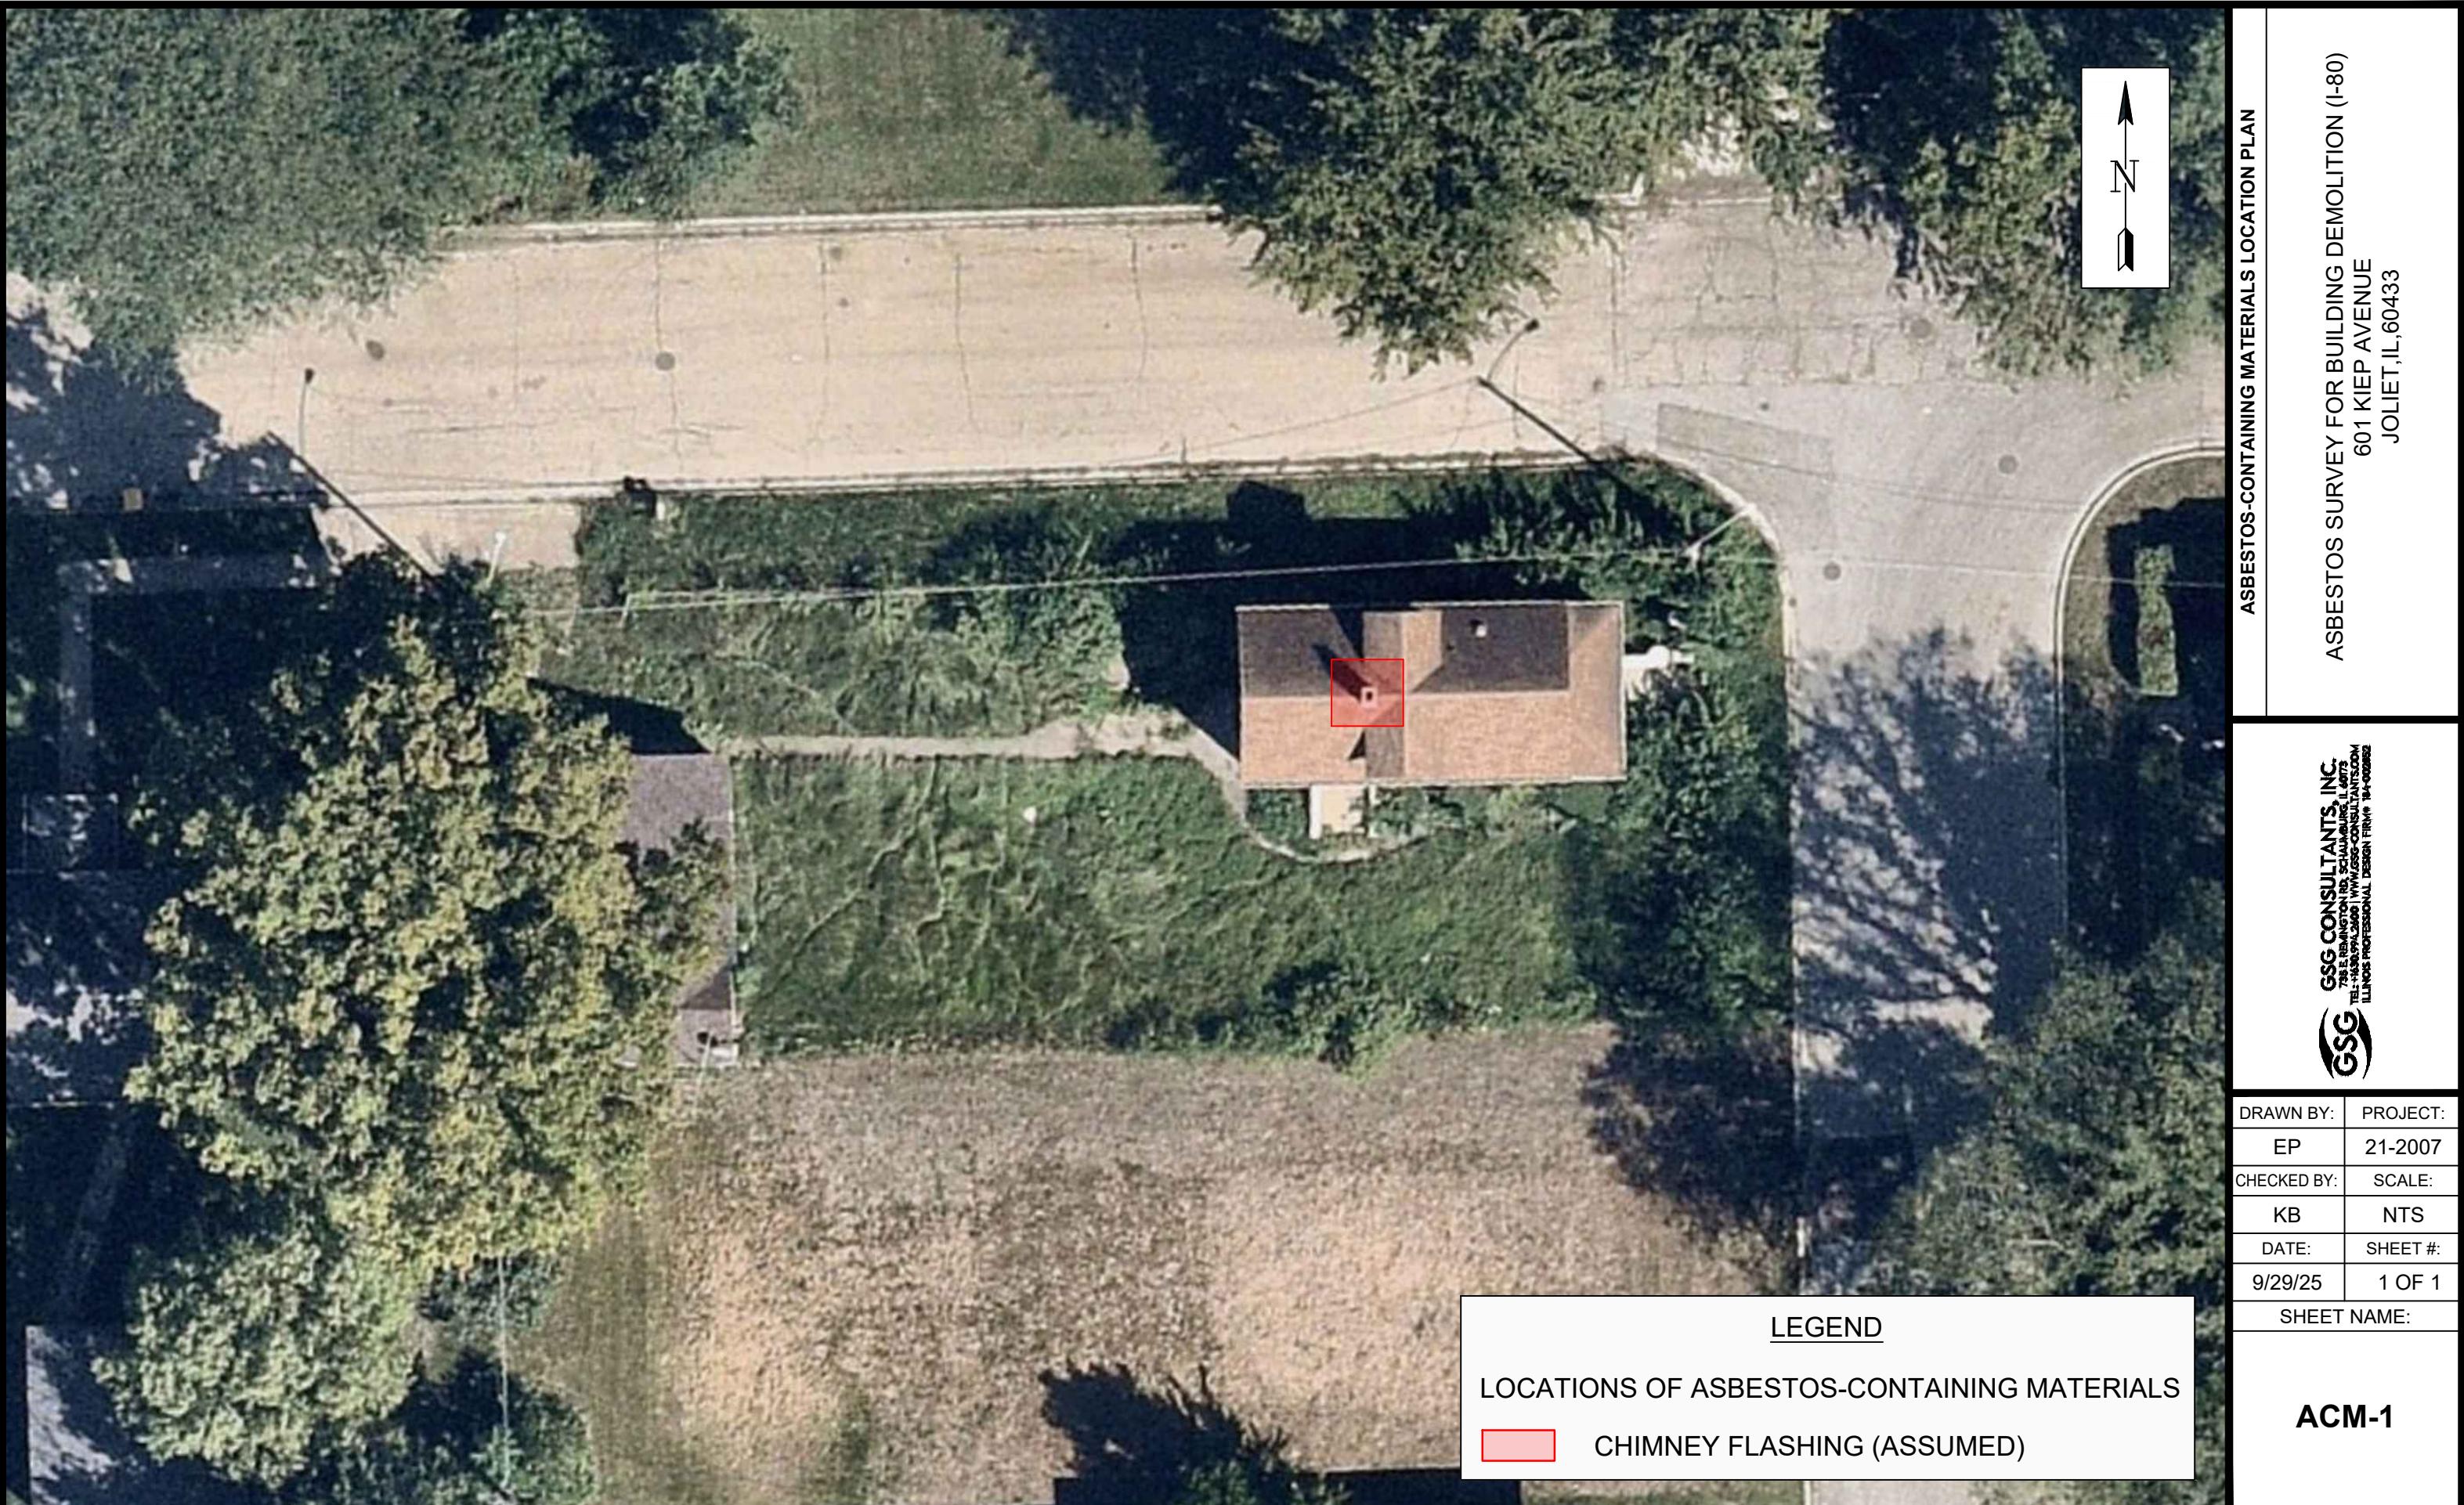
ACM-1 **ACM Location Plan**

All the representative samples collected by GSG during this survey were identified to be non-asbestos-containing. Suspect ACM that was observed but was inaccessible for sampling at the time of the survey, and therefore assumed ACM include the following: **chimney flashing**. These materials will remain assumed until sampling can occur. Please refer to **Table 1** for a list of materials that were sampled for asbestos. **Exhibit 2, ACM Locations**, shows the approximate locations of assumed ACMs present in the building.

GSG understands that the residential property will be demolished as part of the I-80 improvement project. ACMs identified at the site must be removed and managed in accordance with all federal, state, and local regulations governing asbestos. ACMs abatement and management are subject to the USEPA, the Occupational and Health Administration (OSHA), Illinois Department of Public Health (IDPH), the Illinois Environmental Protection Agency (Illinois EPA), and other applicable federal, state, and local government regulations. The following regulations governing asbestos removal and disposal:

All friable asbestos-containing building materials (ACBMs) identified shall be removed from any building(s) or other structures before demolition. Non-friable ACMs may be left in place, unless during demolition, the ACMs may become friable.

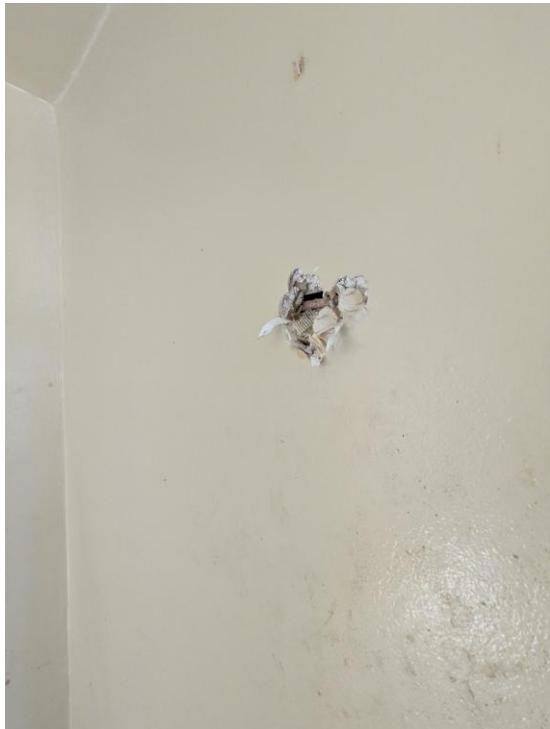
| HA No. | Material Description | Location | Type ⁽¹⁾ | Condition | Friable | % Asbestos* | # of Samples | Estimated Quantity ⁽²⁾ |
|---|---|---|---|---|---|---|---|---|
| 1 | Drywall System (Drywall, Tape Compound) | Throughout | Misc. | Good | No | Asbestos Not Detected | 3 | N/A |

Material Description:
Drywall System (Tape, Compound, Drywall)

Photo Location:
Bedroom

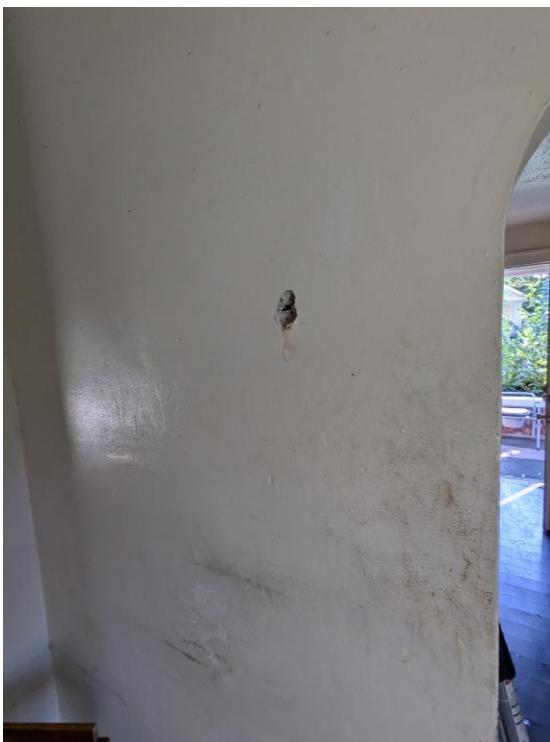
| HA No. | Material Description | Location | Type ⁽¹⁾ | Condition | Friable | % Asbestos* | # of Samples | Estimated Quantity ⁽²⁾ |
|---|---|---|---|---|---|---|---|---|
| 2 | Plaster | Throughout | Surf. | Good | No | Asbestos Not Detected | 3 | N/A |

Material Description:
Plaster

Photo Location:
Living Room

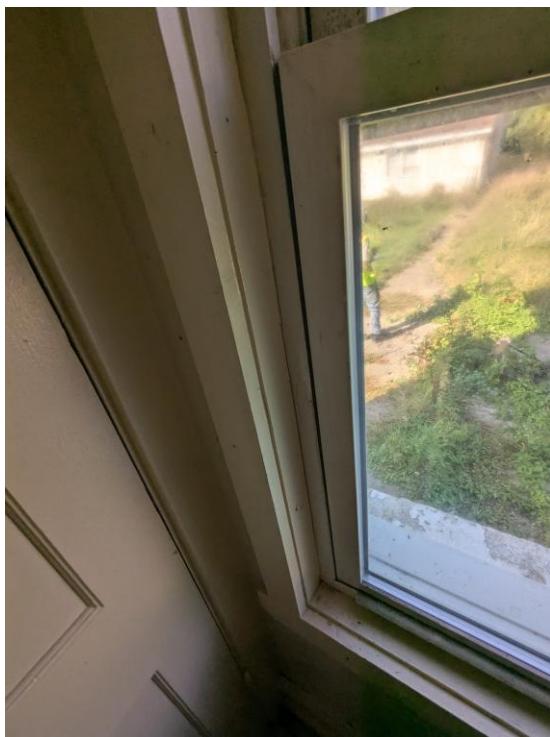
| HA No. | Material Description | Location | Type ⁽¹⁾ | Condition | Friable | % Asbestos* | # of Samples | Estimated Quantity ⁽²⁾ |
|---|---|---|---|---|---|---|---|---|
| 4 | Interior Window Caulk | Throughout | Misc. | Good | No | Asbestos Not Detected | 3 | N/A |

Material Description:
Interior Window Caulk

Photo Location:
Living Room

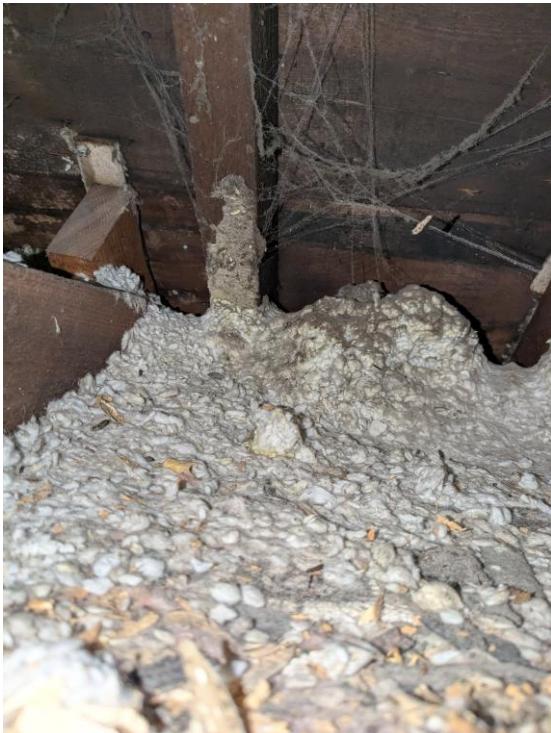
| HA No. | Material Description | Location | Type ⁽¹⁾ | Condition | Friable | % Asbestos* | # of Samples | Estimated Quantity ⁽²⁾ |
|---|---|---|---|---|---|---|---|---|
| 5 | Attic Insulation | Attic | TSI | Good | Yes | Asbestos Not Detected | 3 | N/A |

Material Description:
Attic Insulation

Photo Location:
Attic

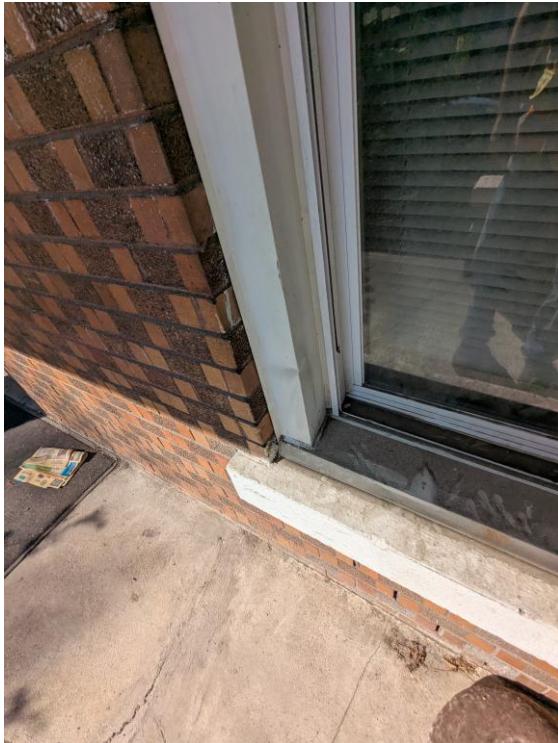
| HA No. | Material Description | Location | Type ⁽¹⁾ | Condition | Friable | % Asbestos* | # of Samples | Estimated Quantity ⁽²⁾ |
|---|---|---|---|---|---|---|---|---|
| 8 | Exterior Window Caulk | Exterior | Misc. | Good | No | Asbestos Not Detected | 3 | N/A |

Material Description:
Exterior Window Caulk

Photo Location:
Exterior

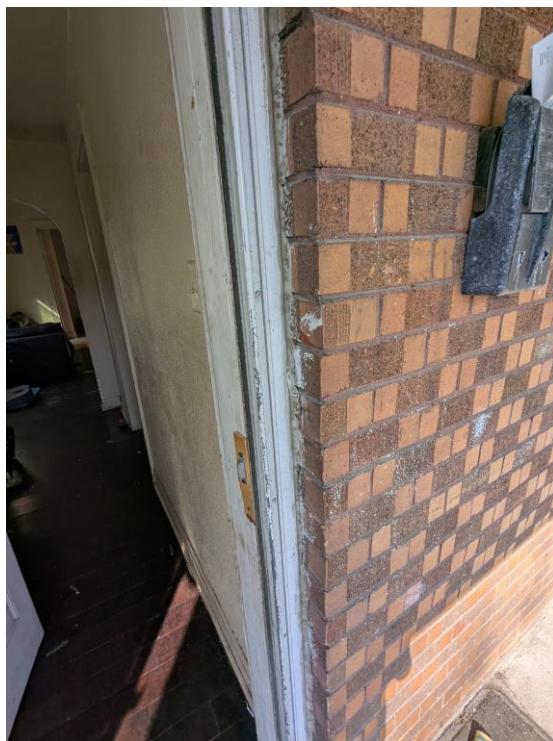
| HA No. | Material Description | Location | Type ⁽¹⁾ | Condition | Friable | % Asbestos* | # of Samples | Estimated Quantity ⁽²⁾ |
|---|---|---|---|---|---|---|---|---|
| 7 | Exterior Door Caulk | Exterior | Misc. | Good | No | Asbestos Not Detected | 3 | N/A |

Material Description:
Exterior Door Caulk

Photo Location:
Exterior

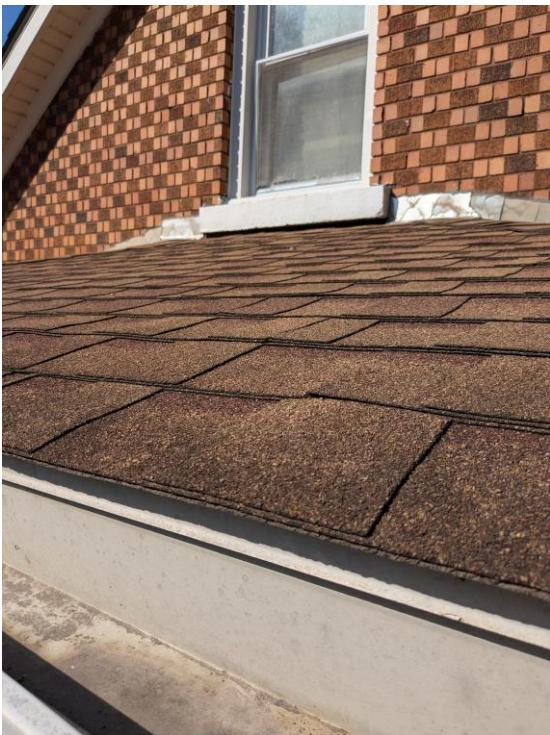
| HA No. | Material Description | Location | Type ⁽¹⁾ | Condition | Friable | % Asbestos* | # of Samples | Estimated Quantity ⁽²⁾ |
|---|---|---|---|---|---|---|---|---|
| 9 | Roofing Material (3 Layers) | Garage & House Roof | Misc. | Good | No | Asbestos Not Detected | 3 | N/A |

Material Description:
Roofing Material (3 Layers)

Photo Location:
Roof

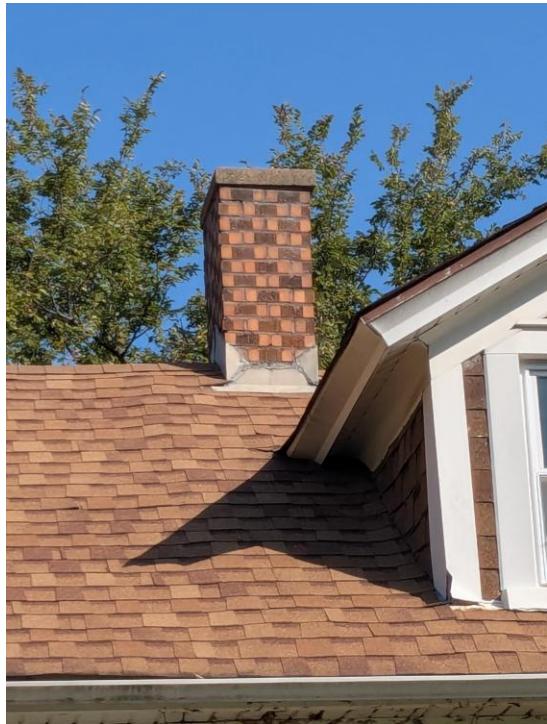
| Building Access Limitations: | Unable to safely access chimney flashing during this inspection. | |

| HA No. | Material Description | Location | Type ⁽¹⁾ | Condition | Friable | % Asbestos* | # of Samples | Estimated Quantity ⁽²⁾ |
|---|---|---|---|---|---|---|---|---|
| 10 | Chimney Flashing | Roof | Misc. | Good | No | ASSUMED | N/A | 5 LF |

Material Description:
Chimney Flashing –
Assumed ACM

Photo Location:
Roof

Abatement and emergency response shall be conducted only by IDPH licensed asbestos abatement contractor(s) under the supervision of a licensed asbestos project manager in accordance with all applicable federal, state, and local regulations. Workers who abate or manage asbestos must receive the proper training and licensing. OSHA prescribes required personnel monitoring including air monitoring and medical monitoring (ref 29 CFR 1926.1101). Personnel protective equipment and procedures are also required.
