# ASBESTOS SURVEY REPORT

**PTB 196-032**

**Asbestos Survey for Building Demolition (I-80)**

**513 Illinois Street, Joliet, Illinois**

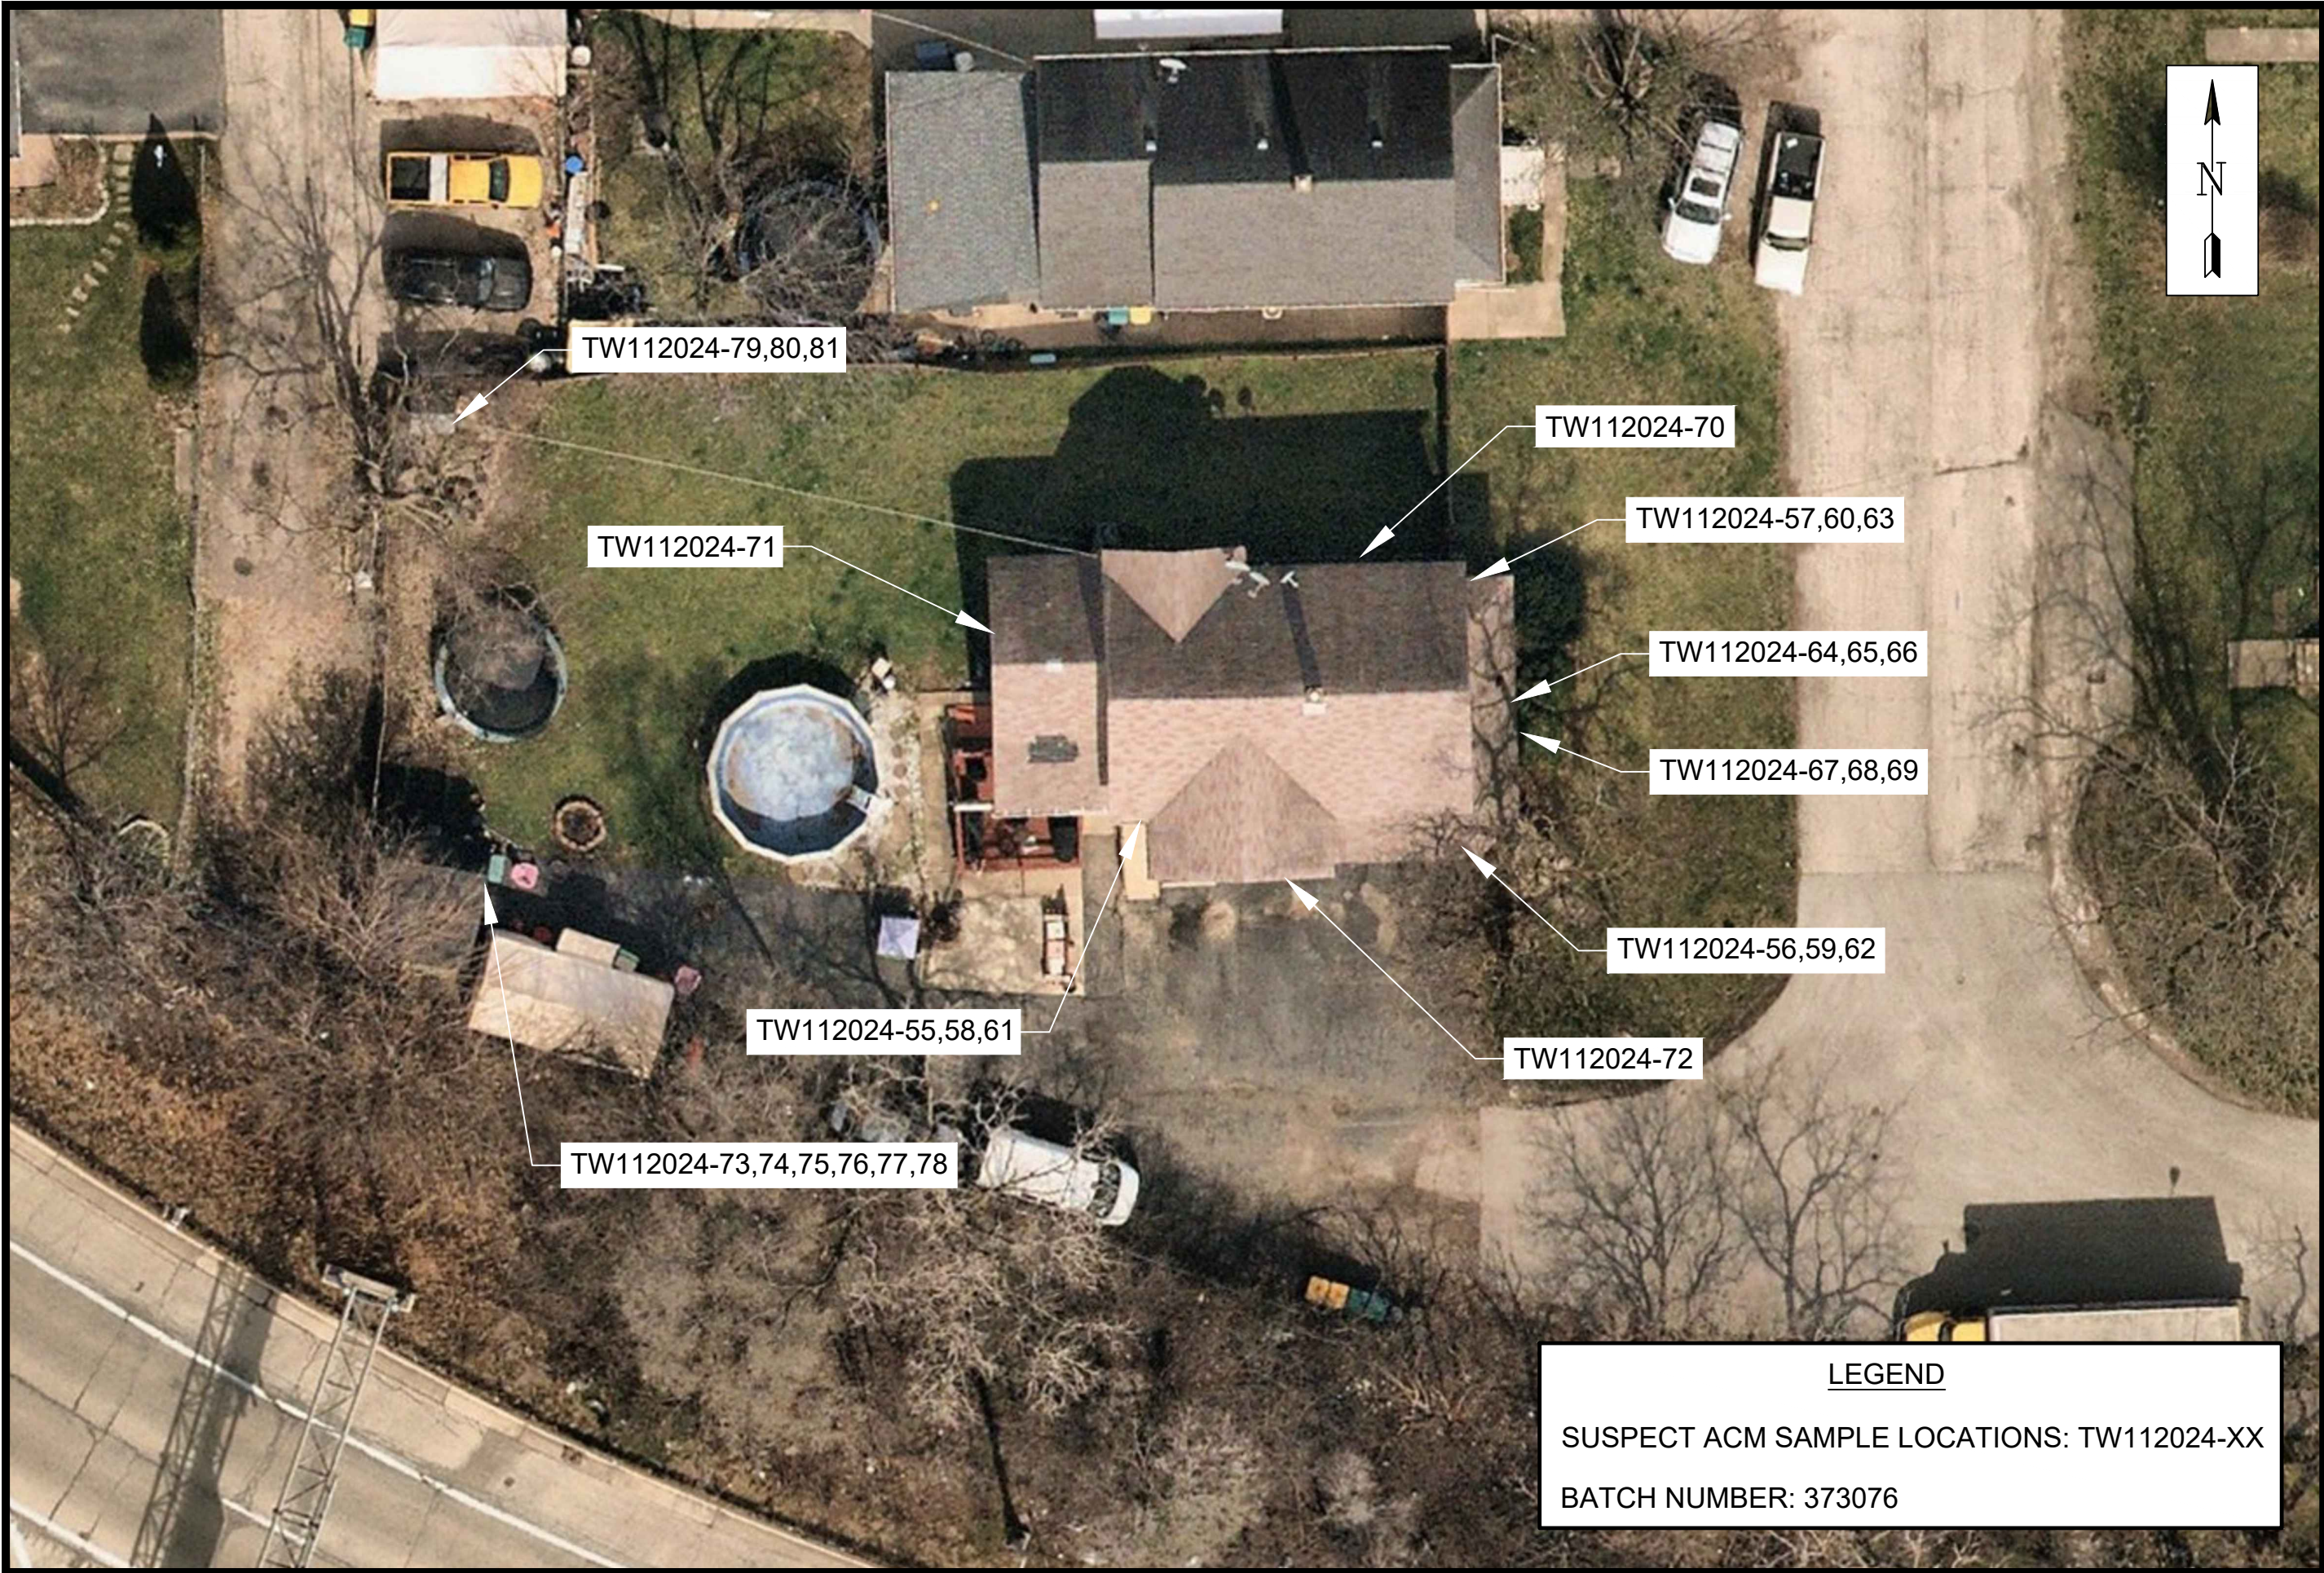
SL-4

SUSPECT ASBESTOS-CONTAINING MATERIALS SAMPLE LOCATION PLAN

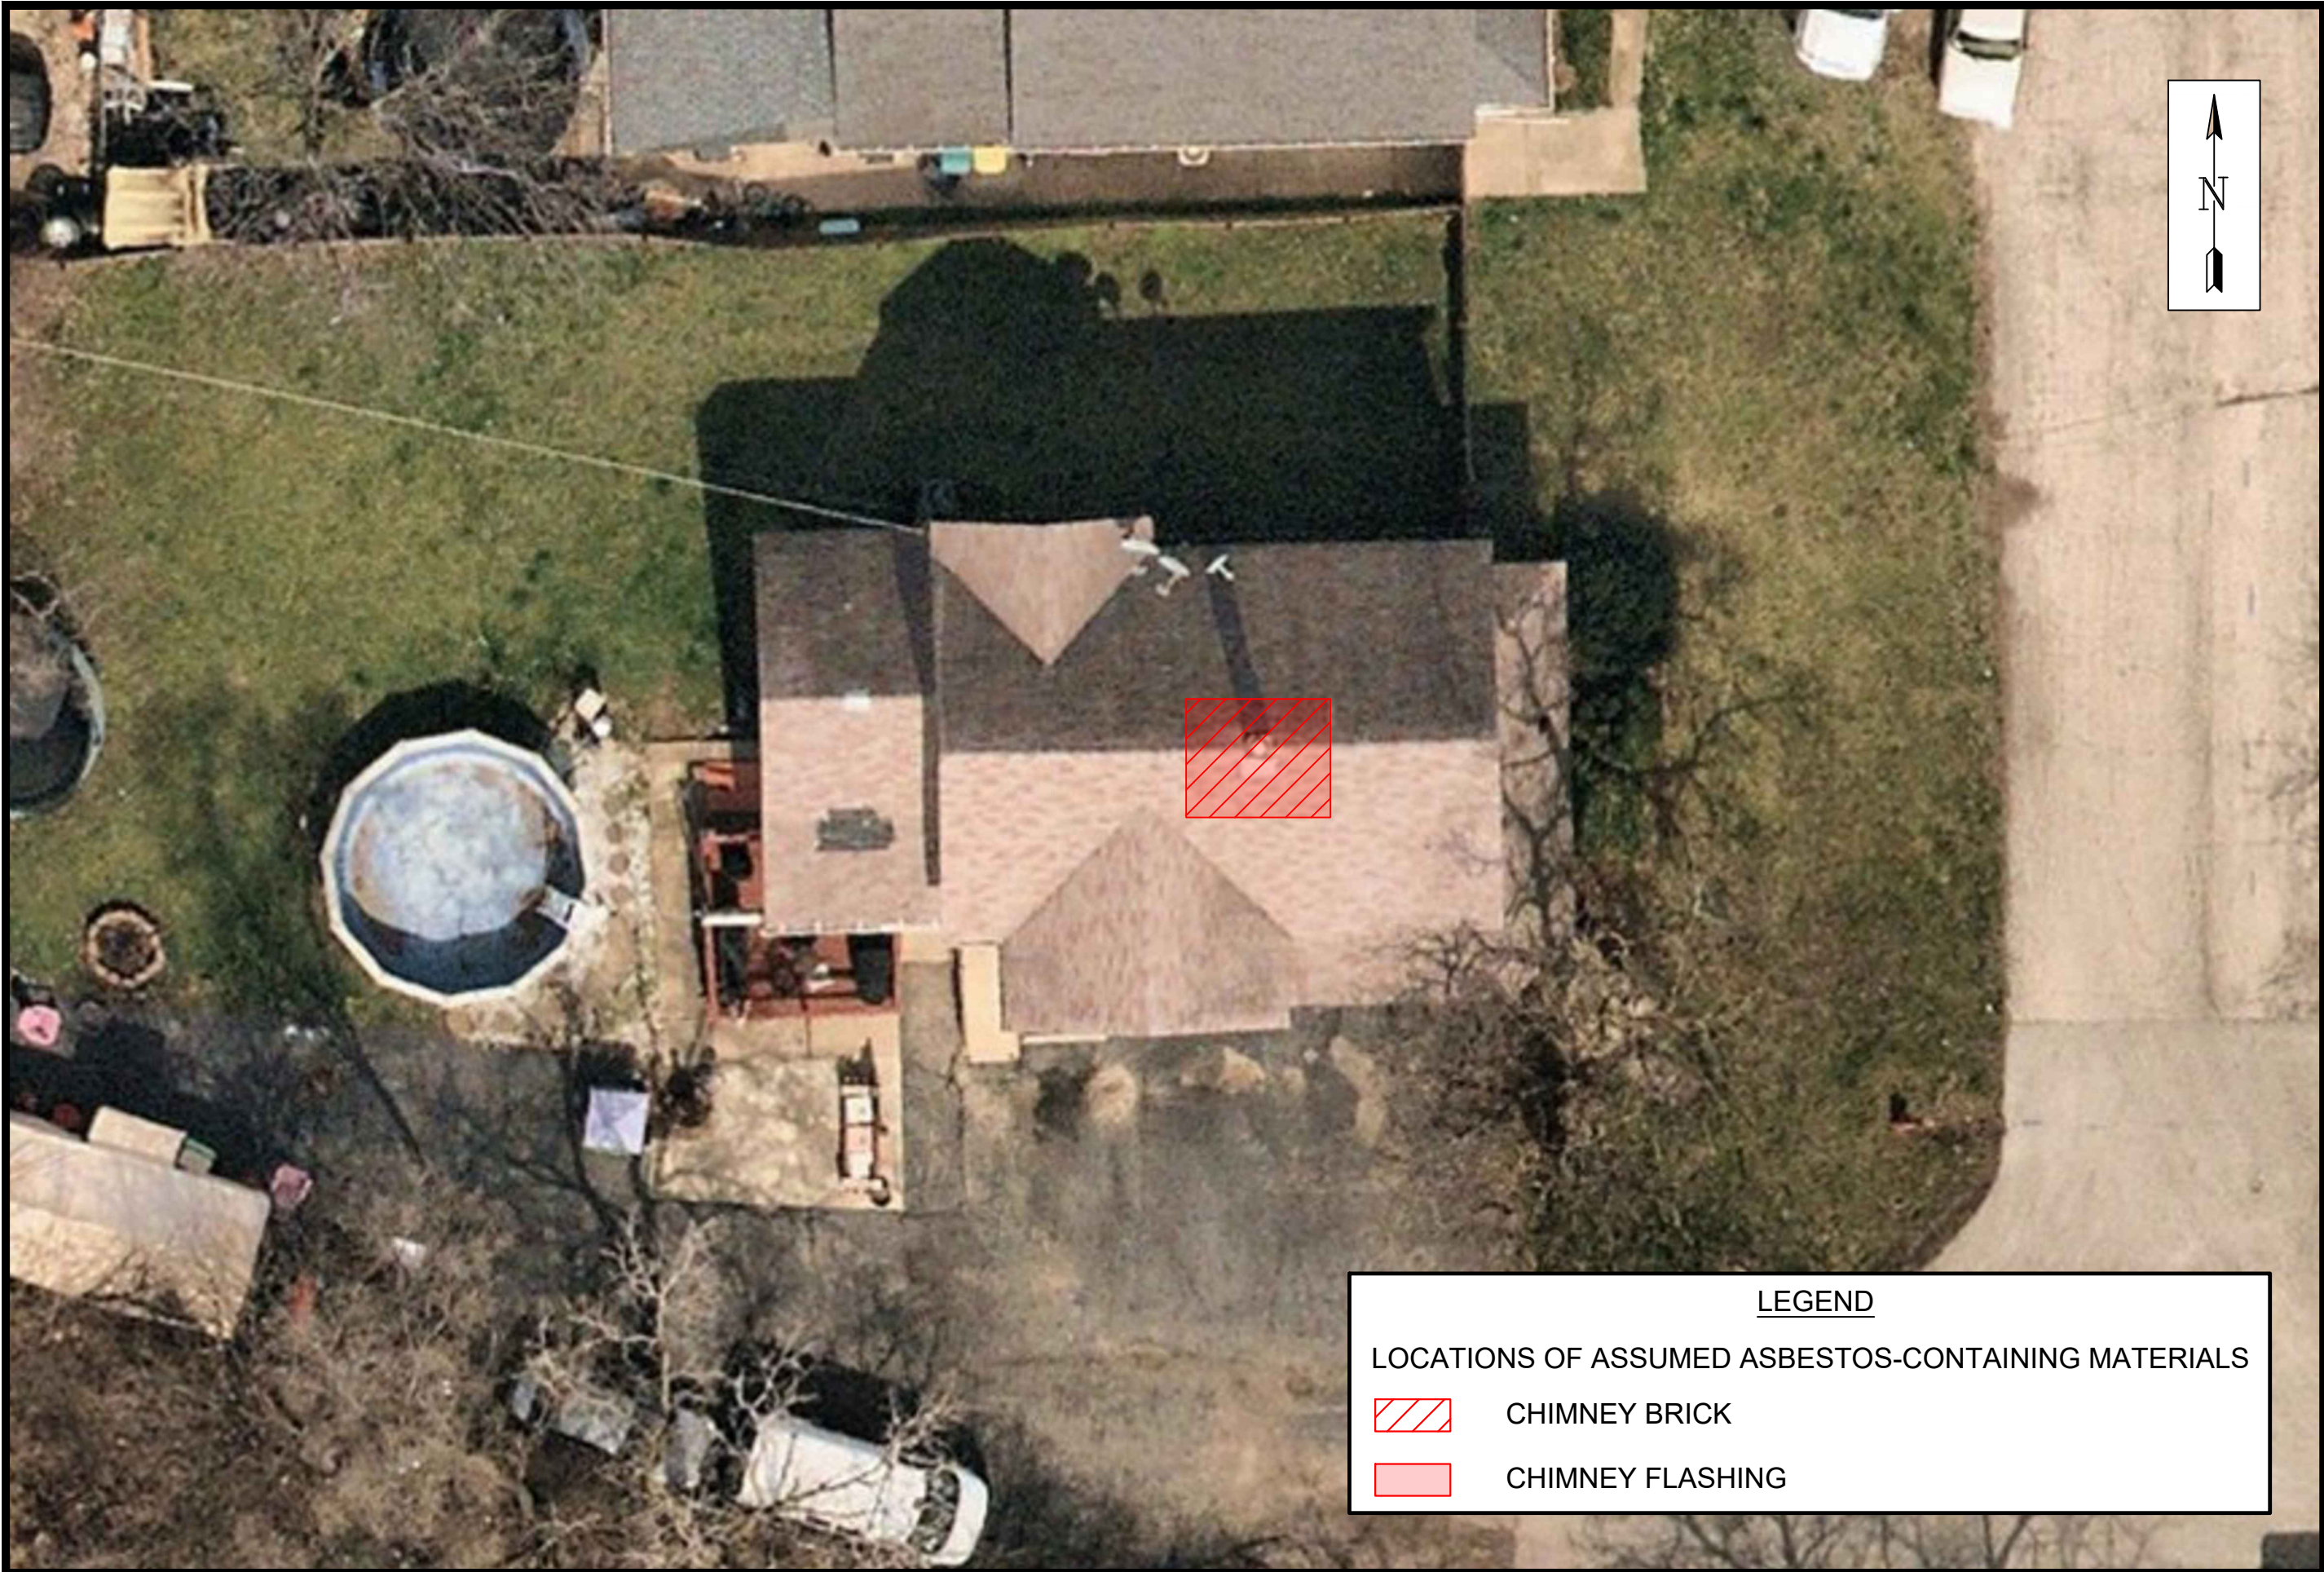
ACM-1

The laboratory reported that asbestos was Not Detected (ND) in the remaining bulk samples collected by GSG. **Exhibit 2, ACM Locations**, shows the approximate locations of ACMs present in the building.

LOCATIONS OF ASSUMED ASBESTOS-CONTAINING MATERIALS

CHIMNEY BRICK

CHIMNEY FLASHING

ASBESTOS-CONTAINING MATERIALS LOCATION PLAN

All friable asbestos-containing building materials (ACBMs) identified shall be removed from any building(s) or other structures before demolition. Non-friable ACMs may be left in place, unless during demolition, the ACMs may become friable. If other suspect materials not referenced in this survey report, within or on the outside of the buildings, are identified, not listed in **Table 1**, such materials shall be assumed ACMs until the materials are inspected by a licensed asbestos inspector, sampled, and submitted for laboratory analysis. As the floor tile identified as asbestos containing is a Category I non-friable material which is not likely to become friable during demolition, it does not need to be removed prior to demolition.

GSG recommends the preparation of an asbestos abatement project design before any demolition. An asbestos abatement design plan and specifications should include information regarding the location of containments and barriers, type of sealant, and air sampling requirements and clearance during the asbestos abatement activities. The asbestos design plan and specifications shall be prepared and signed by an IDPH licensed asbestos project designer following Illinois regulations. Before starting any abatement activities, an Asbestos Abatement notification is required for all asbestos projects and must be applied for at least ten (10) working days before the start of the project. A building demolition notification is required for all demolition projects and must be applied for at least ten (10) working days before the start of the project.

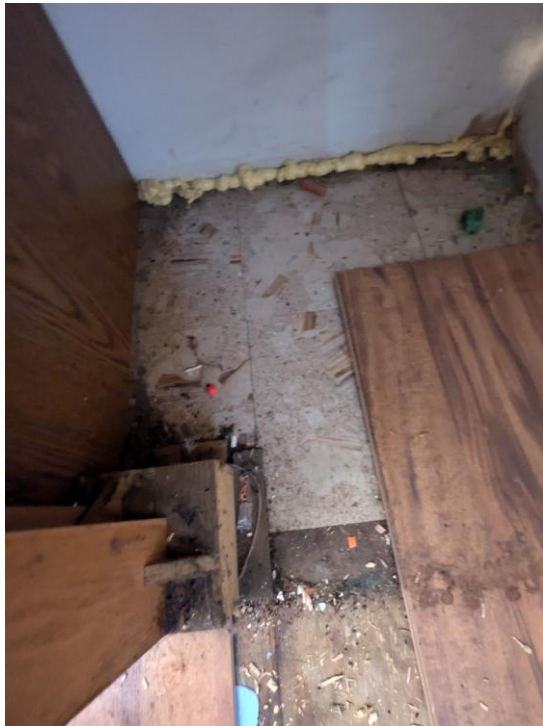
**Material Description:**  
Suspect ACM 12"x12"  
White Multi-Colored  
Floor Tile and Mastic

**Photo Location:**  
Kitchen

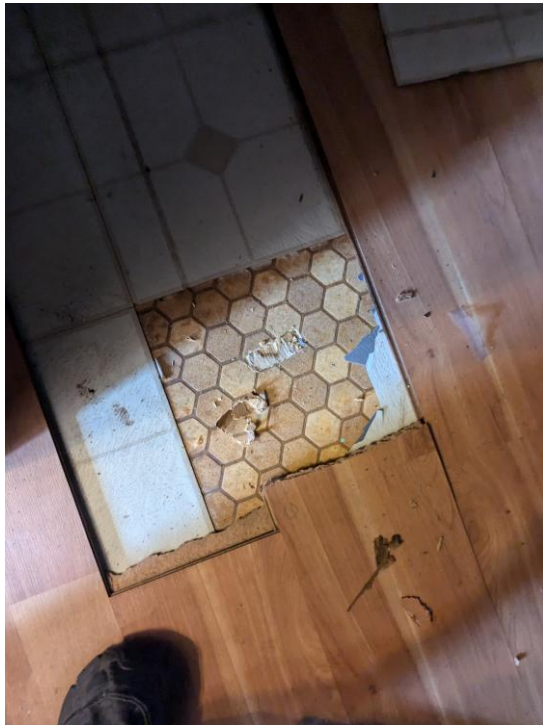
**Material Description:**  
Suspect ACM Tan  
Hexagon Linoleum

**Photo Location:**  
Bathroom

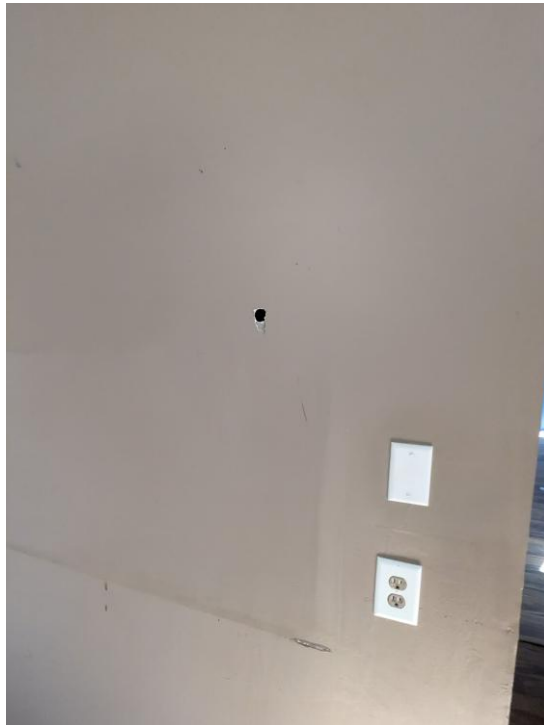
**Material Description:**  
Suspect ACM Drywall  
System

**Photo Location:**  
Living Room

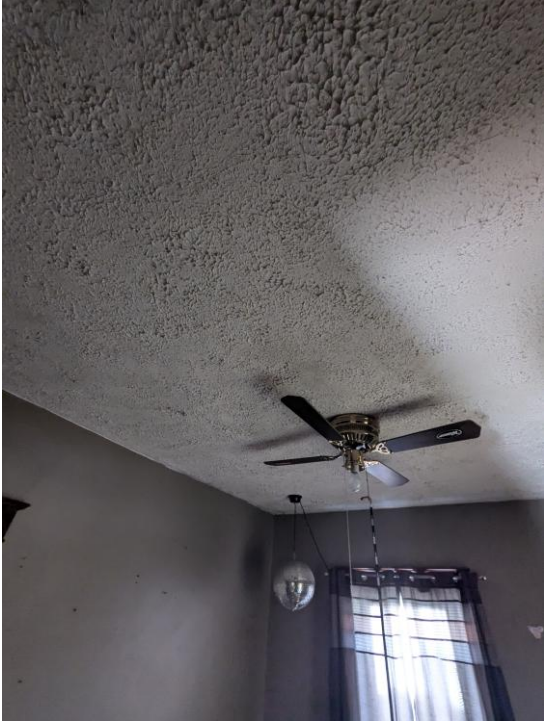
<b>Material Description:</b> Suspect ACM Textured Ceiling	
		<b>Photo Location:</b> Bedroom	
<b>ILLINOIS DEPARTMENT OF TRANSPORTATION I-80 OVER DES PLAINES RIVER BRIDGE IMPROVEMENTS</b>

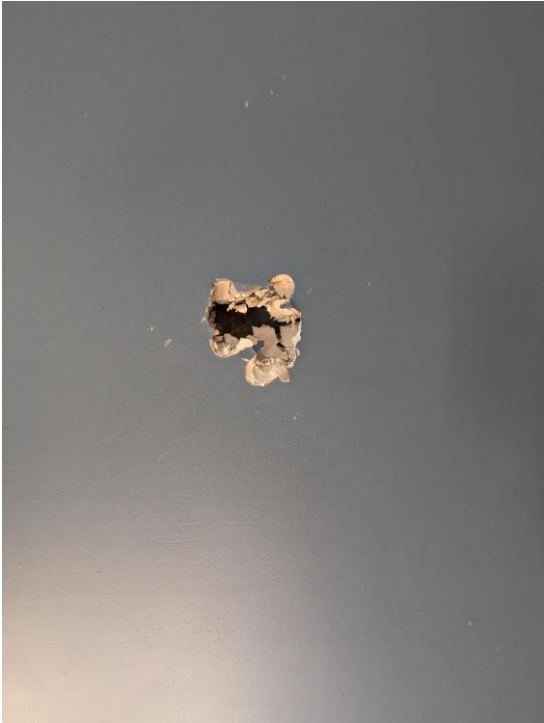
<b>Material Description:</b> Suspect ACM Plaster	
		<b>Photo Location:</b> Bedroom	
<b>ILLINOIS DEPARTMENT OF TRANSPORTATION I-80 OVER DES PLAINES RIVER BRIDGE IMPROVEMENTS</b>

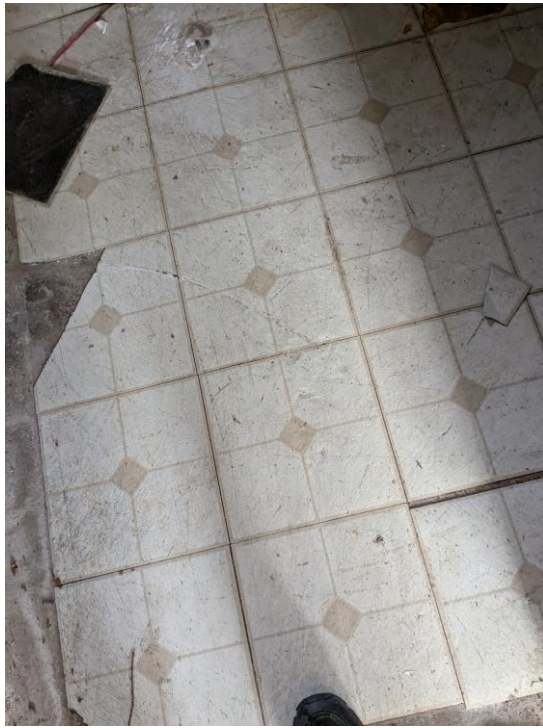
**Material Description:**  
Suspect ACM 12"x12"  
White Floor Tile and  
Mastic

**Photo Location:**  
Basement Bathroom

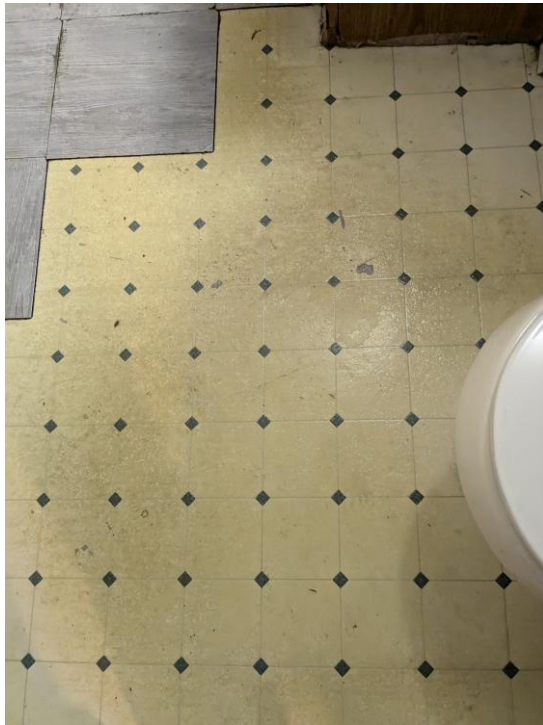
**Material Description:**  
Suspect ACM White  
with Blue Linoleum

**Photo Location:**  
Second Floor  
Bathroom

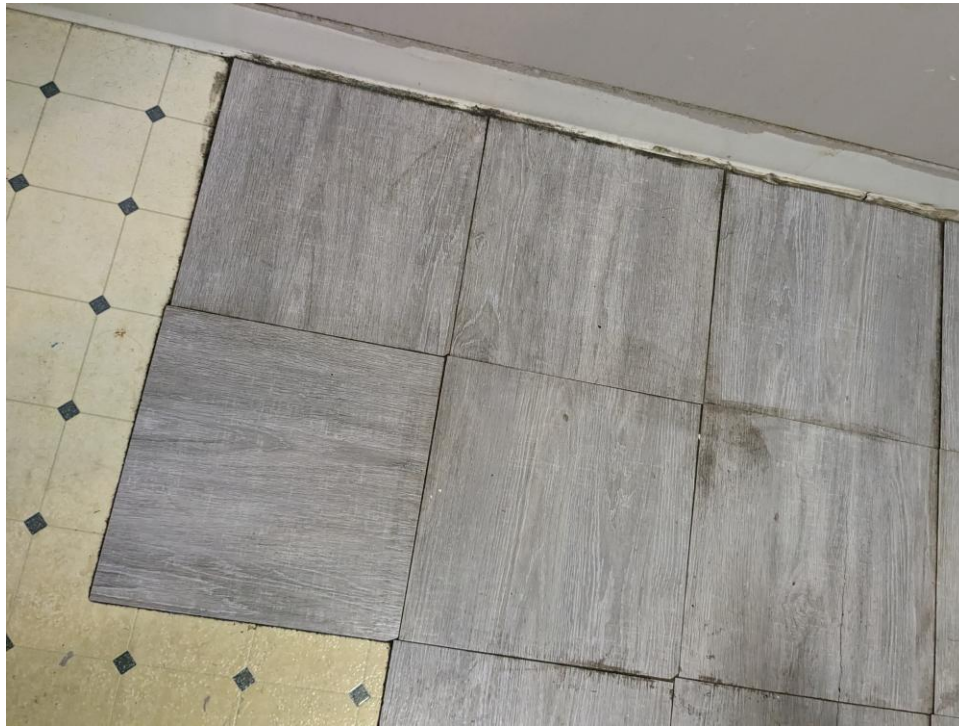
**Material Description:**  
Suspect ACM 12"x12"  
Grey Floor Tile and  
Mastic

**Photo Location:**  
Second Floor  
Bathroom

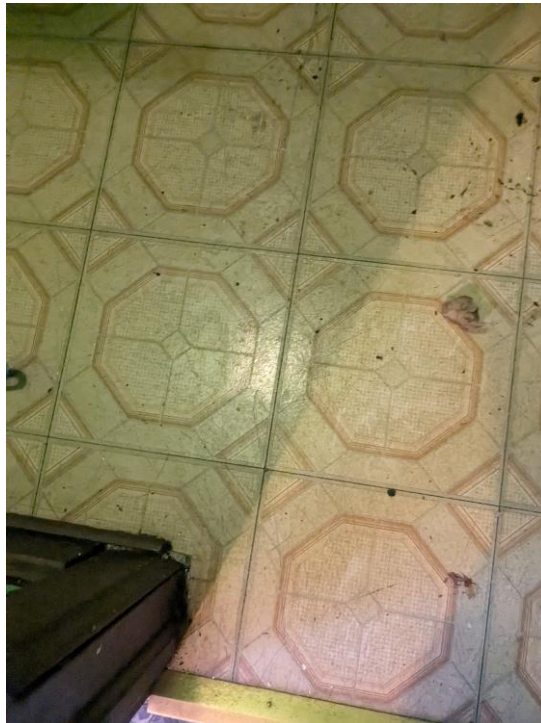
**Material Description:**  
Suspect ACM 12"x12"  
Tan with Brown Floor  
Tile and Mastic

**Photo Location:**  
Second Floor Pantry

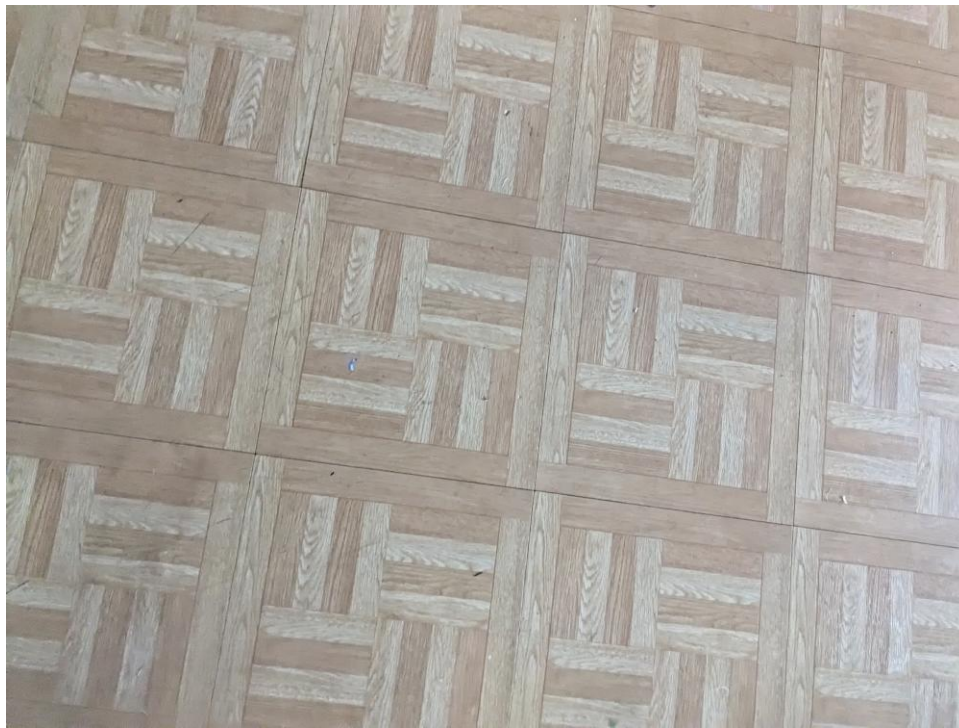
**Material Description:**  
Suspect ACM 12"x12"  
Wood Pattern Floor  
Tile and Mastic

**Photo Location:**  
Second Floor

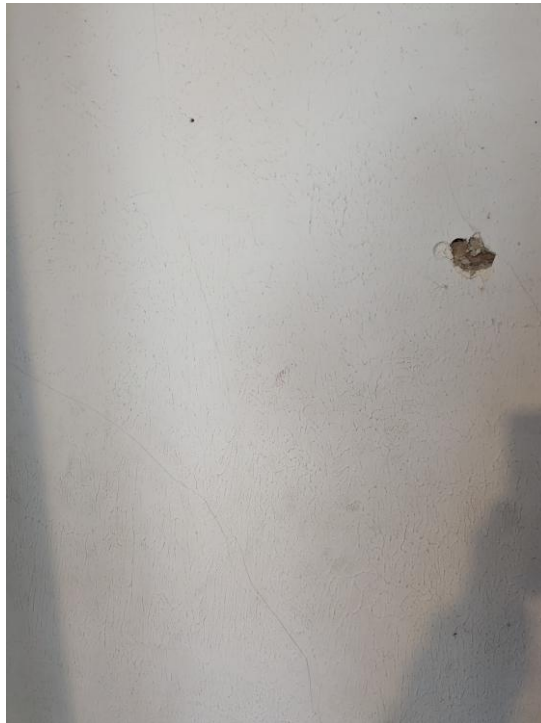
**Material Description:**  
Suspect ACM Textured  
Plaster

**Photo Location:**  
Second Floor

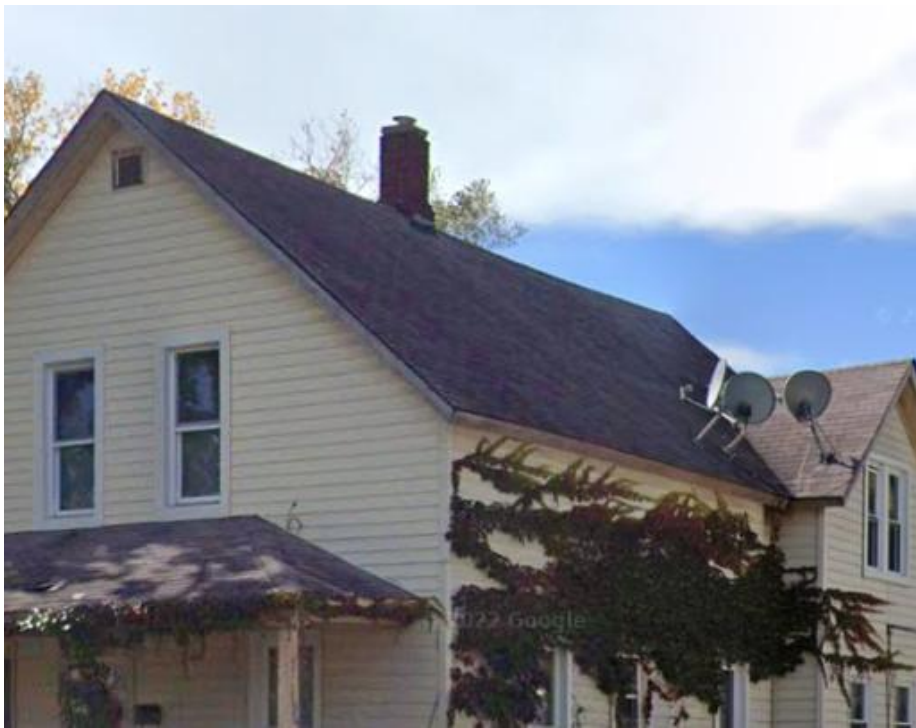
**Material Description:**  
Suspect ACM Roofing  
Material

**Photo Location:**  
Roof

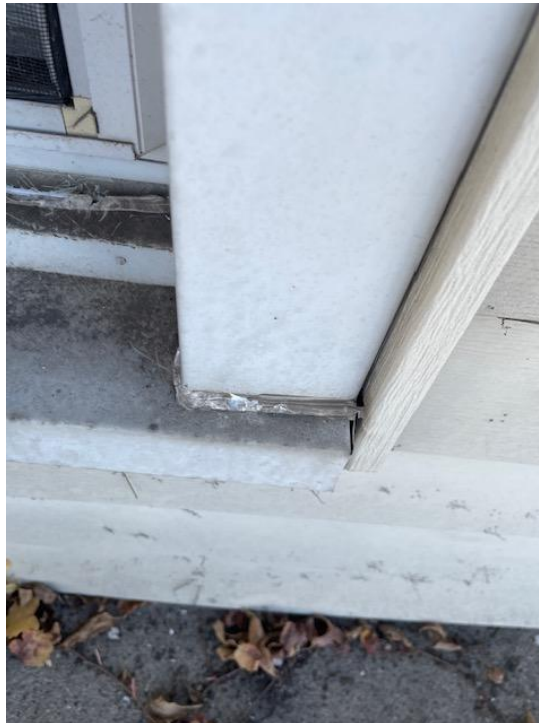
**Material Description:**  
Suspect ACM Exterior  
Window Caulk

**Photo Location:**  
Exterior

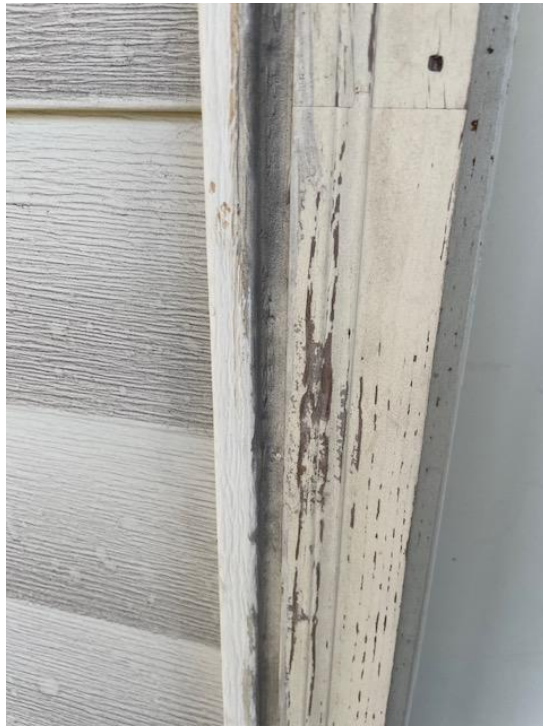
**Material Description:**  
Suspect ACM Exterior  
Door Caulk

**Photo Location:**  
Exterior

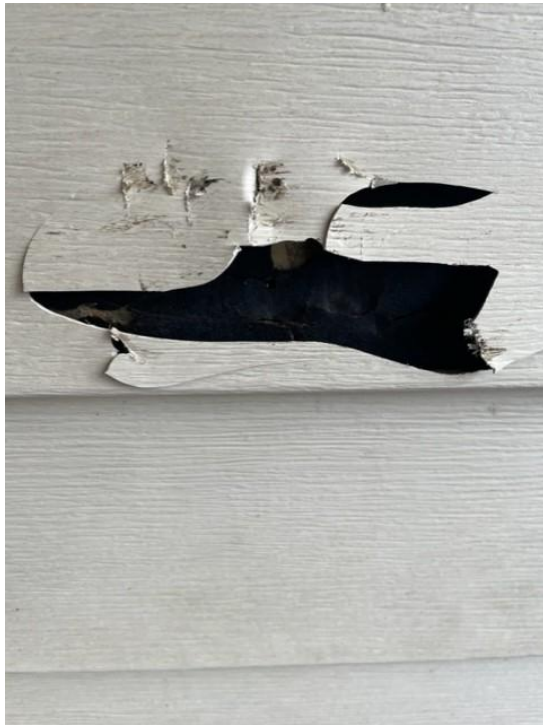
**Material Description:**  
Suspect ACM Felt  
Under Siding

**Photo Location:**  
Exterior

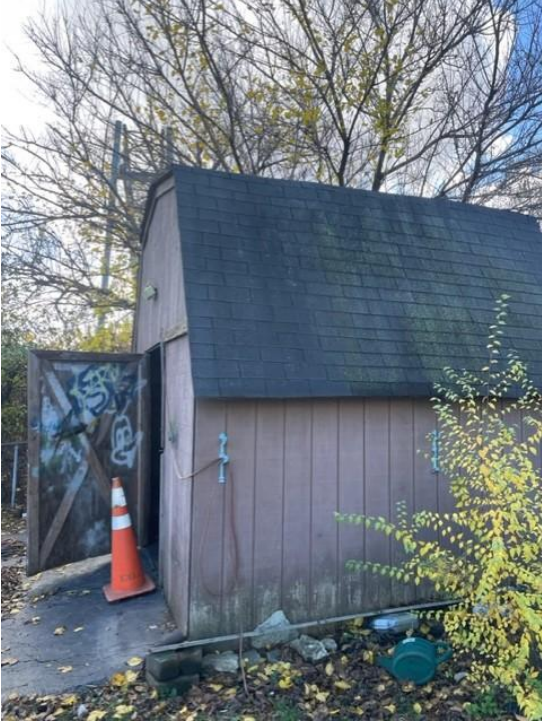
<b>Material Description:</b> Suspect ACM Shed Roofing Material
		<b>Photo Location:</b> Shed Roof
<b>ILLINOIS DEPARTMENT OF          TRANSPORTATION          I-80 OVER DES PLAINES RIVER BRIDGE          IMPROVEMENTS</b>

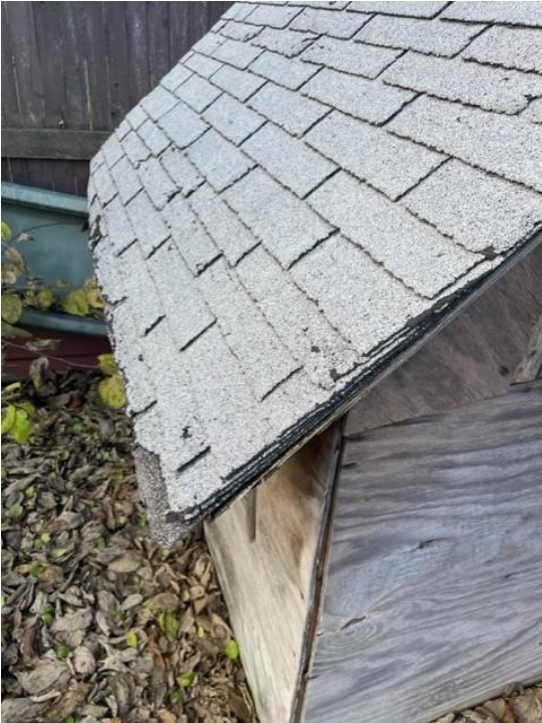
<b>Material Description:</b> Suspect ACM Doghouse Roofing Material
		<b>Photo Location:</b> Doghouse Roof
<b>ILLINOIS DEPARTMENT OF          TRANSPORTATION          I-80 OVER DES PLAINES RIVER BRIDGE          IMPROVEMENTS</b>

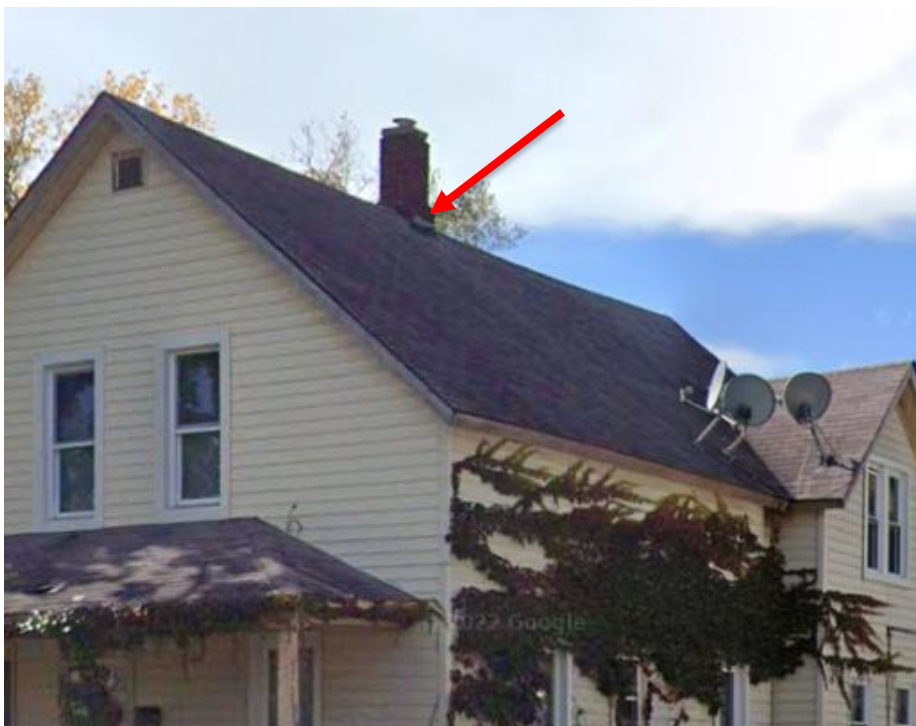
29	<b>Chimney Flashing</b>	<b>Roof</b>	<b>Misc.</b>	<b>Good</b>	<b>No</b>	<b>ASSUMED</b>	<b>N/A</b>	<b>5 LF</b>
Total Estimated Quantity of ACM								40 SF/ 5 LF

**Material Description:**  
Chimney Brick and  
Flashing - **Assumed  
Positive for Asbestos**

**Photo Location:**  
Roof
